Report: Test, Adjust, & Balance

Date: 5/16/2022

05-09 CULVERS - DECATUR, AL

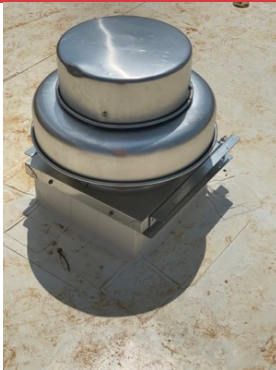
PRV1 RESTROOMS

Issue Name : PRV1 conduit too short

Description : Conduit is too short to tilt fan back. Can only tilt fan an inch from curb

Unit picture

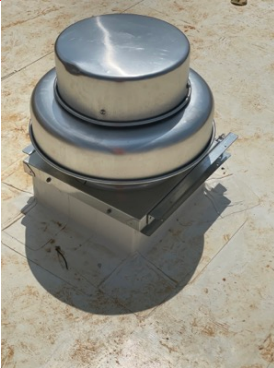
PRV1 RESTROOMS

Unit picture
