Report: TAB Report
Function: Test, Adjust, & Balance
Date: 01/13/2026
Completed By: National TAB

PROJECT
01-05-26 APPLEBEES GREENACRES, FL

Project: 01-05-26 APPLEBEES GREENACRES, FL

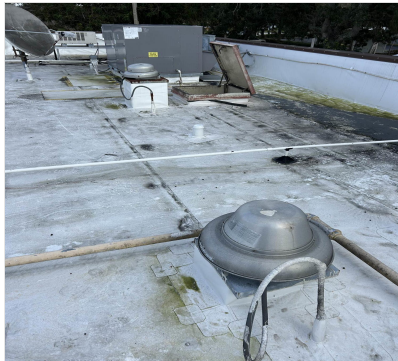
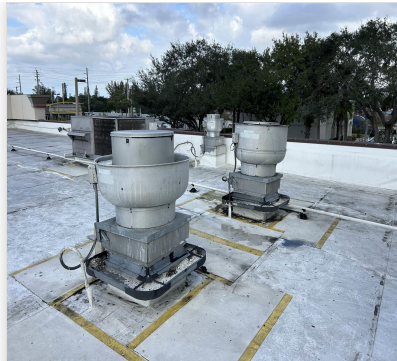
Exterior of fan from multiple angles

If belt driven are the pulleys in good condition and not rusted?	Fail
--	------

FAN PULLEY IS CORRODED

Is the belt tight?	Fail
--------------------	------

BELT LOOSE
