**Report: TAB REPORT**  
**Function: Test, Adjust, & Balance**  
**Date: 04/05/2023**

**PROJECT**  
**03-27-23 FREDDY'S - JASPER, AL**

Project: 03-27-23 FREDDY'S - JASPER, AL

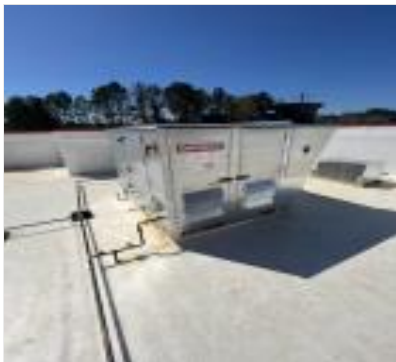
#### DOAS-1

**Description :** Currently DOAS1 is at 3617 CFM when design is at 4800 CFM. Drop is not completely sealed off. Excessive leaking can be felt along edges of drops and around the collars of ductwork.

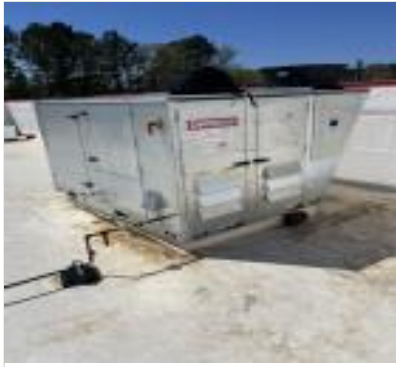
Is space free of drafting?	YES
Is space comfortable in all areas?	YES
Is the space free of ventilation noise?	NO, DOAS-2 LEAKAGE CAN BE HEARD IN THE SPACE.
If deviations from design were necessary to resolve 1-3 what were they? Otherwise put "NA".	NA
