**Report: TAB Survey**  
**Function: Test, Adjust, & Balance**  
**Date: 10/23/2025**  
**Completed By: National TAB**

**PROJECT**  
**10-20-25 APPLEBEES VENICE, FL TAB**  
**SURVEY**

4329 S Tamiami Trl

The scope of this project is to perform a survey of the existing RTU's, EF's, MUA, and hoods. This includes measuring as-is airflows, inspecting the equipment for maintenance issues, and providing additional insight as to the performance and condition.

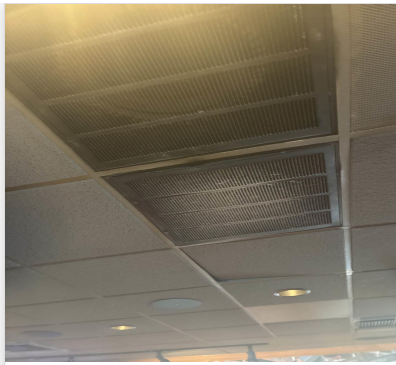
Are all diffusers free of damage and rust? Fail

2 damaged returns in dining area. Damaged supply in women's RR. 1 damaged return in back of house.

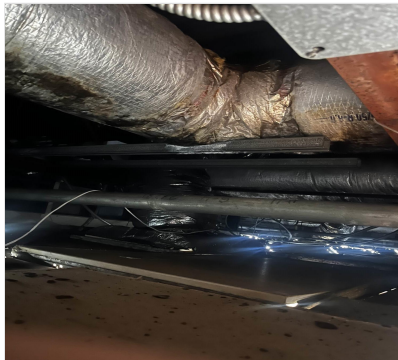
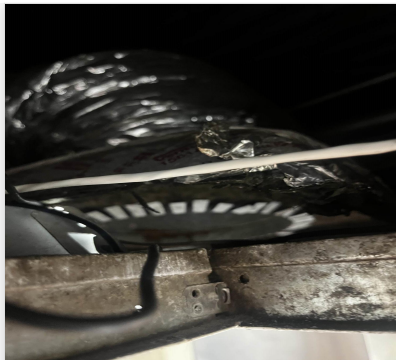
Ductwork appears to be intact and has not come loose above ceiling?

Ductwork appears mostly intact. However the seal between duct and diffuser on most diffusers is not present/adequate

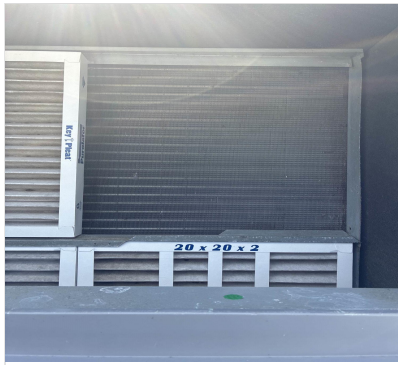
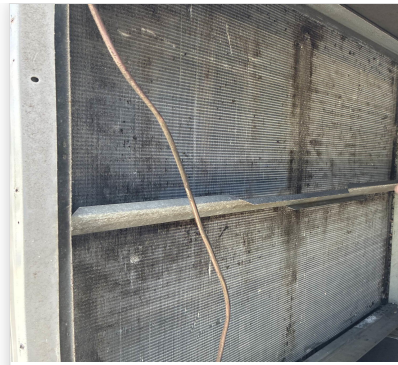
Evaporator coil is clean and in good condition Fail

RTU1: Dirty RTU2: Dirty RTU3: Dirty RTU4: Dirty

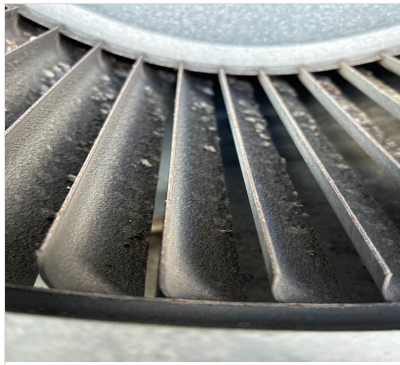
Blower wheel is clean and in good condition

RTU1: Wheel is dirty. RTU2: Wheel is dirty. RTU3: Wheel is dirty.

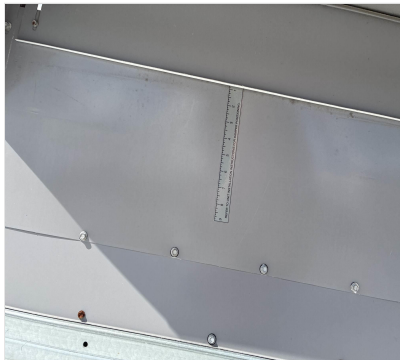
RTU1: No economizer, OA damper is sealed shut RTU2: No economizer, no OA filter, no outside air. RTU3: OA damper only, motor is decoupled from damper. RTU4: Manual OA only

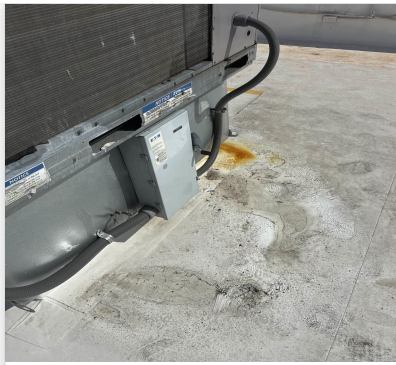
**Issue Name :** Possible compressor oil leak RTU 1  
**Description :** One of the compressors in RTU 1 (labelled as RTU3 on the roof) has a possible oil leak. There is a large amount of oil sitting around base of unit, and the compressors are short cycling.  
**Created By :** National TAB                      **Assigned To :** National TAB - Dan Hertenstein  
**Status :** Open  
**Priority :** Urgent                                      **Asset Tag :**  
**Originated Date :** 10/22/2025 - Jackson Gunnels - National TAB

**Issue Name :** RTU1 Insulation  
**Description :** Insulation lining the blower compartment in RTU1 has separated. Insulation placed in compressor compartment until a repair can be made.  
**Created By :** National TAB **Assigned To :** National TAB - Dan Hertenstein  
**Status :** Open  
**Priority :** Medium **Asset Tag :**  
**Originated Date :** 10/23/2025 - Jackson Gunnels - National TAB

RTU 1 has a short cycling compressor. There is a significant amount of oil around the unit. Unit 1 also has panel of insulation on blower door that has separated. Insulation placed in compressor compartment until repair can be made. RTU2 is not configured to run at one speed.

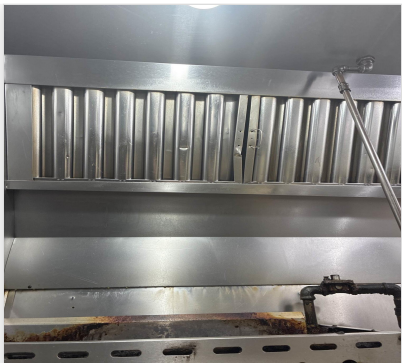
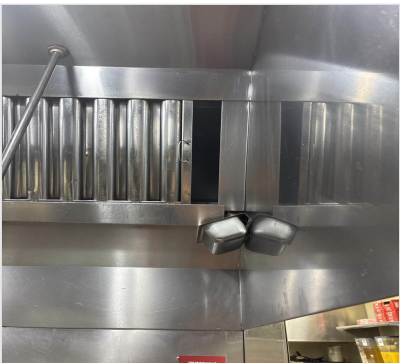
Are all hood filters installed and free of damage? Fail

Hood filters are installed. Most are missing at least one handle, large gap in filters. One dented filter

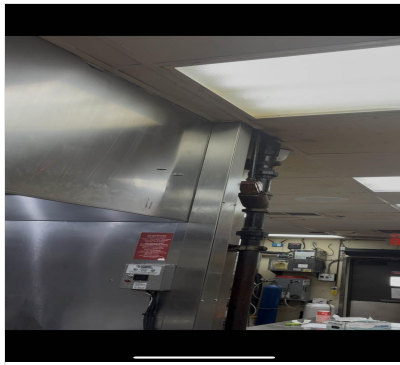
**Issue Name :** Right side hood not capturing all smoke  
**Description :** The right side hood is leaking smoke from fryers on the right side.  
**Created By :** National TAB                      **Assigned To :** National TAB - Dan Hertenstein  
**Status :** Open  
**Priority :** Urgent                                      **Asset Tag :**  
**Originated Date :** 10/23/2025 - Jackson Gunnels - National TAB

100% smoke capture on left hood. 70%-90% capture on right hood, to the right of the fryers.

Mini Split units installed on cook line. Smoke leakage to the right of the fryers.
