**Report: TAB Survey**  
**Function: Test, Adjust, & Balance**  
**Date: 10/23/2025**  
**Completed By: National TAB**

**PROJECT**  
**10-20-25 APPLEBEES VENICE, FL TAB**  
**SURVEY**

The scope of this project is to perform a survey of the existing RTU's, EF's, MUA, and hoods. This includes measuring as-is airflows, inspecting the equipment for maintenance issues, and providing additional insight as to the performance and condition.

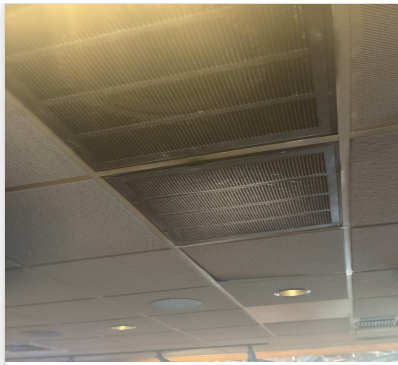
**Are all diffusers free of damage and rust?** Fail

2 damaged returns in dining area. Damaged supply in women's RR. 1 damaged return in back of house.

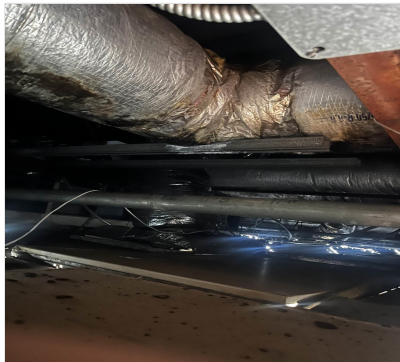
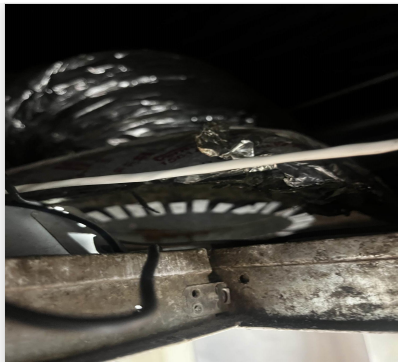
Ductwork appears to be intact and has not come loose above ceiling?

Ductwork appears mostly intact. However the seal between duct and diffuser on most diffusers is not present/adequate

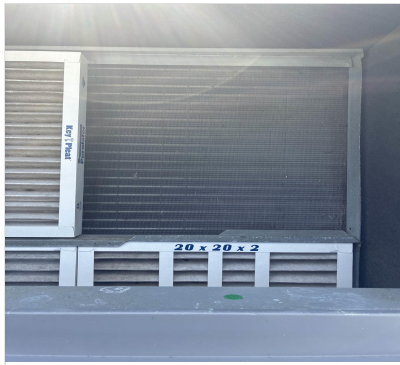
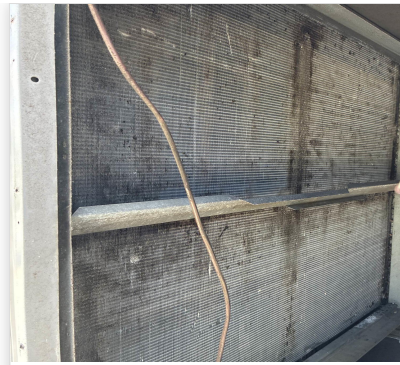
#### Evaporator coil is clean and in good condition

RTU1: Dirty RTU2: Dirty RTU3: Dirty RTU4: Dirty

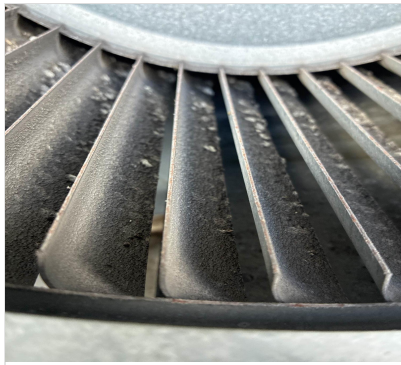
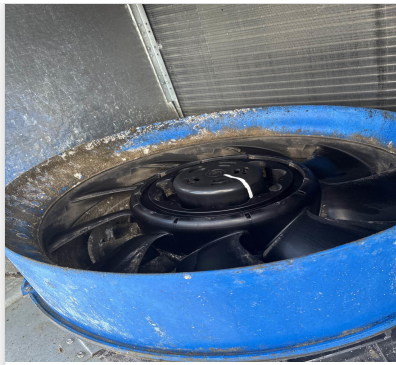
**Blower wheel is clean and in good condition**

RTU1: Wheel is dirty. RTU2: Wheel is dirty. RTU3: Wheel is dirty.

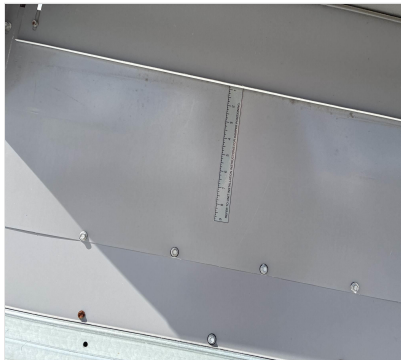
RTU1: No economizer, OA damper is sealed shut RTU2: No economizer, no OA filter, no outside air. RTU3: OA damper only, motor is decoupled from damper. RTU4: Manual OA only

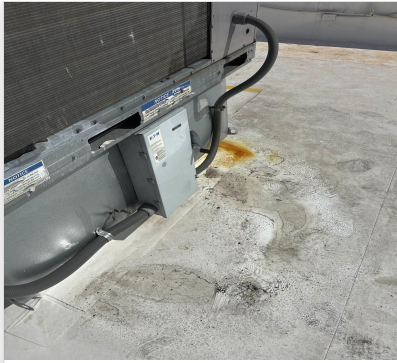
RTU 1 has a short cycling compressor. There is a significant amount of oil around the unit. Unit 1 also has panel of insulation on blower door that has separated. Insulation placed in compressor compartment until repair can be made. RTU2 is not configured to run at one speed.

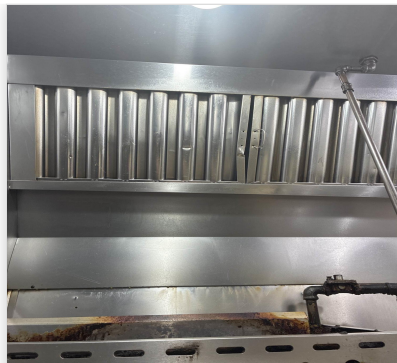
**Are all hood filters installed and free of damage?** Fail

Hood filters are installed. Most are missing at least one handle, large gap in filters. One dented filter

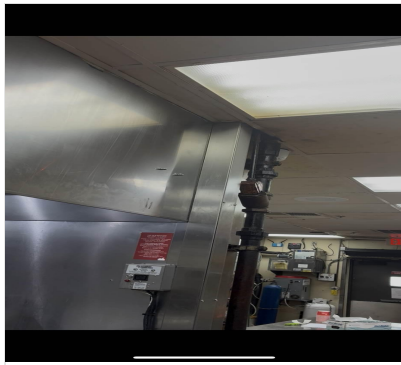
100% smoke capture on left hood. 70%-90% capture on right hood, to the right of the fryers.

Mini Split units installed on cook line. Smoke leakage to the right of the fryers.
