Report: TAB Survey
Function: Test, Adjust, & Balance
Date: 10/23/2025
Completed By: National TAB

PROJECT
10-20-25 APPLEBEES VENICE, FL TAB
SURVEY

The scope of this project is to perform a survey of the existing RTU's, EF's, MUA, and hoods. This includes measuring as-is airflows, inspecting the equipment for maintenance issues, and providing additional insight as to the performance and condition.

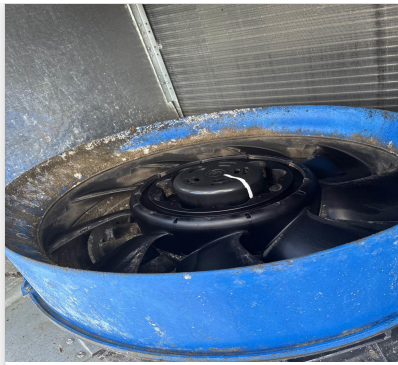
Blower wheel is clean and in good condition

Fail

RTU1: Wheel is dirty. RTU2: Wheel is dirty. RTU3: Wheel is dirty.

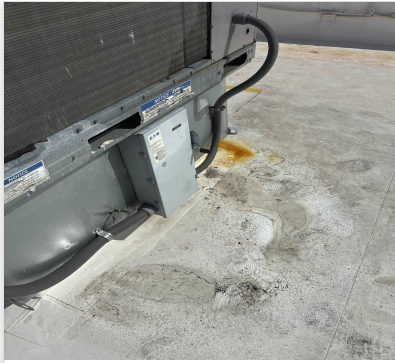
Issue Name : Possible compressor oil leak RTU 1
Description : One of the compressors in RTU 1 (labelled as RTU3 on the roof) has a possible oil leak. There is a large amount of oil sitting around base of unit, and the compressors are short cycling.
Created By : National TAB **Assigned To :** National TAB - Dan Hertenstein
Status : Open
Priority : Urgent **Asset Tag :**
Originated Date : 10/22/2025 - Jackson Gunnels - National TAB

Issue Name : RTU1 Insulation
Description : Insulation lining the blower compartment in RTU1 has separated. Insulation placed in compressor compartment until a repair can be made.
Created By : National TAB **Assigned To :** National TAB - Dan Hertenstein
Status : Open
Priority : Medium **Asset Tag :**
Originated Date : 10/23/2025 - Jackson Gunnels - National TAB

RTU 1 has a short cycling compressor. There is a significant amount of oil around the unit. Unit 1 also has panel of insulation on blower door that has separated. Insulation placed in compressor compartment until repair can be made. RTU2 is not configured to run at one speed.
