Issue List

10-14-24 ULTA 1697 SELMA, NC

Project Issue Information

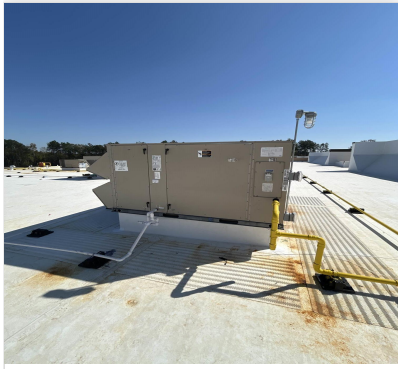
- EF-1 not powered
- EF-2 Restroom fan unable to access
- RTU -4 is currently an alarm.
- RTU 2 hitting max amps with low airflow
- RTU-1 Motor at max amps. The Pulley is at 2 turns out with belt over hang.
- RTU-3 missing damper on supply diffuser SGRD2 & 7
- RTU-4 outside filters not properly attached
- Unable to safely reach damper above ceiling on RTU-2

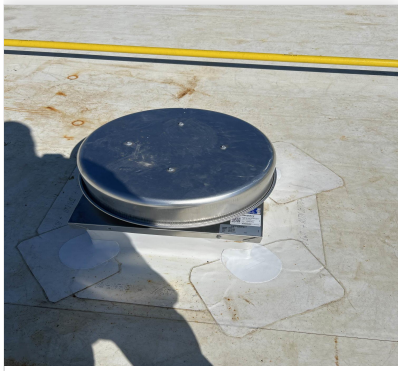
Issue Name : EF-1 not powered
Description : On exhaust fan 1. I am not getting any flow from either supply. The dampers are 100% open.
Created By : National TAB **Assigned To :** National TAB - Dan Hertenstein
Status : Open
Priority : Urgent **Asset Tag :**
Originated Date : 10/14/2024 - Jearod Ferrette - National TAB

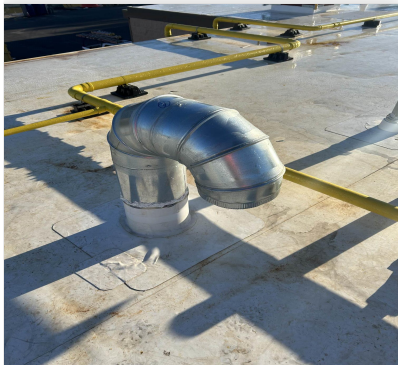
Issue Name : EF-2 Restroom fan unable to access
Description : I am unable to reach the controller for the restroom exhaust fan. The control is above hard ceiling. I am unable to reach from other side with ladder due to piping obstructing access. There are no dampers on either exhaust duct or face. The unit is running at 117% of design.
Created By : National TAB **Assigned To :** National TAB - Dan Hertenstein
Status : Open
Priority : High **Asset Tag :**
Originated Date : 10/14/2024 - Jearod Ferrette - National TAB
