Report: PRELIMINARY TAB REPORT

Function: Test, Adjust, & Balance

10-14-24 ULTA 1697 SELMA, NC

Rectenwald Brothers Construction

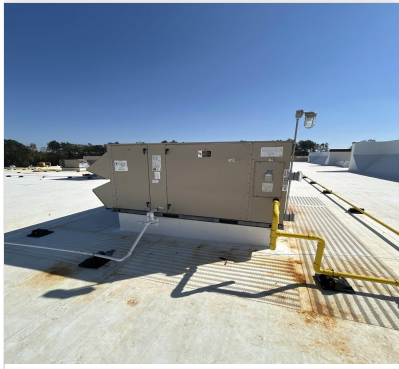
Issue Name : RTU 2 airflow is 72% of design
Description : RTU-2 airflow is 72% of design (3435 CFM at diffusers) with motor at FLA. The duct is installed as 24"x18" inner dimensions but plans show 30"x20". Duct traversed as 3819 CFM. Velocity is 1273 FPM which is high. There is also an additional 90 degree transition installed. A larger motor would be required to achieve design.

Traversed RTU-2 from the main drop and was reading 4245 CFM's. Suggest inspection for leakage due to difference in CFM's. DIFFUSER 24 DAMPER IS CLOSED AND UNACCESSILBE.

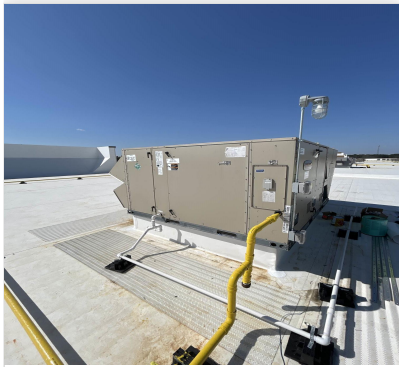
Issue Name : RTU-3 missing damper on supply diffuser SGRD2 & 7
Description : Missing supply damper on RTU-3 SGRD 2 & SGRD 7. Needs to be installed to complete balancing.
Created By : National TAB **Assigned To :** National TAB - Dan Hertenstein
Status : Open
Priority : High **Asset Tag :** RTU3
Originated Date : 10/15/2024 - Jearod Ferrette - National TAB

Notes:
RTU-3 SUPPLY DIFFUSERS ARE MISSING DAMPERS ON SGRD 3 AND SGRD 7. THIS UNIT IS SET TO TOTAL DESIGN AIRFLOW. ONCE DAMPERS ARE INSTALLED, IT CAN BE BALANCED. HIGH WINDS OF ROOF MAY HAVE AFFECTED THE OUTSIDE AIR MEASUREMENT.

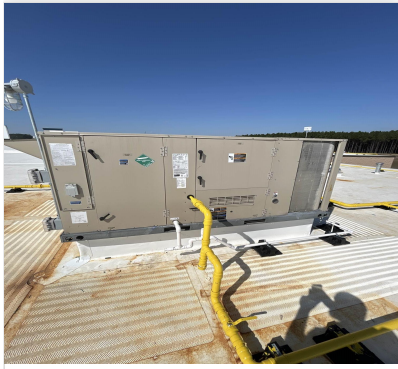
Issue Name : RTU -4 airflow is 149% of design
Description : RTU-4 airflow is 149% of design. Unable to slow unit down with the CORE controller. There is an alarm code 244 (Blower differential pressure sensor error) that appears to be preventing speed adjustment.
Created By : National TAB **Assigned To :** National TAB - Dan Hertenstein
Status : Open
Priority : High **Asset Tag :** RTU4
Originated Date : 10/14/2024 - Jearod Ferrette - National TAB

Notes:
RTU-4 IN ALARM CODE 244 (BLOWER DIFFERENTIAL PRESURE SENSOR ERROR) UNABLE TO SLOW UNIT DOWN. WE ARE GETTING (149%) TOTAL AIRFLOW TO DESIGN. HIGH WINDS ON THE ROOF MAY HAVE AFFECTED THE OUTSIDE AIR MEASUREMENT. WE EXPECT TO BE ABLE TO REDUCE FAN SPEED ONCE SENSOR IS REPAIRED.

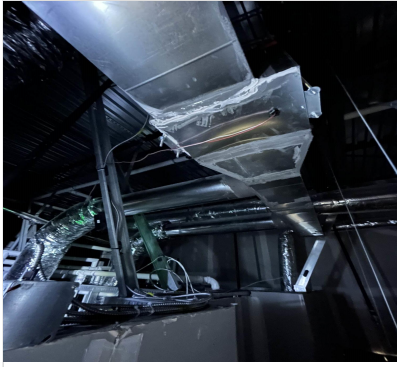
Issue Name : EF-2 Dampers not installed
Description : EF-2 dampers are not installed. However the airflows are proportional so they likely will not be required.
Created By : National TAB **Assigned To :** National TAB - Dan Hertenstein
Status : Open
Priority : Low **Asset Tag :** EF2
Originated Date : 10/17/2024 - Will Turnbough - National TAB
