Final TAB Punchlist

Jan 21, 2025

L05792_North Platte FSU (NE)

1902 South Jeffers Street, North Platte, Nebraska

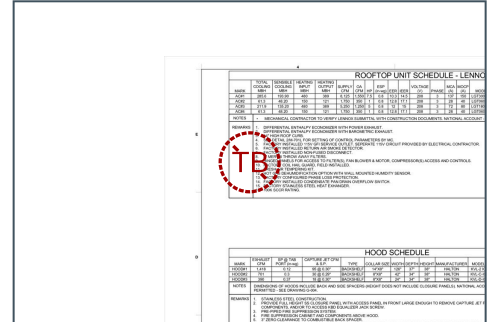
#126 [UNIT 504] [NEW] Equipment Fresh Air Tempering.

Units with Fresh Air Tempering kits are to have the discharge sensor routed per specification into the discharge duct via wiring portal. If Lennox turn on FAH and set parameter #156 to 60 in Kitchen, 62 in Drive-Thru/Serving, & 63 in Dining/Play Area; then set parameters #157 to 14 & #158 to 300 on all.

all 4 sensors have been moved past the first elbow, wired back into the units and sensors covered with insulation. Settings on RTU's have been checked

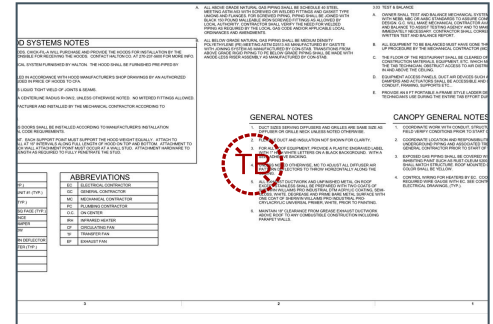
#125 [DUCT 500] [NEW] Air pattern deflections.

Air pattern deflections are called to be changed on plans by MC to adhere to design intent. General note 4 on M-001 states "UNLESS NOTED OTHERWISE, MC TO ADJUST ALL DIFFUSER AIR PATTERN DEFLECTORS TO THROW HORIZONTALLY ALONG THE CEILING."

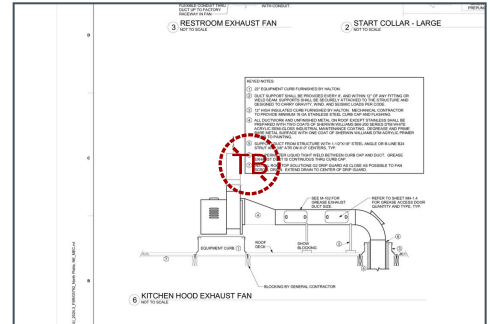
Description
Exhaust fan G2 Drip Guard is missing.

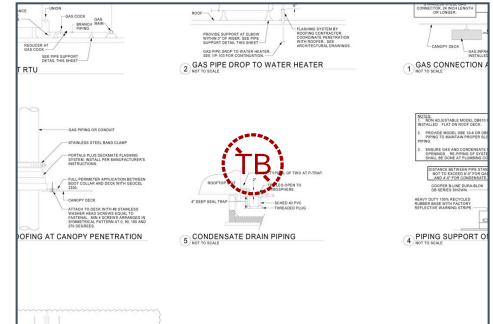
Description
Equipment condensate piping or p-trap is not constructed per normal CFA specifications.

Redid condensate lines
