Final TAB Punchlist

Prepared by Jacob Davidson

Jan 21, 2025

L05792_North Platte FSU (NE)

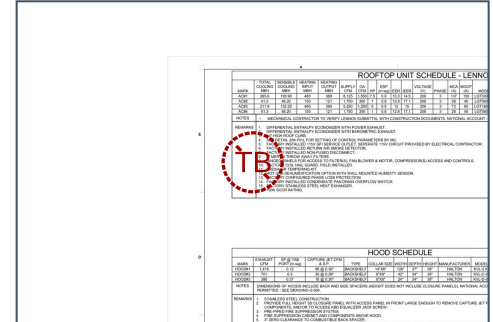
Units with Fresh Air Tempering kits are to have the discharge sensor routed per specification into the discharge duct via wiring portal. If Lennox turn on FAH and set parameter #156 to 60 in Kitchen, 62 in Drive-Thru/Serving, & 63 in Dining/Play Area; then set parameters #157 to 14 & #158 to 300 on all.

all 4 sensors have been moved past the first elbow, wired back into the units and sensors covered with insulation. Settings on RTU's have been checked

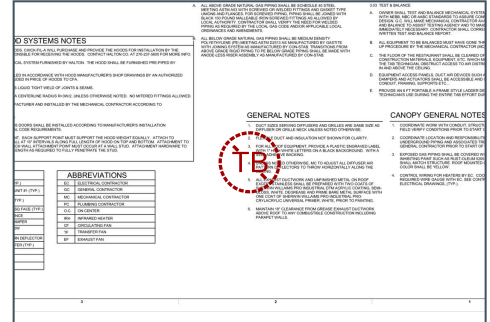
Air pattern deflections are called to be changed on plans by MC to adhere to design intent. General note 4 on M-001 states "UNLESS NOTED OTHERWISE, MC TO ADJUST ALL DIFFUSER AIR PATTERN DEFLECTORS TO THROW HORIZONTALLY ALONG THE CEILING."

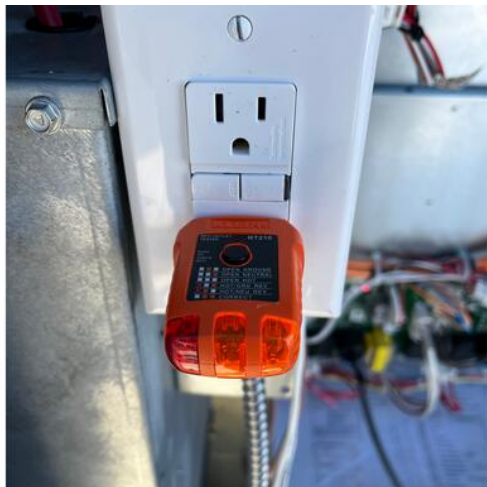
2025_01_12T21_51_41
Jared Locke
Jan 13, 2025 10:39 AM

Equipment GFI outlet missing components (GFI itself, din rail with fuses) or not terminated/operational. Per the AC unit schedule, each unit should have a factory installed GFI outlet with a separate 115V circuit provided by the electrical contractor.

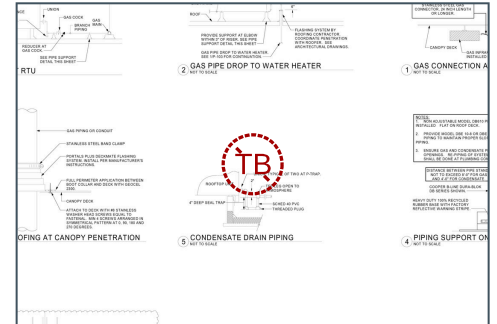
Equipment condensate piping pitch is not sloped correctly downward away from the unit. Current pitch is blocking doors from opening on the units on AC1, AC2, and AC4
