## Summary:

The purpose of the visit to True Food in Santa Monica was to address hood capture issues.

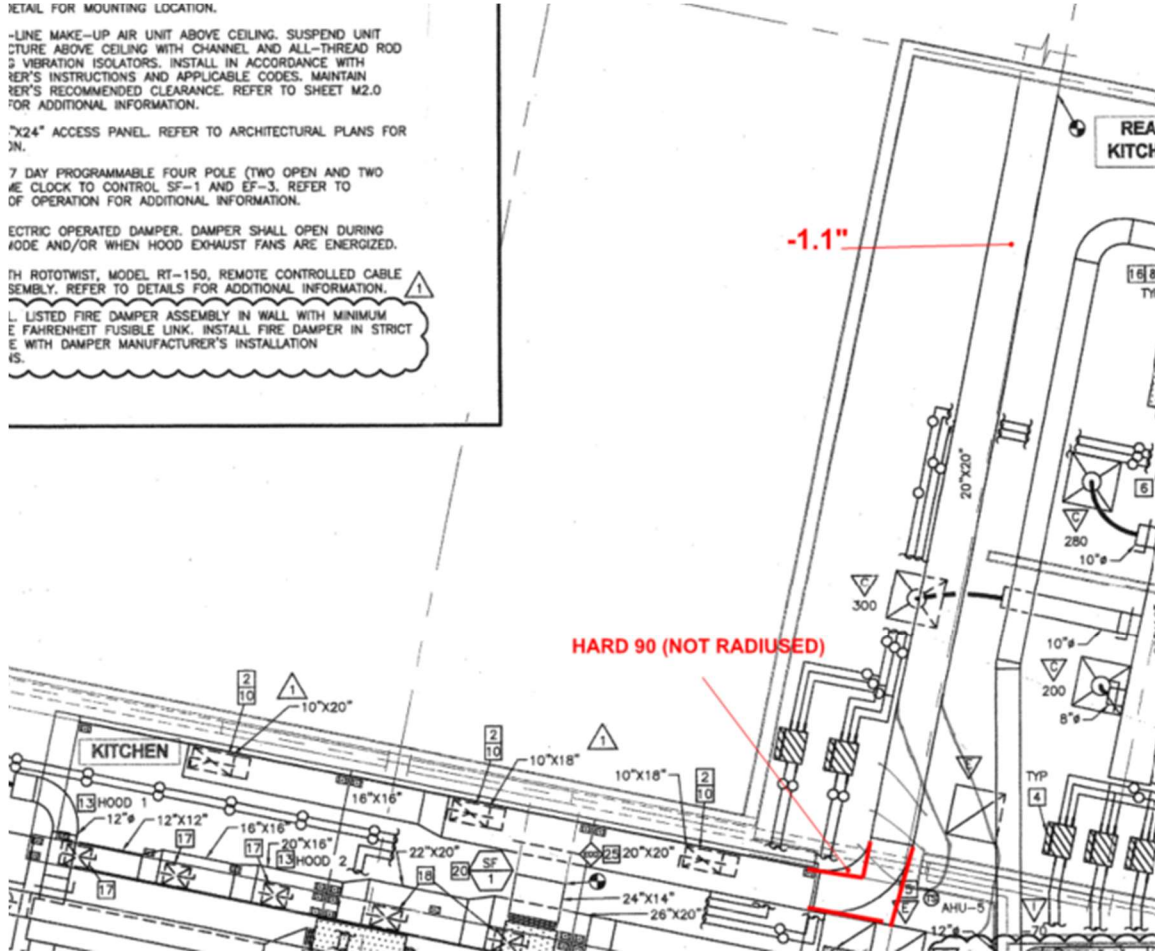
**VERTICAL ISOMETRIC SKETCH  
OF MALL GREASE DUCTWORK**

The remaining accessible exhaust duct run was inspected except for the second floor section of ductwork. Not all transitions are visible, but it appears there are between 6 to 8 transitions in the ductwork. There is also about a half of an inch of grease build up at one of the 90 degree transitions outside of True Foods. (see photos and sketches on the following pages).

2. Grease duct is extremely dirty both in True Food space and out side of it. Recommend the ductwork be thoroughly cleaned. This buildup could be having an impact on airflow, so cleaning thoroughly may increase flow some.
