Report: FINAL REPORT
Function: Test, Adjust, & Balance
Date: 11/01/2022

10-24 WALGREENS #03606 - SARASOTA, FL

Project: 10-24 WALGREENS #03606 - SARASOTA,FL

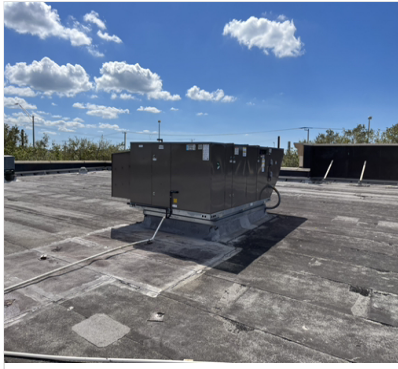
Description : RTU-3 (Pharmacy) has high static pressures which appear to be a result of a restrictive curb adapter. The unit is proportionally balanced to 90% of the design. The pharmacy is comfortable in this condition.

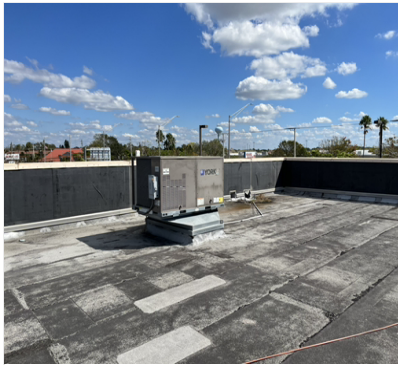
Issue Name : RTU-4 Disconnect Failure

Description : RTU 4 (Liquor) main disconnect switch failed on the last day of TAB. Unable to set outside air and retrieve final data.

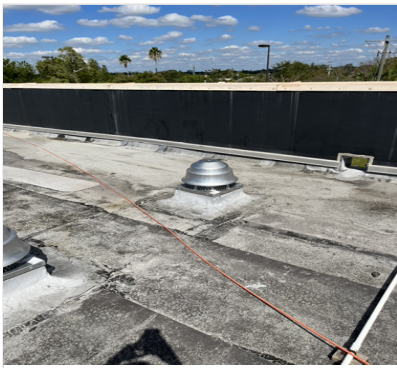
EF-3 NOT FUNCTIONAL AT TIME OF BUILDING PRESSURE TESTING. MC WORKING ON REPAIR OF SPEED CONTROLLER.
