Report By:

National TAB
1329 E. KEMPER ROAD
SUITE 4210
CINCINNATI, OH 45246

Report: FINAL REPORT
Function: Test, Adjust, & Balance
Date: 11/01/2022

10-24 WALGREENS #03606 - SARASOTA,FL

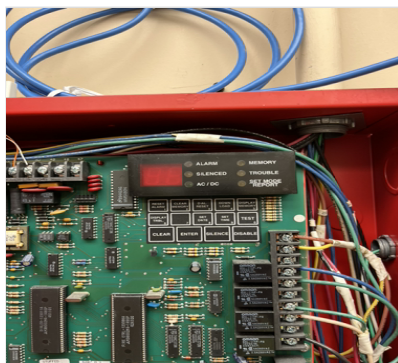
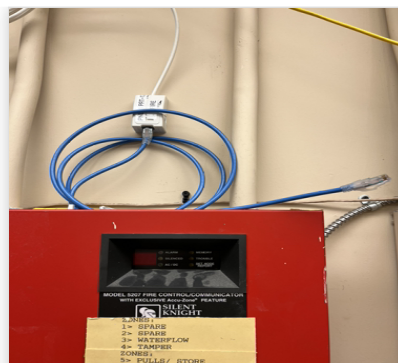
In duct smoke detectors are installed	Pass
Fire alarm panel status (visual inspection where possible)	NO MESSAGES DISPLAYED ON PANEL
