Report: FINAL REPORT
Function: Test, Adjust, & Balance
Date: 11/01/2022

10-24 WALGREENS #03606 - SARASOTA, FL

Project: 10-24 WALGREENS #03606 - SARASOTA,FL

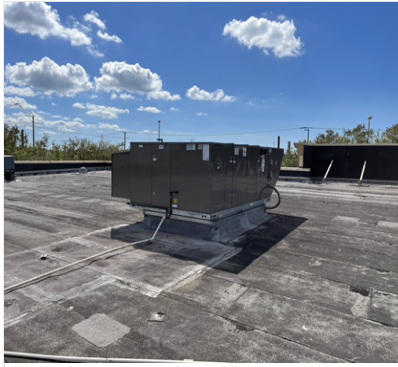
Description : RTU-3 (Pharmacy) has high static pressures which appear to be a result of a restrictive curb adapter. The unit is proportionally balanced to 90% of the design. The pharmacy is comfortable in this condition.

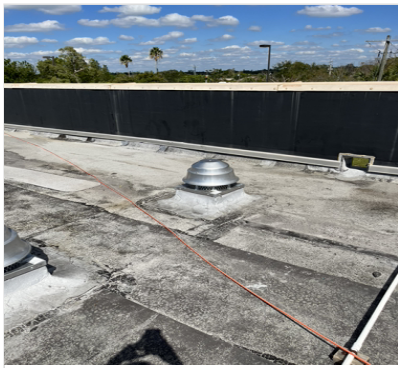
EF-3 NOT FUNCTIONAL AT TIME OF BUILDING PRESSURE TESTING. MC WORKING ON REPAIR OF SPEED CONTROLLER.
