**Report: TAB REPORT**  
**Function: Test, Adjust, & Balance**  
**Date: 01/16/2023**

**01-09-23 WALGREENS #03606 -  
SARASOTA, FL**

Project: 01-09-23 WALGREENS #03606 - SARASOTA,FL

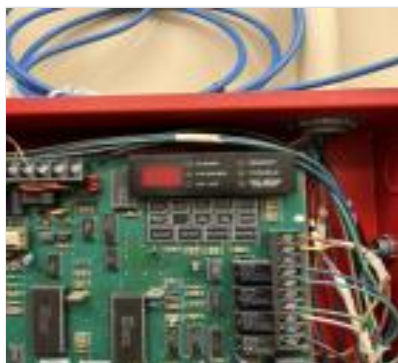
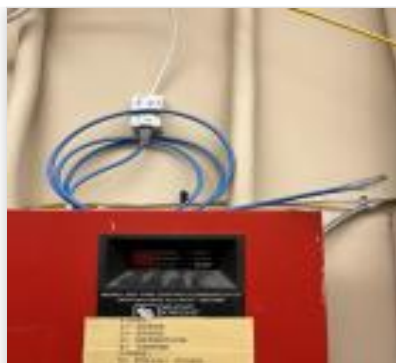
**Fire/Smoke Alarm Systems**

In duct smoke detectors are installed	Pass
Fire alarm panel status (visual inspection where possible)	NO MESSAGES DISPLAYED ON PANEL
