**Report: FINAL REPORT**  
**Function: Test, Adjust, & Balance**  
**Date: 11/01/2022**

## 10-24 WALGREENS #03606 - SARASOTA, FL

6465 S TAMIAMI TRL

SARASOTA, FL 34231

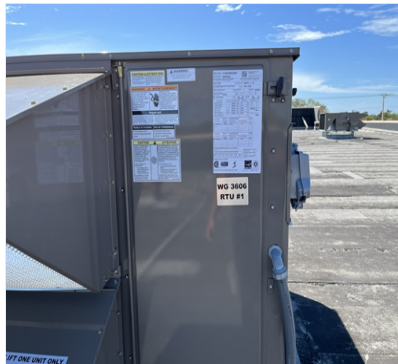
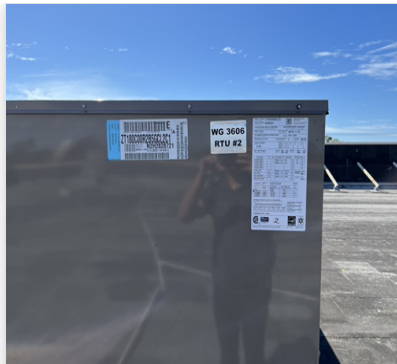
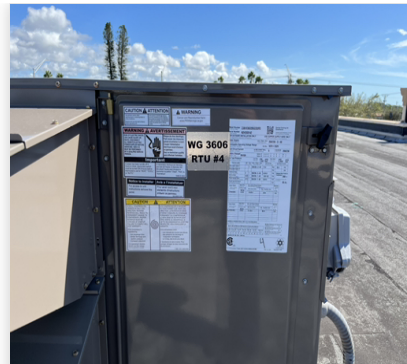
Verify all required equipment has been replaced per TA and BOM.	Pass
All units are installed in the proper locations	Pass
Units are labeled correctly	Pass
Asset tag installed	Pass

Roof is clear of debris.	Pass
Maintenance access for all unit access panels is acceptable and panels open freely.	Pass
Cabinet and general installation is complete.	Pass
Unit is secure to curb and level horizontally and vertically.	Pass

Access doors close tightly with no leaks	Pass
Condensate and gas piping is properly supported.	Pass
Costgaurd is installed per scope of work and piping unions are cemented.	Fail
Additional Comments	COSTGARD PIPING IS NOT CEMENTED.

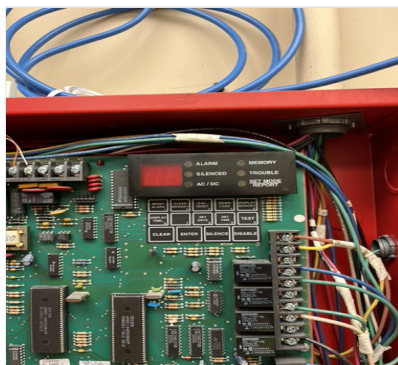
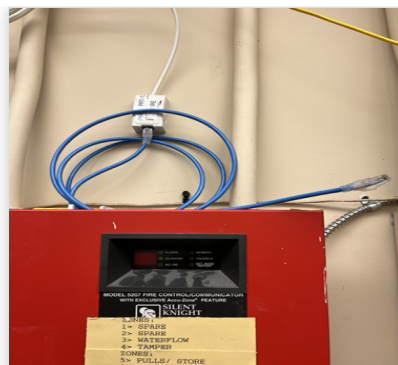
In duct smoke detectors are installed	Pass
Fire alarm panel status (visual inspection where possible)	NO MESSAGES DISPLAYED ON PANEL
