**Report: TAB REPORT**  
**Function: Test, Adjust, & Balance**  
**Date: 01/16/2023**

**01-09-23 WALGREENS #03606 -  
SARASOTA, FL**

Project: 01-09-23 WALGREENS #03606 - SARASOTA,FL

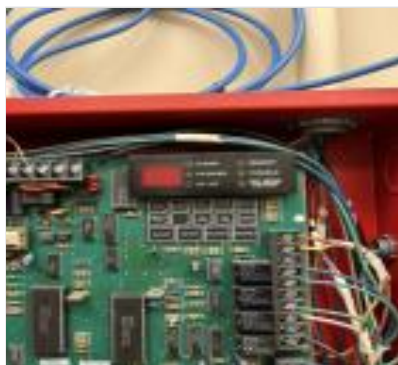
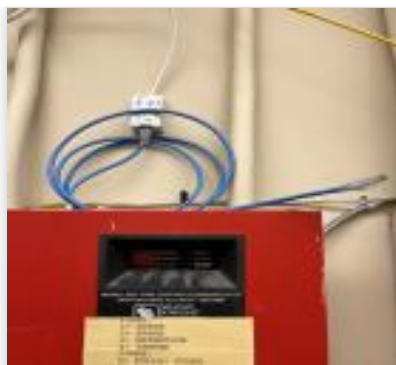
In duct smoke detectors are installed	Pass
Fire alarm panel status (visual inspection where possible)	NO MESSAGES DISPLAYED ON PANEL
