National TAB
1329 E. KEMPER ROAD
SUITE 4210
CINCINNATI, OH 45246

Report: TAB REPORT
Function: Test, Adjust, & Balance
Date: 01/16/2023

**01-09-23 WALGREENS #03606 -
SARASOTA, FL**

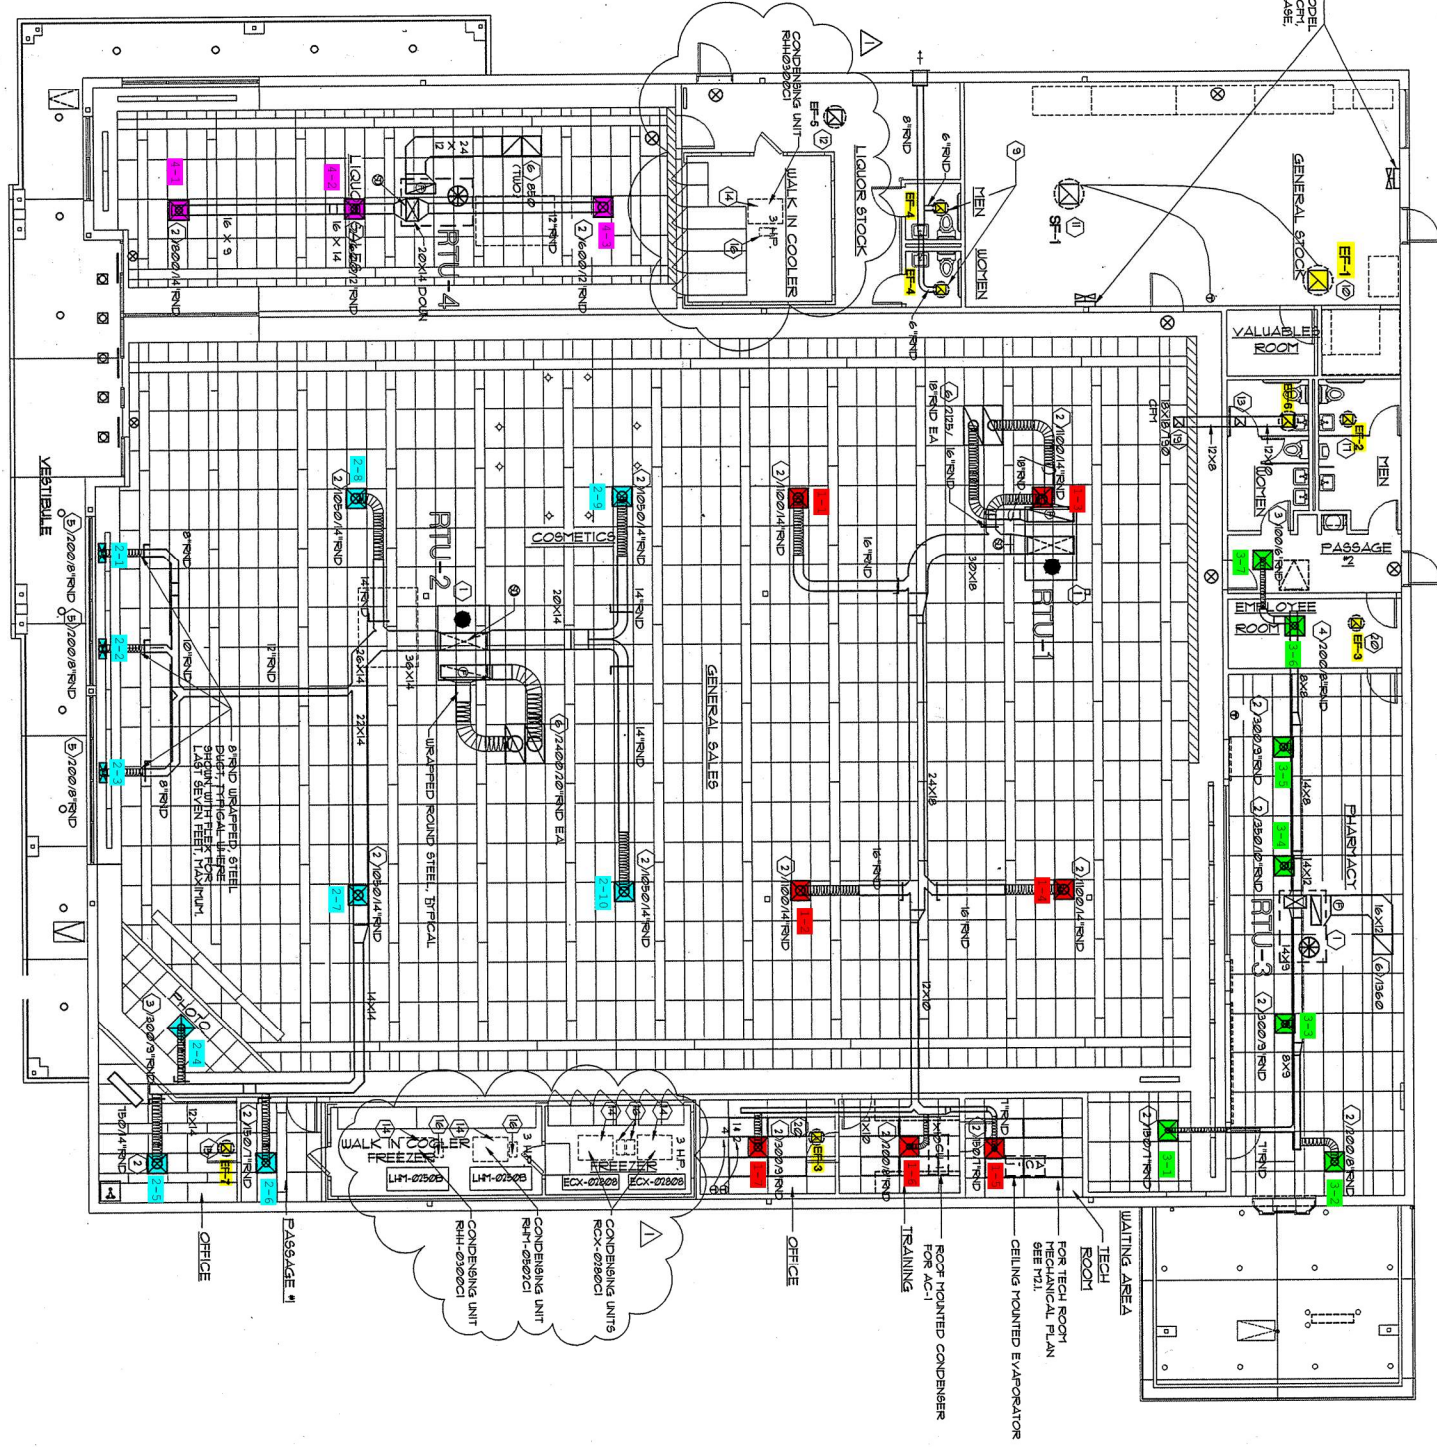
MECHANICAL PLAN

Notes: FAN SHOULD BE REMOVED AND CAPPED.
