Report: TAB REPORT
Function: Test, Adjust, & Balance
Date: 08/14/2023

PROJECT
07-31-23 SWEETGREEN - BLOOMINGTON, IN
(TAB, IAQ)

210 E KIRKWOOD AVE

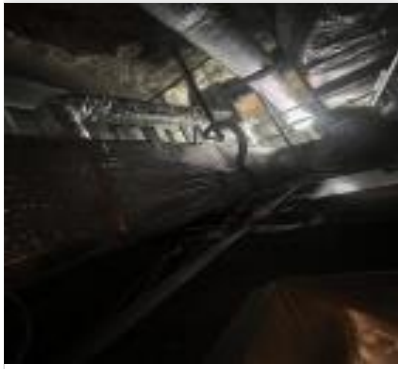
EF-2
08/14/2023

- AHU-1 airflow is low due to possible duct leakage.
- AHU-2 ductwork has a large gap.
- Diffuser 2-1 (Vestibule) is missing a damper.
- EF-2 is not accessible
