**Report: TAB REPORT**  
**Function: Test, Adjust, & Balance**  
**Date: 06/20/2024**

**PROJECT**  
**06-24-24 CAVA HOUSTON, TX**  
**(COPPERFIELD)**

Project: 06-24-24 CAVA HOUSTON, TX (COPPERFIELD)

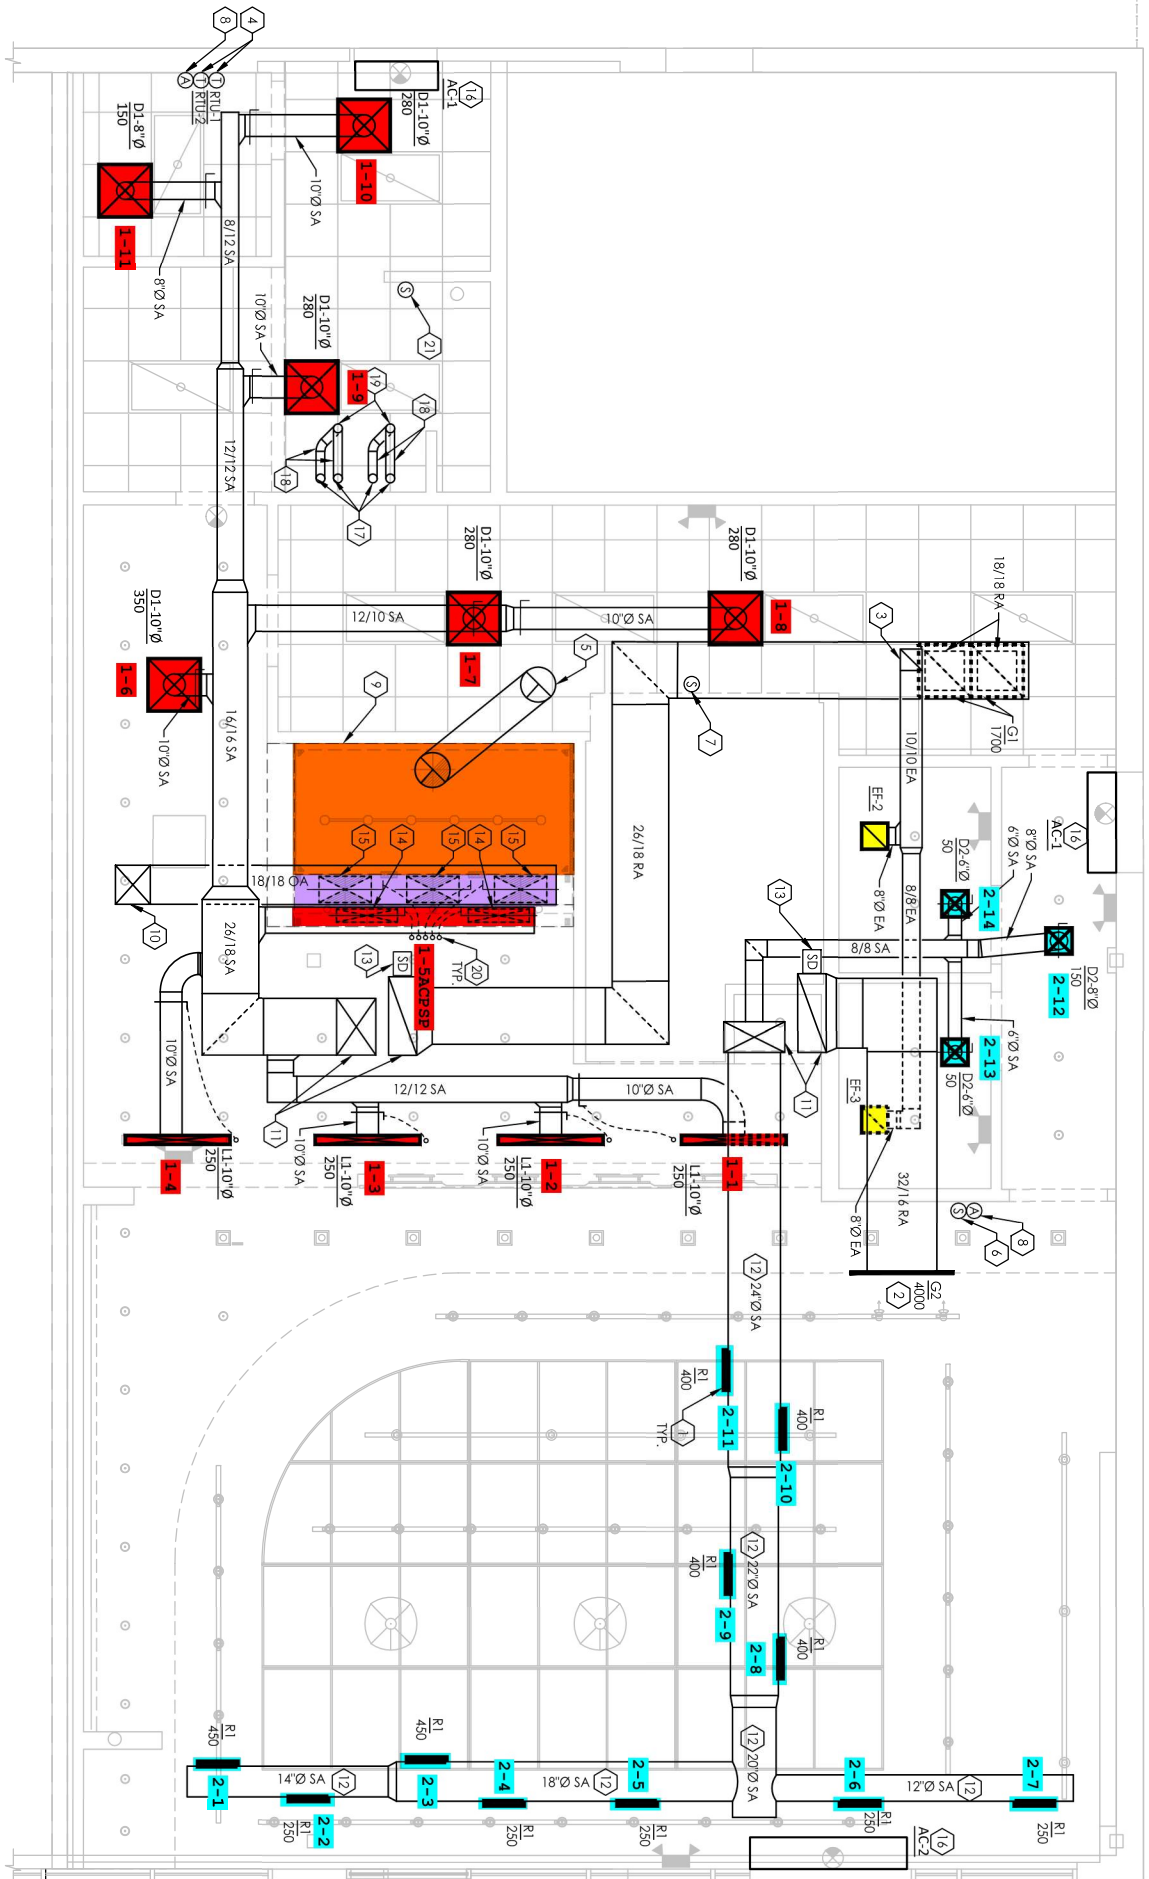
Cooking Equipment		
	Design	Actual
Item 1	-	GRIDDLE
Item 2	-	FRYER
Item 3	-	OVEN
Item 4	-	GAS STOVE TOP

Test Data Supply		
	Design	Actual
Total AK Area	13.61	13.61
Kv factor (Vel)	0.89	0.89
Num of Readings	-	10
Reading1 FPM	-	161
Reading2 FPM	-	143
Reading3 FPM	-	135
Reading4 FPM	-	153
Reading5 FPM	-	145
Reading6 FPM	-	138
Reading7 FPM	-	157
Reading8 FPM	-	151
Reading9 FPM	-	135
Reading10 FPM	-	157
Ave FPM(corr)	-	147
CFM	1976	1780
