**Report: TAB REPORT**  
**Function: Test, Adjust, & Balance**  
**Date: 03/08/2023**

## 03-06-23 TACO BELL - JACKSONVILLE, NC

Project: 03-06-23 TACO BELL - JACKSONVILLE, NC

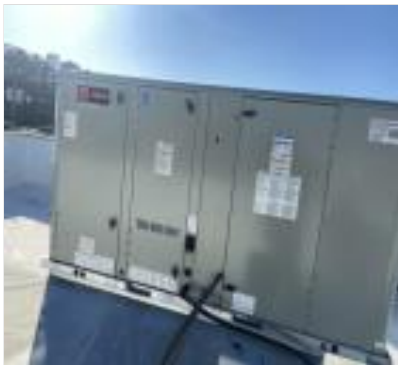
- RTU-1
  - OA (outside air) damper was 100% open and the Return was closed.
  - Economizer enthalpy set point was on C (this will allow unit to economize during warmer/more humid outside air conditions)
  - Very Dirty Evaporator Filters
  - Broken apart Condensate drain.
- RTU-2
  - Extremely loose belt
  - Sheave is rusted
  - OA damper was found fully open
  - No OA filter
  - No Evaporator filter
- MUA-1
  - Rusted Fan Sheave
  - Rusted Fan Bore.
  - Corroded/dirty fan blades

On RTU-1 airflow was measured to be just slightly low and so a small increase in speed (~10%) brought the unit into the target airflow. The OA was then set to an acceptable ratio and reduced the enthalpy setpoint.

**Issue Name :** RTU-1 dirty filters  
**Description :** RTU-1 filters are filthy and need to be replaced.  
**Created By :** National TAB                      **Assigned To :** National TAB - Will Turnbough  
**Status :** Open  
**Originated Date :** 03/08/2023 - JOASH ALBIN - National TAB

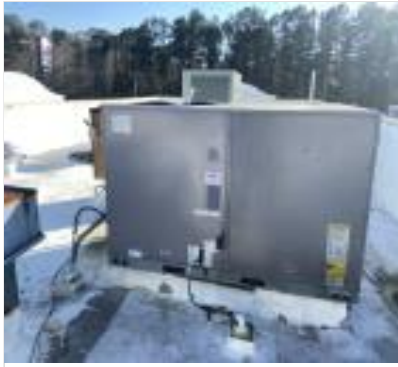
RTU-2 the belt was really loose and was tightened. The motor sheave was rusted and spent significant time breaking it free so that airflow could be sped up. Airflow was initially around 310 CFM/ton (which is low) and it was increased to 387 CFM/ton. OA was reduced to an appropriate level.

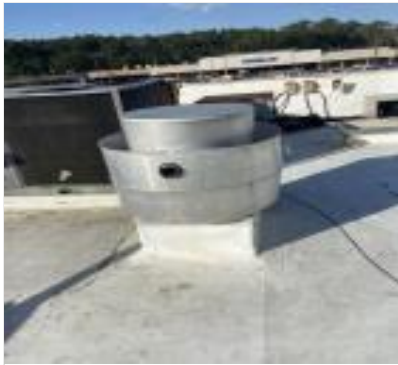
EF-1

**Description :** Grease trough not installed for KEF-1. Grease is pooling on the roof near RTU-2. Recommend installing.

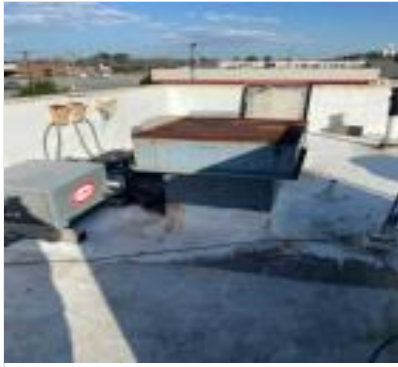
The MUA discharges in front of the hood with a linear style plenum. Inside the plenum there is a perforated grille. This style is not conducive for hood performance. Measured airflow to be around 300 CFM but based on the building pressure is probably closer to 500 CFM. While this unit is very low, did not attempt to increase it as doing so could cause capture problems or make comfort issues worse
