Report: TAB REPORT
Function: Test, Adjust, & Balance
Date: 05/02/2023

PROJECT
04-24-23 CULVERS - CAMDENTON, MO

Accurex
PO Box 410
Schofield, WI 54476

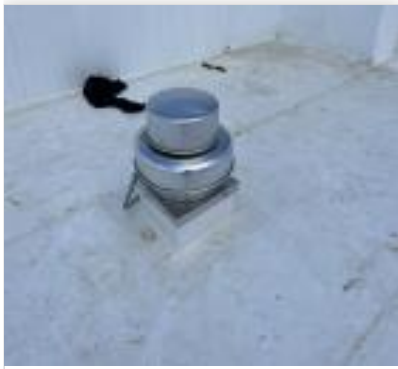
PRV1
04/25/2023

Description : INFO ONLY Restroom exhaust fan is missing the backdraft damper at the curb on the roof. This needs to be installed but will not affect the scope of the TAB.

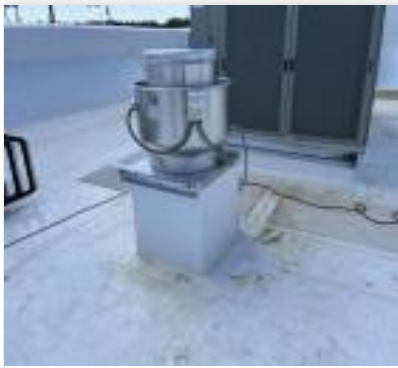
PRV2
04/25/2023

Issue Name : PRV2/PRV3 missing grease cups
Description : INFO ONLY The grease cups for both hood fans have not been installed. They will need to be installed for when the restaurant starts cooking. This does not affect scope of the TAB.
Created By : National TAB **Assigned To :** National TAB - Jacob Davidson
Status : Open
Originated Date : 04/24/2023 - Jacob Davidson - National TAB
