PlanGrid Task Report - Oct 6, 2025

27 tasks in this report.

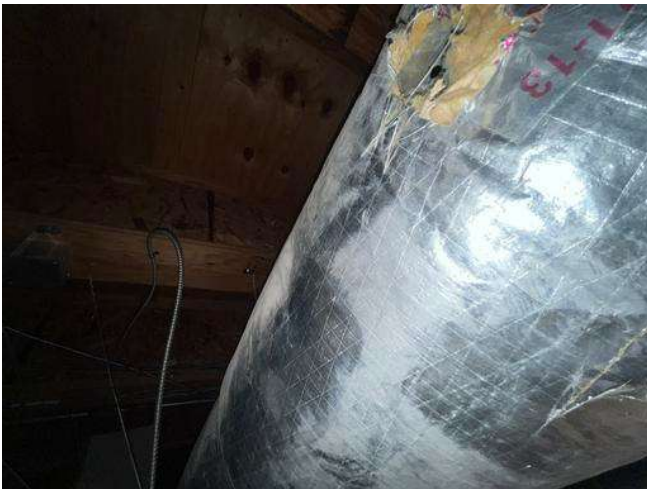
IMG_7644
Stephen Tassinaro
Sep 12, 2025 6:20 AM

The existing dampers in the space are in poor condition. Several are already broken off and several more broke as soon as NTi attempted to make adjustments. Rust and corrosion is visible. Existing ductwork balanced for comfort and total flows only. This applies to RTUs 2 & 3.

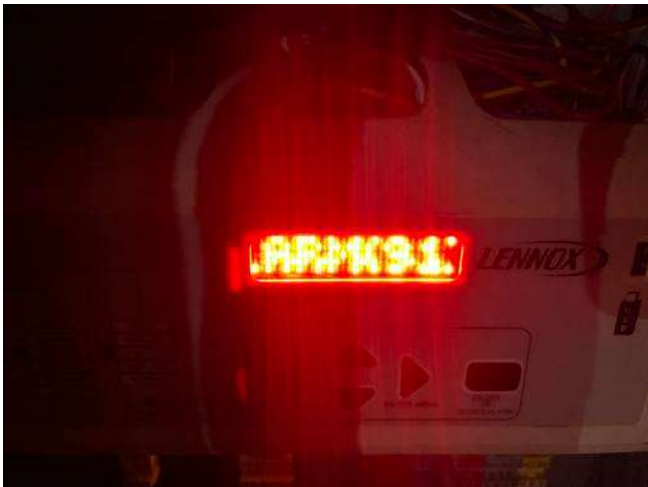
IMG_7689

RTU-2 is alarming for outdoor enthalpy sensor.

Unresolved.

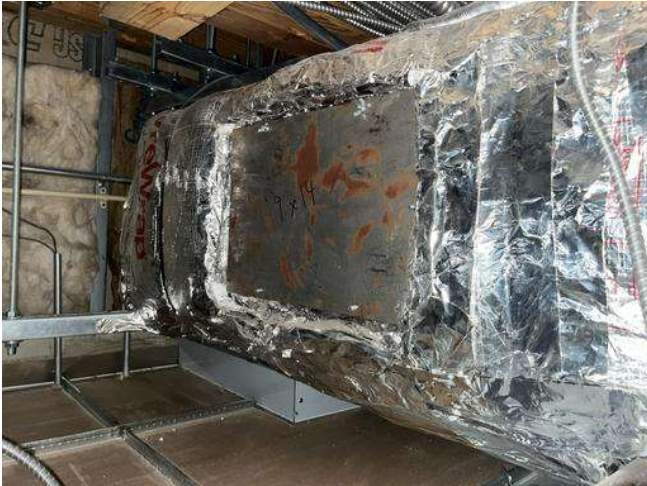
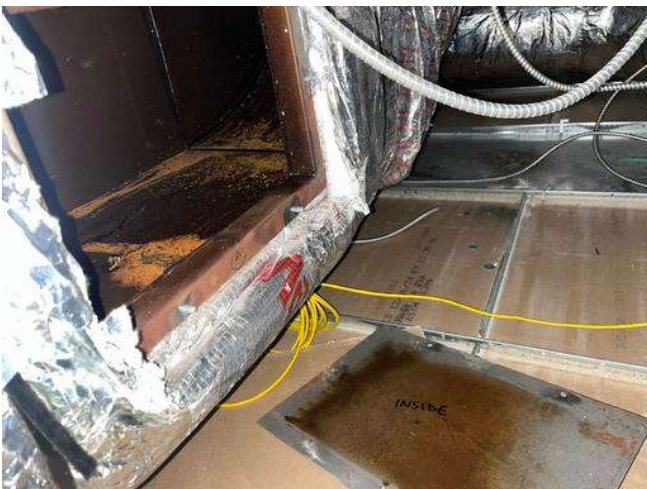
Access door on HD-1R duct is missing its cover and is open to the ceiling. This needs to be replaced immediately. Other access panels are missing necessary hardware which will also need to be replaced. Verify ALL.

The door was replaced with a piece of sheet metal, that was then self tapered into the flange with no gasket. NONE of the access doors have gaskets installed, nor a complete set of hardware.

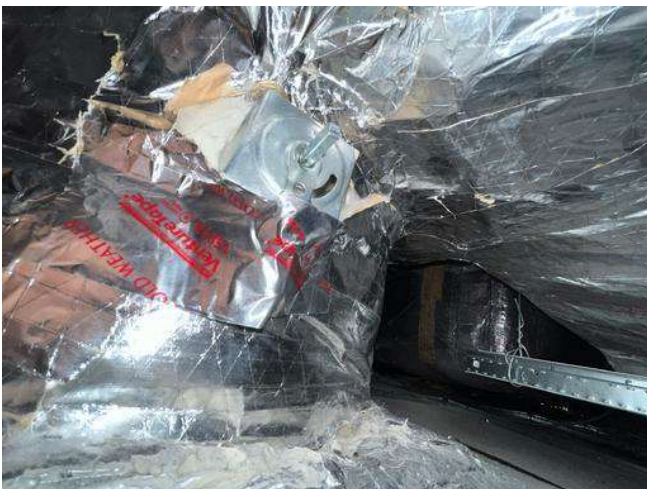
IMG_7643

RTU-3 new return damper missing hardware. Center return grille. Temporarily taped open for TAB.

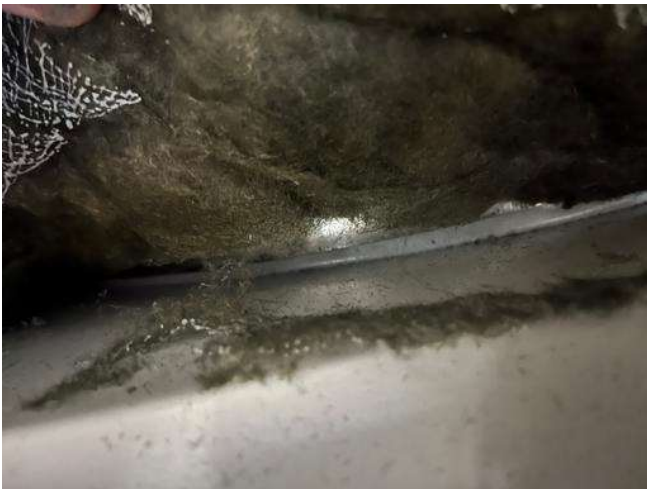
IMG_7681
Stephen Tassinaro
Sep 12, 2025 6:24 AM

No mastic was found at the rigid connections to the diffusers. New or existing.
