Report: FINAL TAB REPORT
Function: Test, Adjust, & Balance
Date: 07/25/2022

PROJECT
08-29 NIKE LIVE - CARY, NC

Project: 08-29 NIKE LIVE - CARY, NC

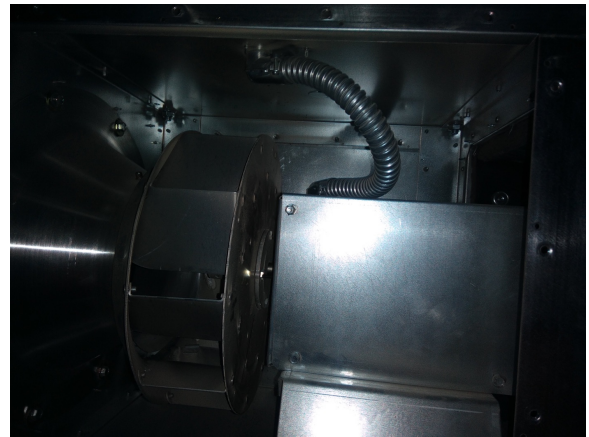
Notes: [1] EMS DOES NOT HAVE CONTROL OF SF1 OR OA DAMPER POSITIONS OA COULD NOT BE SET. [2] AMPS HAD GO BE TAKEN WITH BLOWER DOOR OFF. [3] SF1 FAN WHEEL WAS GRINDING BADLY, FAN WAS SHUT OFF TO PREVENT DAMAGE.
