Report: FINAL TAB REPORT
Function: Test, Adjust, & Balance
Date: 9/6/2022

PROJECT
08-29 NIKE LIVE - CARY, NC

Project: 08-29 NIKE LIVE - CARY, NC

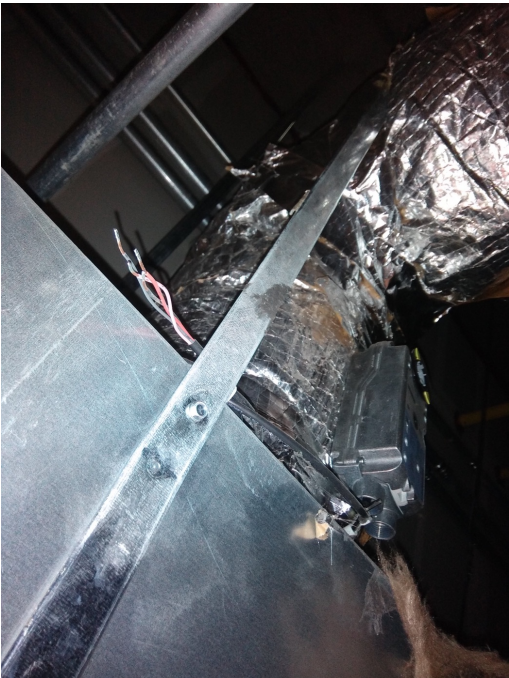
FCU1

Notes: [1] EMS DOES NOT HAVE CONTROL OF SF1 OR OA DAMPER POSITIONS OA COULD NOT BE SET. [2] AMPS HAD GO BE TAKEN WITH BLOWER DOOR OFF. [3] SF1 FAN WHEEL WAS GRINDING BADLY, FAN WAS SHUT OFF TO PREVENT DAMAGE.
