# TAB Punchlist

Prepared by Tyler Youells

Jul 2, 2025

**L05629\_Langhorne (PA) FSU**

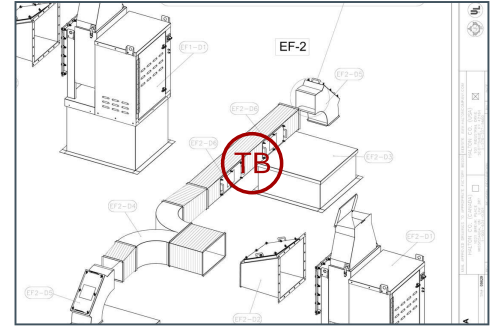
**Sheet**  
MH-1.5

EF-2 needs another Greas cleanout installed on the Runout for HD-2. Specd is two cleanout in the run only one is cut-in and installed.

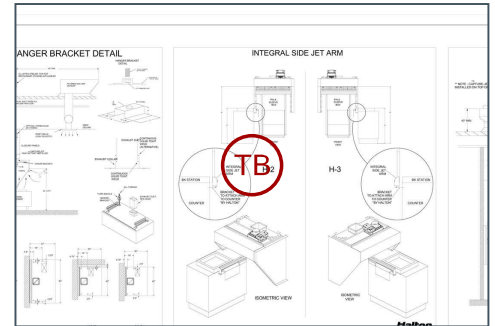
MH-1.2

(HD-2)The Halton supplied angle bracket that connects the integral sidejet arm to the counter is missing or not installed correctly. Secure bracket to arm and bracket to counter underneath removeable fry dump via stainless steel rivets.

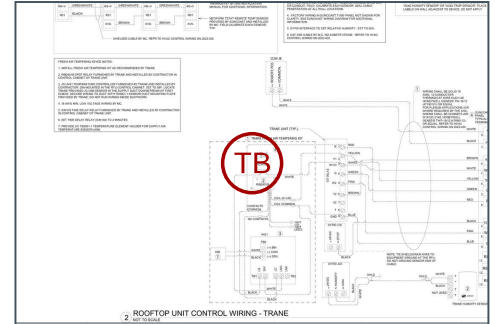
M-701

104 Timers are not functioning correctly. It was observed Heating turns on immediately after cooling stops and runs for approximately 1 min before turning off

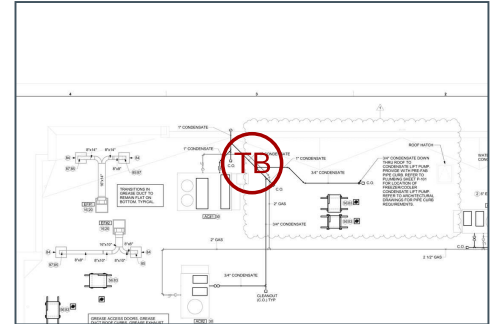
**Sheet**  
M-102

Equipment condensate piping Roof routing does not match prints.

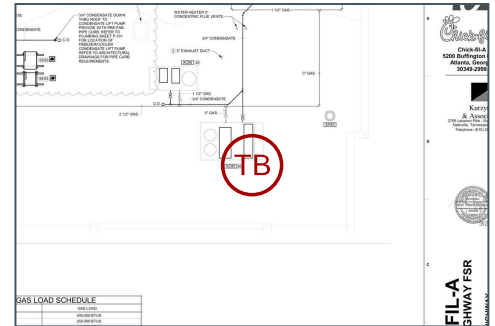
M-102

AC-3 Powered Exhaust fan wheel does not spin freely and rubs.

Item Reopened, Powered exhaust fan is rubbing again\

MC has adjusted the fan wheel and now spins freely.

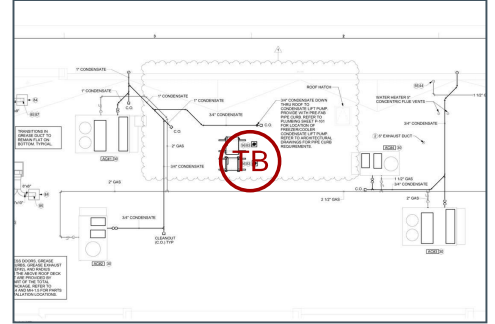
**Sheet**  
M-102

**Description**  
Electrical disconnects are properly labeled.

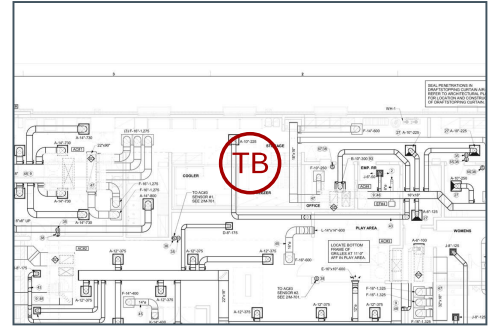
M-101

WIF Thermometer is not reading true to the Freezer Temp, Inside was 2F and thermometer is reading -15F
