Report: Test and Balance

Date: 10/16/2018

FREDDY'S - LIBERTY, MO (FULL BALANCE) [OPEN STORE]

9800 NE BARRY ROAD
KANSAS CITY, MO 64157

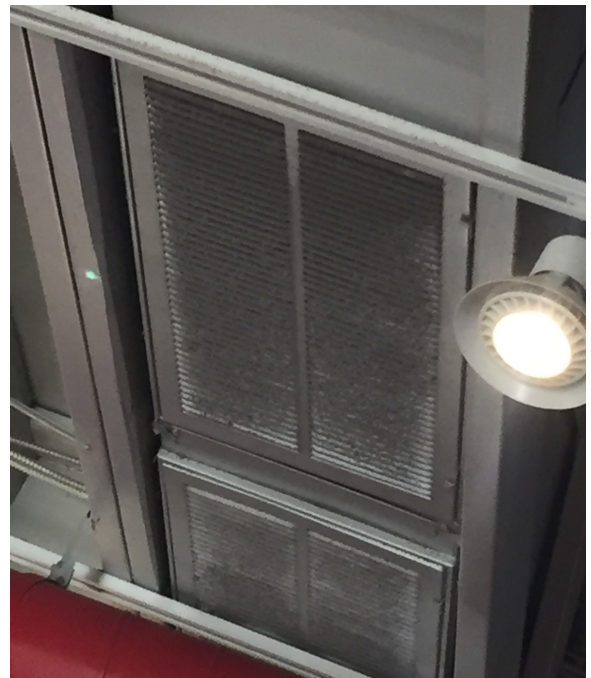
RTU 1 Return

PRIORITY (HIGH/LOW/INFO ONLY)	
High	RTU 1(Dining) is at 267 CFM/ton which is below the recommended 350 to 400 cfm/ton. The motor pulley is rusted where it can't be adjusted. The pulley needs to be replaced and the return grille needs to be clean. The return grille was not accessible during operating hours.
High	EF 1(Restroom) is not operational. Unable to turn fan blades freely by hand. Unit needs to be replaced.
High	KEF 2(Griddle) is under design on airflow and the hood is not capturing properly. The duct above the ceiling needs to be inspected to see if a clean out door is loose. If there are no issues, then the unit needs to be replaced. Unable to get above the ceiling during operating hours.
High	KEH 3(Griddle) and slightly KEF 2(Griddle) are being affected by a cross draft created by RTU 2(Kitchen) The duct layout will need to be evaluated to improve hood capture.
Low	MAU has an electrical short and trips the circuit breaker when the heater tries to start up. Unable to troubleshoot any further due to not being able to shut the unit off during operating hours. Not an urgent issue due summer approaching.

Notes: Sheave is frozen with rust.
907 initial RPM
Dirty returns see pictures.
