Report: FINAL TAB REPORT
Function: Test, Adjust, & Balance
Date: 7/27/2022

PROJECT
07-18 APPLEBEE'S - VINELAND, NJ
(REVIVE)

The purpose of the visit to Applebee's in Vineland was to investigate the cause for high humidity inside of the space.

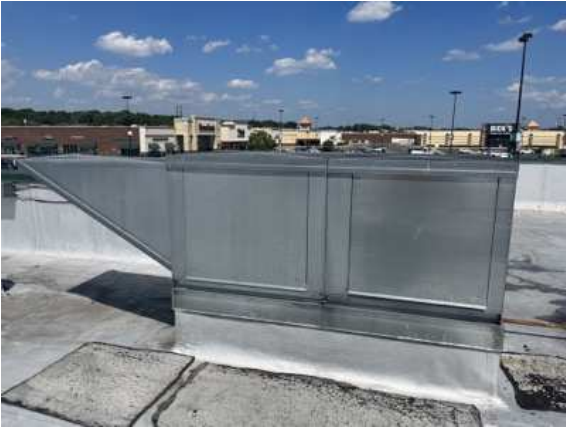
MAU-1

Gas Heat		
	Design	Actual
Heater Operates (y/n)	-	No
Flame Status (pass/fail)	-	Fail
Inlet Air Temp SetPt	-	55
Discharge Air Temp SetPt	-	60
Air Flow Switch SP Actual	-	0.37"

7. Not related to humidity issue, but the MUA heater is not functional and should be repaired.
8. Full vertical end panels should be installed on both hoods to allow for better performance and for exhaust rates to be reduced.
