Report: TAB Report
Function: Test, Adjust, & Balance
Date: 12/11/2025
Completed By: National TAB

PROJECT
12-08-25 QT #1417 GOODYEAR, AZ

Project: 12-08-25 QT #1417 GOODYEAR, AZ

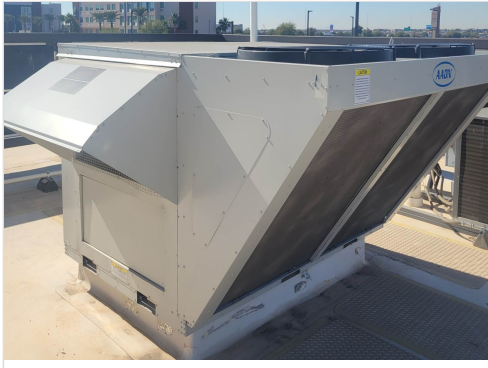
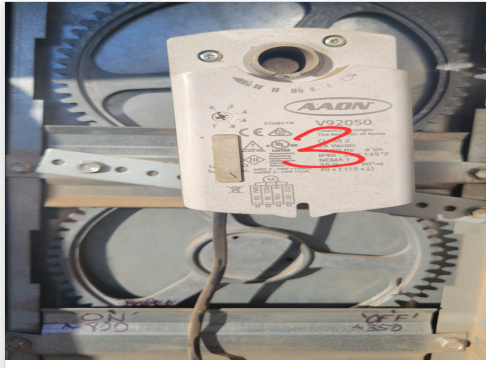
General	
	Actual
Fan Rotation Correct	YES
Unit Filters Clean	YES
Condensate Drain Installed	YES - DAMAGED

Notes:
CONDENSATE PIPE IS BROKEN, SEE REMARKS.

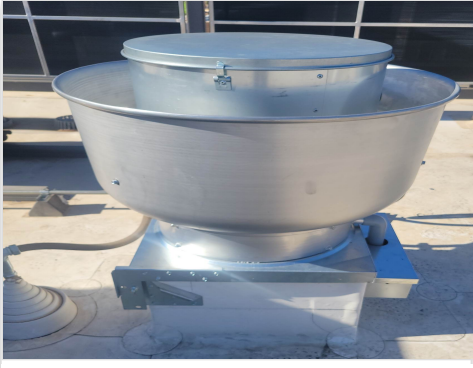
Asset	Notes	Date	Written By
EGRD4	DAMPER NOT SAFELY ACCESSIBLE. RECOMMEND MOVING DAMPER TO A MORE ACCESSIBLE LOCATION.	12/11/2025	Christine Weale
