**Report: REVIVE REPORT
Function: Test, Adjust, & Balance
Date: 03/10/2023**

**02-20-23 FREDDY'S - MCDONOUGH, GA
(REVIVE)**

1410 HWY 20 W

MCDONOUGH , GA

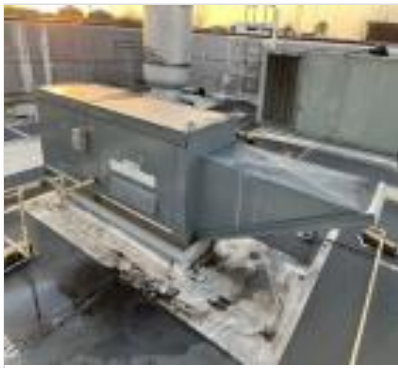
MUA-1

Test Data		
	Design	Actual
CFM	2321	1072
SF RPM	1109	957
Motor RPM	-	1777
RL Voltage	-	211/211/212
RL Amperage	-	2.5/2.2/2.3
