Report: REVIVE REPORT
Function: Test, Adjust, & Balance
Date: 03/10/2023

**02-20-23 FREDDY'S - MCDONOUGH, GA
(REVIVE)**

1410 HWY 20 W

MCDONOUGH , GA

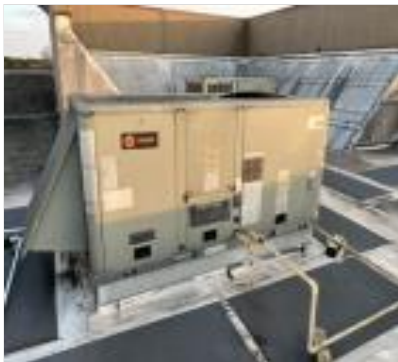
RTU-1

Description : Units are extremely dirty and need to be thoroughly cleaned. May require multiple cleanings. The condition is having a significant impact on airflow.

Description : Recommend ensuring that the adjustable motor pulleys for all RTU's can be adjusted so that airflows can be balanced. If they are found to be seized recommend breaking free or ordering a new identical pulley.

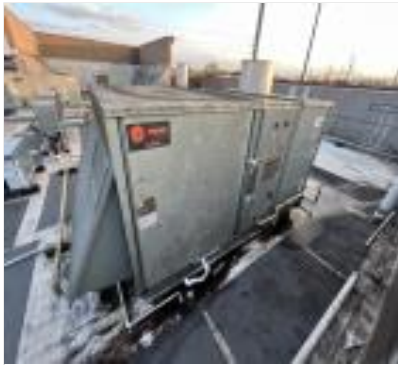
5. The AC-PSP portion of the hoods are dirty and need to be dropped down and cleaned.
6. RTU-3 evaporator coil had frost forming likely due to the very low airflow on this unit. Once unit and diffusers are cleaned, anticipated airflow will increase and that the frosting will stop.

8. Economizer for RTU-3 is not functional and needs to be repaired. It was found unplugged. Plugged in and heard the actuator moving but the damper did not move.

Description : Rtu3 economizer was found unplugged. Plugged in but damper didn't move. Recommend repair

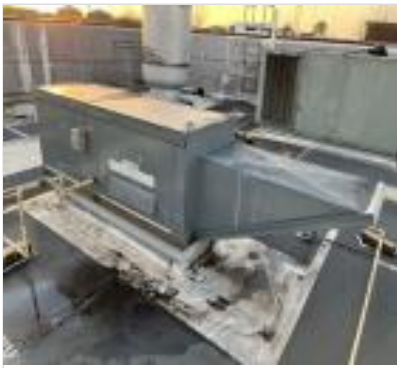
MUA-1

Initial airflows were measured. The hood exhaust airflow was found to be at design. However the MUA airflow is very low (1072 CFM out of 2321 CFM). There was some minor grease accumulation on the bottom of the PSP at the hood. Pulled down the PSP and confirmed that the tops were clean and not clogged. RTU's 1 and 3 are low on flow. RTU-2 is within tolerance but on the low end. The outside air dampers for RTU's 1 and 2 were opened too much and bringing in a high ratio of outside air. Reduced some for better performance. Building pressure is currently very negative. Smoke capture was observed on both hoods. Hood serving the fryer has adequate capture unless the drive thru door is left open in which case there is some loss. The grill hood has significant smoke loss out the back of the hood and is the primary cause of grease throughout the space.

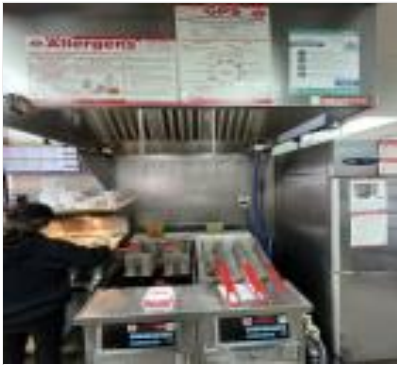
HOOD-1

Description : Grill is not centered under the hood and is primary reason for the poor smoke capture. Island hood needs 12" of overhang on all sides. The only smoke loss is noted on the side without overhang.

Description : Recommend dropping the AC-ssp portion and cleaning the top and bottom of the perforated grilles.
