Report: TAB

Function: Test, Adjust, & Balance

Date: 06/30/2025

06-30-25 CHIPOTLE #5591 HORN LAKE, MS

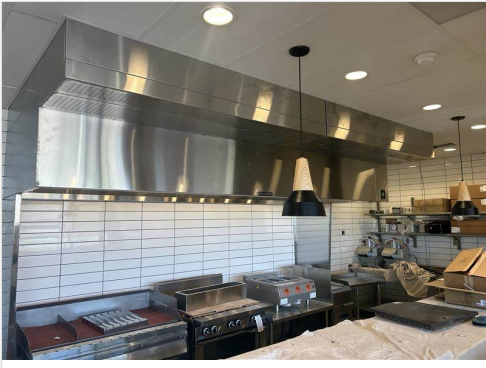
06/25/2025

Gas Heat		
	Design	Actual
Heater Operates (y/n)	-	N
Flame Status (pass/fail)	-	Fail
Inlet Air Temp SetPt	-	0
Discharge Air Temp SetPt	-	0
Air Flow Switch SP Actual	-	0
