Report: TAB Report
Function: Test, Adjust, & Balance
Date: 07/09/2025
Completed By: National TAB

07-07-25 WAWA #8687 WILLIAMSBURG, VA

4007 IRONBOUND RD

Wawa
260 West Baltimore Pike
Wawa, PA 19063

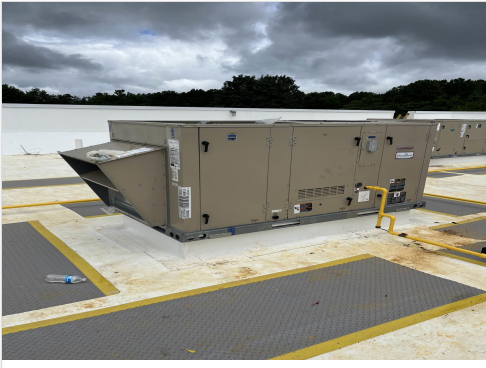
Unit Data - PHOTO LOG

Asset	Notes	Date	Written By
SGRD10	BROKEN DAMPER. UNABLE TO BALANCE DIFFUSER WITHIN DESIGN.	07/08/2025	Ian Fuller
