**Report: TAB Report**  
**Function: Test, Adjust, & Balance**  
**Date: 06/10/2024**

**PROJECT**  
**08-26-24 WAWA #5443 YULEE, FL**

50 DAYDREAM AVE

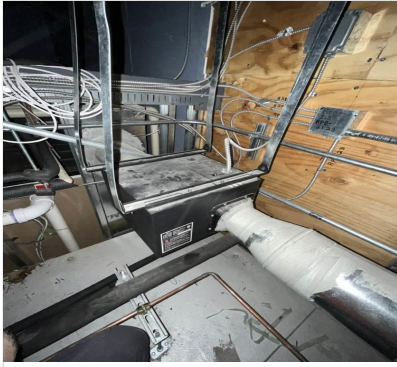
EF-2

**Issue Name :** EF 2 No Speed Controller  
**Description :** No speed controller located. Manual damper installed on fan inlet. Recommend removing damper and installing speed controller per M3.0 HVAC EXHAUST FAN SCHEDULE.  
**Created By :** National TAB                      **Assigned To :** National TAB - Will Turnbough  
**Status :** Open  
**Priority :** Urgent                                      **Asset Tag :**  
**Originated Date :** 06/13/2024 - Stephen Tassinaro - National TAB

**Speed controller installed and functional (if applicable)?** Fail
