Report: TAB RPT
Function: Test, Adjust, & Balance
Date: 7/1/2022

05-16 CULVERS - INDIANAPOLIS, IN (SHEAR AVE)

Project Summary

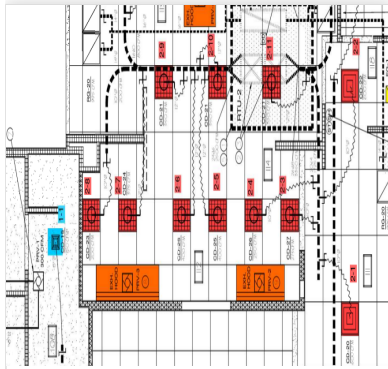
- 05/20/2022 National TAB - Will Turnbough
 - DIFFUSER NOMENCLATURE

Issue Name : DIFFUSER 2-7 IS ABOVE THE CEILING AND NOT INSTALLED IN THE GRID

Description : Diffuser is above ceiling and needs to be installed in the grid. Diffuser 2-8 is installed where 2-7 would go. Ceiling grid may be too small to install a 2'x2' diffuser. May need to install a 1'x2' perforated diffuser. There is some smoke loss out right side of fryer hood as a result.

Diffuser 2-8 needs to be installed where drawn to improve the hood capture. This is done preferably by installing a 12"x24" diffuser in front of the ansul cabinet inline with the other diffusers. If that's not possible moving the diffuser to the spot marked in blue is the next best option. The missing diffuser is allowing smoke to escape out the right side of the fryer hood
