Report: TAB Submittal
Function: Test, Adjust, & Balance
Date: 05/13/2025
Completed By: National TAB

PROJECT
05-12-25 CHILI'S CLEARWATER FL

Project: 05-12-25 CHILI'S CLEARWATER FL

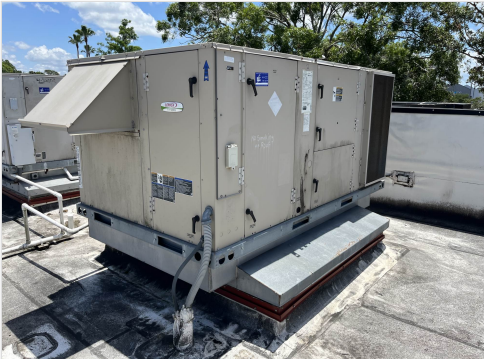
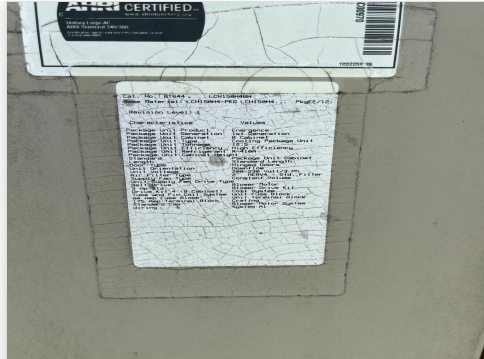
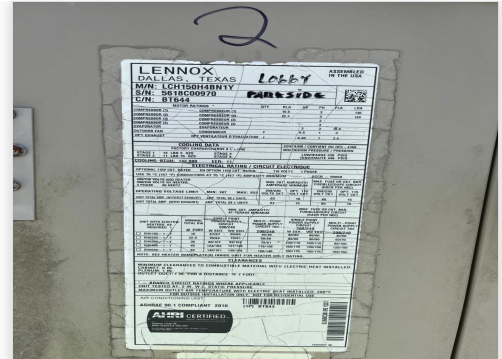
Asset: RTU2

Issue Name : RTU-2 & RTU-3 Minor Rust Damage
Description : There is some minor rust damage on the outside air hoods of RTU-2 & RTU-3. It is recommended to patch these rust holes to prevent foreign materials, bugs, or other small animals from entering the unit.
Created By : National TAB **Assigned To :** National TAB - Dan Hertenstein
Status : Open
Priority : Low **Asset Tag :**
Originated Date : 05/16/2025 - Stephen Tassinaro - National TAB
