Report: TAB REPORT
Function: Test, Adjust, & Balance
Date: 09/29/2023

PROJECT
09-25-23 CULVERS BLUE SPRINGS, MO
REVIVE

1307 MO-7

MPH Dinning

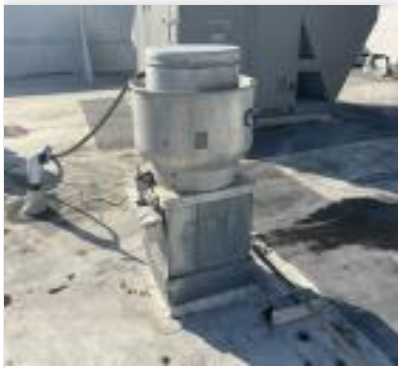
PRV2
09/29/2023

Issue Name : PRV1/PRV2 grease plug missing
Description : Grease plug is missing from both hood exhaust fans which can allow grease to fall onto the roof. Recommend replacing the grease plugs.
Created By : National TAB **Assigned To :** National TAB - Jacob Davidson
Status : Open
Originated Date : 09/29/2023 - Jacob Davidson - National TAB
