**Report: TAB Report**  
**Function: Test, Adjust, & Balance**  
**Date: 01/03/2024**

## 10-23-23 WALGREENS #11134 - SMYRNA, DE

Walgreens

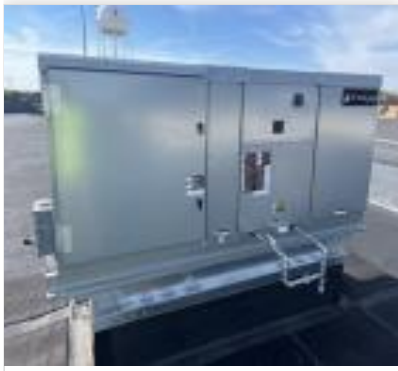
**Issue Name :** EH-1 Not running correctly  
**Description :** Found flow was extremely low and blower rotation incorrect. Flipped phases and confirmed correct rotation now blower will kick on for two seconds then shut off, back on then off. Unable to balance unit  
**Created By :** National TAB                      **Assigned To :** National TAB - Tyler Youells  
**Status :** Open  
**Priority :** Urgent                                      **Asset Tag :**  
**Originated Date :** 10/26/2023 - Tyler Youells - National TAB
