**Report: TAB REPORT**  
**Function: Test, Adjust, & Balance**  
**Date: 06/20/2024**

**PROJECT**  
**06-17-24 CULVERS - STURTEVANT, WI**  
**(REIMAGE)**

Project: 06-17-24 CULVERS - STURTEVANT, WI (REIMAGE)

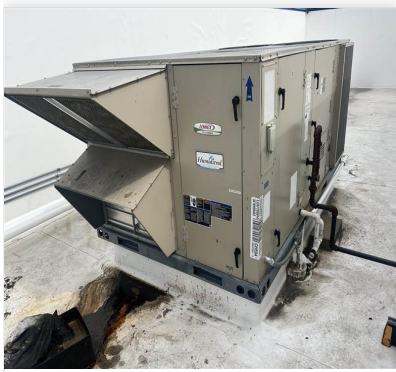
RTU-1

The dining room unit was measured to be supplying 4,427 cfm, or 354 cfm/ton. This is within design and no adjustments were made to the unit’s fan speed. The outside air was initially measured at 957 cfm. Because the unit has humidity control, we increased the outside air to an acceptable ratio to help bring the building closer to a positive state. The unit needs some maintenance as outlined in the Report below. According to staff, this unit maintains temperature in the dining room during hot weather. It

appears the unit also has Fresh Air Tempering as an installed option. Recommend this is enabled to prevent cold air from being driven into the space when unit operates in fan only during winter season.

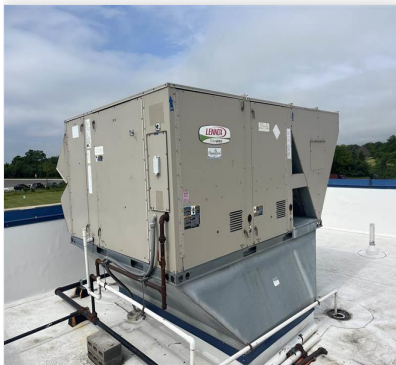
The unit is significantly low on airflow, operating at 66% of the airflow it should be providing. The unit could not be sped up during our visit because the motor sheave is locked and frozen in place, unable to be adjusted. There does not appear to be much adjustment left on the pulley, maybe 1 turn, and a pulley change is recommended to bring RTU-2 closer to an efficient airflow. The unit is mounted on a curb adapter, this could be inhibiting airflow, we often find these to be restrictive. The blower wheel was found to be very dirty, and cleaning this effectively will increase airflow.

**Issue Name :** 02. RTU-2 (Kitchen): Low on Supply Airflow  
**Description :** RTU-2 is a 15 ton unit and is supplying 3503 cfm to the kitchen space. For performance and efficiency, blower should operate at around 350 cfm/ton, or 5250 cfm. Per Staff, kitchen is not achieving or maintaining set temp. The RTU is installed with a curb adapter, which may be restricting airflow. Recommend airflow is increased on this unit.

- **06/20/2024    National TAB - Michael McDonnell**
  - The motor sheave is frozen at 1-2 turns open and could not be adjusted to increase the speed of the fan. Recommend sheave is broken free and set to 1 turn open. Regardless, a pulley change will be required to bring the RTU closer to an efficient airflow. The motor is operating at 7.8 amps with an FLA rating of 14.6, so there is room to increase fan speed. Recommend pulley change is performed to increase airflow, consult NTAB.

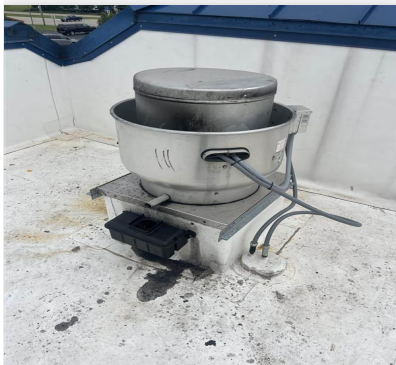
Both the Griddle exhaust hood (HD-1) and the Fryer exhaust Hood (HD-2) are exhausting their design airflow of 1500 cfm. Their respective fans, PRV-2 (griddle) and PRV-3 (fryer), are misaligned on their curbs. It appears this misalignment is due to the original installation of the grease duct; the duct is not centered. As result, the hood exhaust fans had to be set at much higher than typical setpoints to achieve design airflow. This is causing unnecessary energy usage and strain on the exhaust fans. Recommend the fans are properly aligned with the duct. Once corrected, we anticipate the exhaust rates of both hoods to significantly increase. The PRV setpoints will need to be lowered and hoods rebalanced.

**Description :** Exhaust fans are not centered over the grease exhaust duct / the duct is not centered in the curb. Appears this is from the original installation of the duct. Both exhaust fans are performing at design airflow, but require much higher than typical setpoints due to misalignment. Recommend curb is reconfigured so fan and grease duct properly align.

- **06/20/2024 National TAB - Michael McDonnell**
  - Both exhaust fans are set to much higher than typical setpoints. Once alignment is corrected, exhaust airflow will likely increase significantly. Recommend NTAB is consulted to readjust setpoints.
