Report: TAB REPORT
Function: Test, Adjust, & Balance
Date: 06/20/2024

PROJECT
06-17-24 CULVERS - STURTEVANT, WI
(REIMAGE)

Project: 06-17-24 CULVERS - STURTEVANT, WI (REIMAGE)

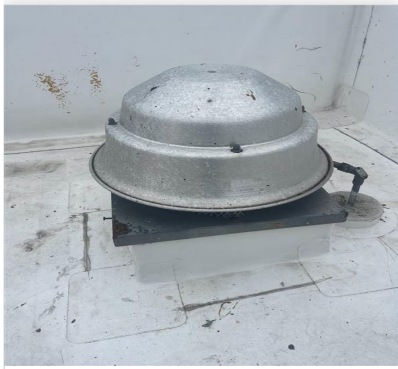
Issue Name : 05. PRV-1 (RESTROOM EXHAUST): Not Functional
Description : PRV-1, the restroom exhaust fan, is not operational. Recommend the fan is serviced or replaced so that odor can be effectively removed from restrooms.
Created By : National TAB **Assigned To :** National TAB - Will Turnbough
Status : Open
Priority : High **Asset Tag :**
Originated Date : 06/20/2024 - Michael McDonnell - National TAB
