Report: TAB REPORT
Function: Test, Adjust, & Balance
Date: 06/20/2024

PROJECT
06-17-24 CULVERS - STURTEVANT, WI
(REIMAGE)

Project: 06-17-24 CULVERS - STURTEVANT, WI (REIMAGE)

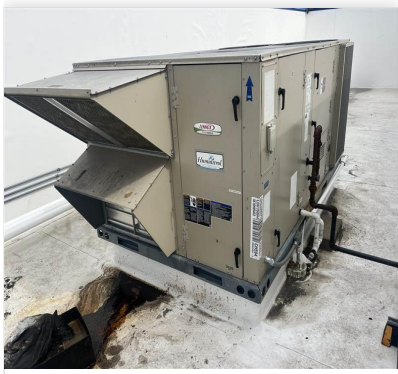
RTU-1

The dining room unit was measured to be supplying 4,427 cfm, or 354 cfm/ton. This is within design and no adjustments were made to the unit’s fan speed. The outside air was initially measured at 957 cfm. Because the unit has humidity control, we increased the outside air to an acceptable ratio to help bring the building closer to a positive state. The unit needs some maintenance as outlined in the Report below. According to staff, this unit maintains temperature in the dining room during hot weather. It

appears the unit also has Fresh Air Tempering as an installed option. Recommend this is enabled to prevent cold air from being driven into the space when unit operates in fan only during winter season.

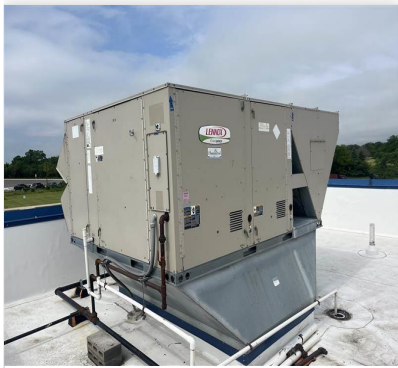
The unit is significantly low on airflow, operating at 66% of the airflow it should be providing. The unit could not be sped up during our visit because the motor sheave is locked and frozen in place, unable to be adjusted. There does not appear to be much adjustment left on the pulley, maybe 1 turn, and a pulley change is recommended to bring RTU-2 closer to an efficient airflow. The unit is mounted on a curb adapter, this could be inhibiting airflow, we often find these to be restrictive. The blower wheel was found to be very dirty, and cleaning this effectively will increase airflow.

- **06/20/2024 National TAB - Michael McDonnell**
 - Insulation loose in RTU-2 blower compartment. Recommend it is affixed to prevent it from causing future issue.

If airflow on RTU-2 is substantially increased, we recommend some changes to the cookline area to help improve the distribution of air, improve comfort, and prevent any hood capture issues. Currently, there are three 4-way diffusers installed on the cookline. If airflow is increased to these diffusers, they will likely cause hood capture issues. We recommend these 4-ways are switched to perforated style, and three additional perforated diffusers, if possible, are installed on the cookline. This will allow more air to be distributed, and not be disruptive to hood capture. Note that the diffuser serving the office was found disconnected from the system with its flex laying in the ceiling.

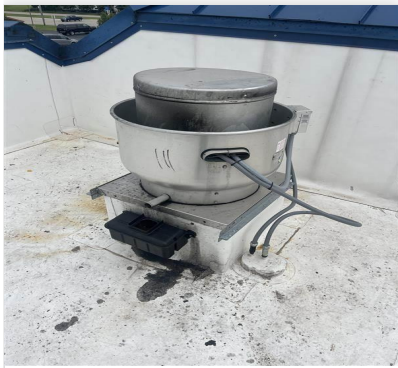
Both the Griddle exhaust hood (HD-1) and the Fryer exhaust Hood (HD-2) are exhausting their design airflow of 1500 cfm. Their respective fans, PRV-2 (griddle) and PRV-3 (fryer), are misaligned on their curbs. It appears this misalignment is due to the original installation of the grease duct; the duct is not centered. As result, the hood exhaust fans had to be set at much higher than typical setpoints to achieve design airflow. This is causing unnecessary energy usage and strain on the exhaust fans. Recommend the fans are properly aligned with the duct. Once corrected, we anticipate the exhaust rates of both hoods to significantly increase. The PRV setpoints will need to be lowered and hoods rebalanced.
