Report: TAB REPORT
Function: Test, Adjust, & Balance
Date: 06/20/2024

PROJECT
06-17-24 CULVERS - STURTEVANT, WI
(REIMAGE)

Project: 06-17-24 CULVERS - STURTEVANT, WI (REIMAGE)

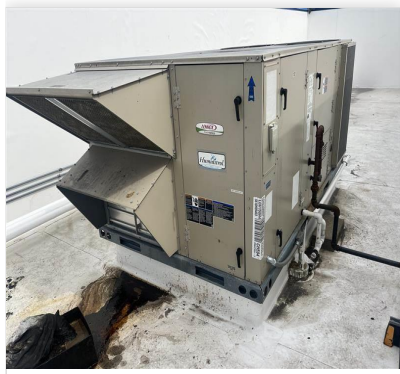
RTU-1

The dining room unit was measured to be supplying 4,427 cfm, or 354 cfm/ton. This is within design and no adjustments were made to the unit’s fan speed. The outside air was initially measured at 957 cfm. Because the unit has humidity control, we increased the outside air to an acceptable ratio to help bring the building closer to a positive state. The unit needs some maintenance as outlined in the Report below. According to staff, this unit maintains temperature in the dining room during hot weather. It

appears the unit also has Fresh Air Tempering as an installed option. Recommend this is enabled to prevent cold air from being driven into the space when unit operates in fan only during winter season.

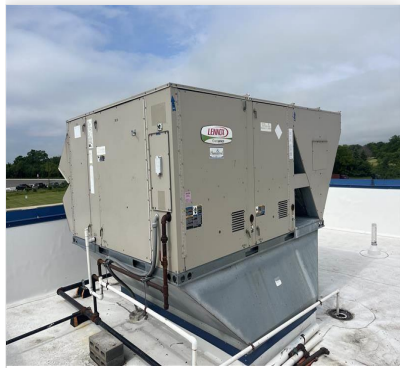
The unit is significantly low on airflow, operating at 66% of the airflow it should be providing. The unit could not be sped up during our visit because the motor sheave is locked and frozen in place, unable to be adjusted. There does not appear to be much adjustment left on the pulley, maybe 1 turn, and a pulley change is recommended to bring RTU-2 closer to an efficient airflow. The unit is mounted on a curb adapter, this could be inhibiting airflow, we often find these to be restrictive. The blower wheel was found to be very dirty, and cleaning this effectively will increase airflow.

- **06/20/2024 National TAB - Michael McDonnell**
 - Insulation loose in RTU-2 blower compartment. Recommend it is affixed to prevent it from causing future issue.

If airflow on RTU-2 is substantially increased, we recommend some changes to the cookline area to help improve the distribution of air, improve comfort, and prevent any hood capture issues. Currently, there are three 4-way diffusers installed on the cookline. If airflow is increased to these diffusers, they will likely cause hood capture issues. We recommend these 4-ways are switched to perforated style, and three additional perforated diffusers, if possible, are installed on the cookline. This will allow more air to be distributed, and not be disruptive to hood capture. Note that the diffuser serving the office was found disconnected from the system with its flex laying in the ceiling.

Outside air on this unit was initially measured at 989 cfm. We increased this slightly to 1217 cfm, an acceptable ratio for a humiditrol RTU. If the airflow on this unit is increased, we will be able to slightly lower the ratio of outside air to supply air, while still increasing the total make-up air and bringing the building positive.
