**Report: TAB REPORT  
Function: Test, Adjust, & Balance  
Date: 12/29/2022**

## **12-26 CULVERS - GREEN BAY, WI (FACILITY TAB)**

2945 Voyager Dr

McCon Building Corporation  
1059 Circle Drive  
PO Box 247  
Highland, WI 53543

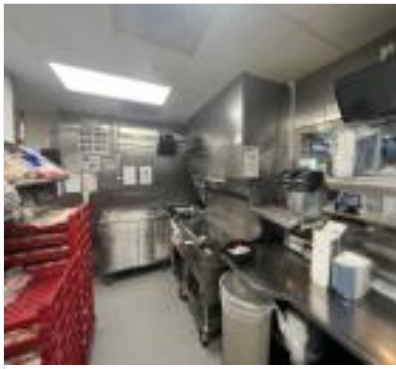
HOOD 1

**Issue Name :** 5. HD-1 (fryer) filter damaged.

**Description :** Several hood filters have significant wear. One filter on HD-1 is fairly damaged and needs replacement. Recommend all filters are evaluated and replaced as necessary.
