**Report: TAB REPORT
Function: Test, Adjust, & Balance
Date: 12/29/2022**

12-26 CULVERS - GREEN BAY, WI (FACILITY TAB)

McCon Building Corporation
1059 Circle Drive
PO Box 247
Highland, WI 53543

Project: 12-26 CULVERS - GREEN BAY, WI (FACILITY TAB)

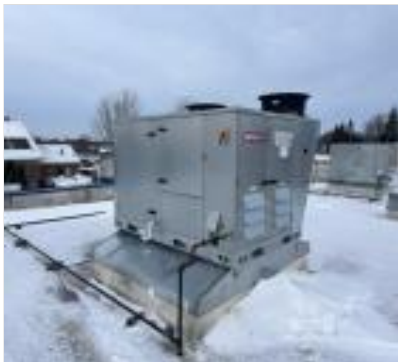
RTU-1

Notes:[1] TAKEN FROM VFD HMI. [2] BALANCED OA TO HIGH END OF DESIGN TO ACCOMODATE PRV-1 AND PRV-4 EXHAUST (ONCE REPAIRED) AND KEEP BUILDING PRESSURE NEUTRAL.

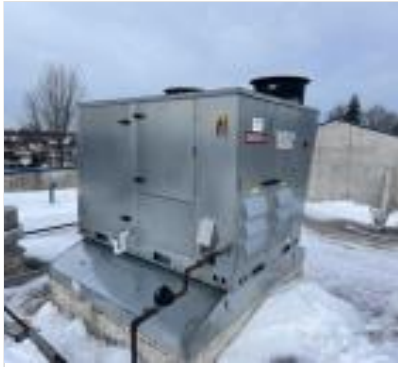
RTU-2

Notes:[1] TAKEN FROM VFD HMI. [2] BALANCED OA TO HIGH END OF DESIGN TO ACCOMODATE PRV-1 AND PRV-4 EXHAUST (ONCE REPAIRED) AND KEEP BUILDING PRESSURE NEUTRAL.
