**Report: TAB REPORT
Function: Test, Adjust, & Balance
Date: 12/29/2022**

12-26 CULVERS - GREEN BAY, WI (FACILITY TAB)

Project: 12-26 CULVERS - GREEN BAY, WI (FACILITY TAB)

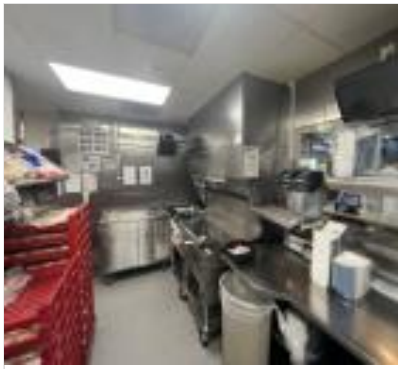
HOOD 1

Issue Name : 5. HD-1 (fryer) filter damaged.

Description : Several hood filters have significant wear. One filter on HD-1 is fairly damaged and needs replacement. Recommend all filters are evaluated and replaced as necessary.

Notes: [1] UNIT LABEL WORN OFF. [2] FILTER DAMAGED AND IN NEED OF REPLACEMENT.
