Report: TAB Survey
Function: Test, Adjust, & Balance
Date: 11/11/2025
Completed By: National TAB

11-10-25 APPLEBEES - MACON, GA (Tab Survey)

The scope of this project is to perform a survey of the existing RTU's, EF's, MUA, and hoods. This includes measuring as-is airflows, inspecting the equipment for maintenance issues, and providing additional insight as to the performance and condition.

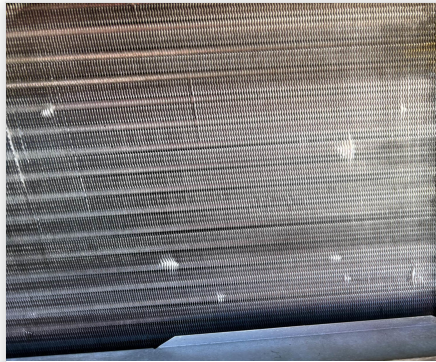
Issue Name : ALL RTUs: EVAPORATOR COILS DIRTY AND DAMAGED
Description : The evaporator coils in all RTUs are dirt and show signs of damage.
Created By : National TAB **Assigned To :** National TAB - Dan Hertenstein
Status : Open
Priority : High **Asset Tag :**
Originated Date : 11/11/2025 - Sagar Patel - National TAB

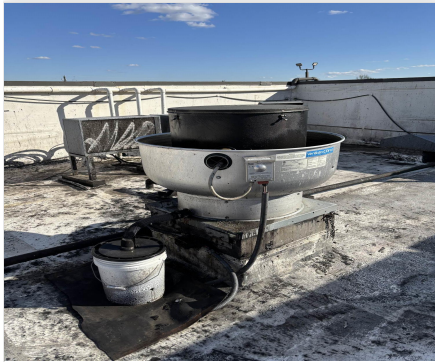
Issue Name : EF 1 AND 2: INCORRECT GREASE CATCH
Description : The grease catch is a plastic bucket. The metal catch for both exhaust fans are behind EF 2.
Created By : National TAB **Assigned To :** National TAB - Dan Hertenstein
Status : Open
Priority : High **Asset Tag :**
Originated Date : 11/10/2025 - Sagar Patel - National TAB

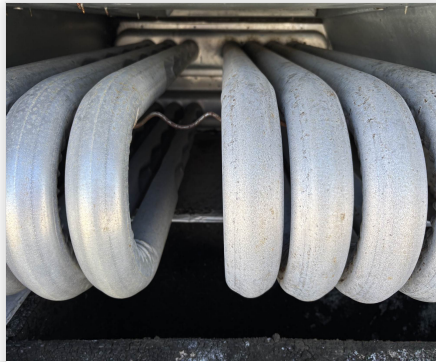
Issue Name : RTU 3, 4, AND 5: HEAT EXCHANGERS ARE DIRTY
Description : The evaporator coils on RTU 3, 4, and 5 are dirty and recommended to be clean.
Created By : National TAB **Assigned To :** National TAB - Dan Hertenstein
Status : Open
Priority : High **Asset Tag :**
Originated Date : 11/10/2025 - Sagar Patel - National TAB

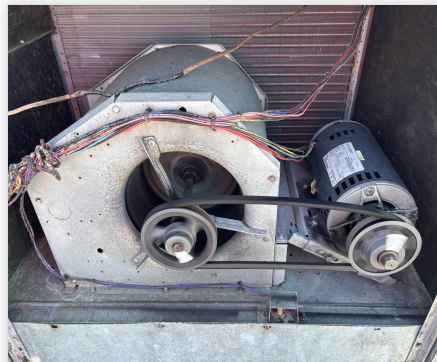
Issue Name : RTU 4 AND 5: LOOSE BELT
Description : The belt in RTUs 4 and 5 are loose and recommended to be tighten.
Created By : National TAB **Assigned To :** National TAB - Dan Hertenstein
Status : Open
Priority : High **Asset Tag :**
Originated Date : 11/10/2025 - Sagar Patel - National TAB

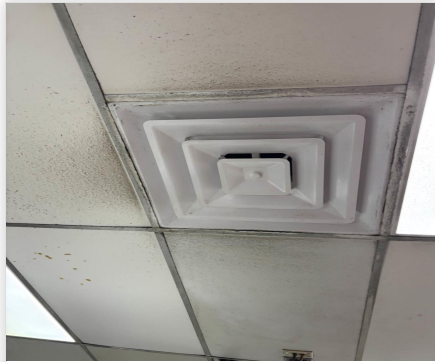
Issue Name : STAINED CEILING TILES AROUND HOOD AND KITCHEN DIFFUSERS
Description : Ceiling tiles in the kitchen are stained and recommended to be cleaned or replaced
Created By : National TAB **Assigned To :** National TAB - Dan Hertenstein
Status : Open
Priority : Medium **Asset Tag :**
Originated Date : 11/10/2025 - Sagar Patel - National TAB

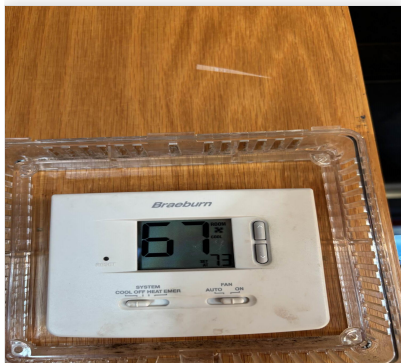
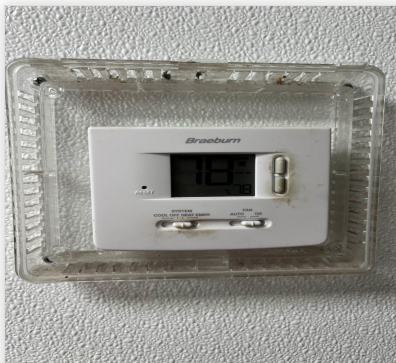
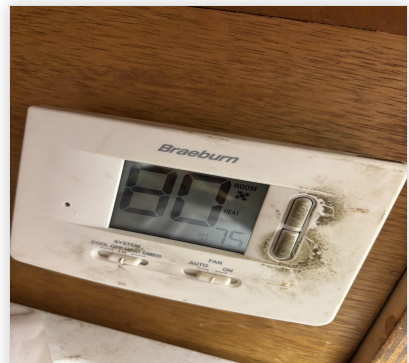
Thermostats

Are thermostats programmable and can they be programmed for a Fan On schedule? Fail
