**National TAB
1329 E. KEMPER ROAD
SUITE 4210
CINCINNATI, OH 45246**

**Report: TAB REPORT
Function: Test, Adjust, & Balance
Date: 01/27/2023**

**01-23-23 SWEETGREEN (CHI276) -
NORTHBROOK, IL (TAB)**

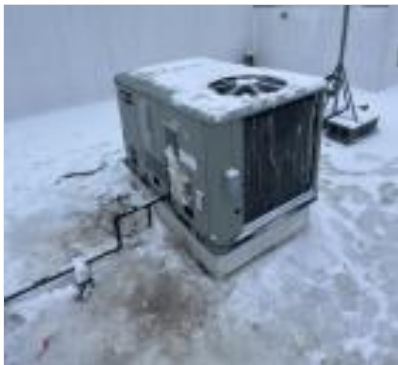
RTU-1

Notes: [1] RTU IS NOT OPERATIONAL, REQUIRES SERVICE. UNIT WAS JUMPERED IN FAN ONLY TO BALANCE AIRFLOW AND SET OA. [2] EXISTING RTU IS A 5-TON UNIT. RTU IS SCHEDULED TO BE REPLACED WITH AN 8.5-TON UNIT. AIRFLOWS WERE PROPORTIONALLY REDUCED FROM 3200 CFM TO 1970 CFM FOR UNIT CAPABILITY AND PERFORMANCE. [3] THREE DIFFUSERS NOT INSTALLED (1-3, 1-4, AND 1-14). SCHEDULED AIRFLOW FOR THESE DIFFUSERS WAS PROPORTIONALLY SPREAD ACROSS INSTALLED DIFFUSERS.

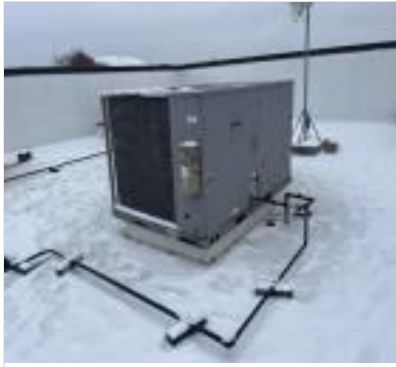
- RTU-2 Issues: Economizer not functional (OA manually set), Discharge panel leaking air, No OA filter installed, No condensate drain installed. RTU-1 is not operational, is not currently capable of heat, and needs service.

Notes: [1] UNIT HAS SEVERAL ISSUES: OA FILTER NOT INSTALLED, CONDENSATE DRAIN NOT INSTALLED, DISCHARGE PANEL NOT SECURE AND LEAKING AIR, ECONOMIZER NOT FUNCTIONAL. UNIT IS SCHEDULED TO BE REPLACED MARCH 2023. [2] DIFFUSERS 2-1 AND 2-9 NOT INSTALLED. SCHEDULED AIRFLOW FOR THESE DIFFUSERS WAS PROPORTIONALLY SPREAD ACROSS INSTALLED DIFFUSERS.

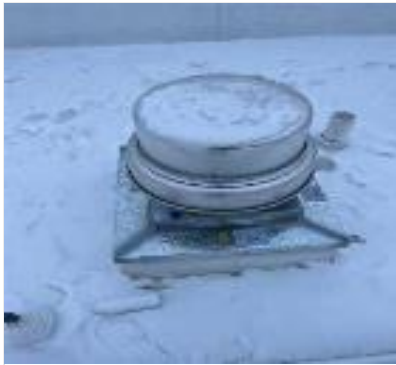
Description : EF-1 and EF-2 are not secured to their curbs. Recommend fans are secured.

Notes: [1] COULD NOT SAFELY ACCESS. [2] FAN IS NOT SECURED TO CURB. [3] NO SPEED CONTROLLER FOUND INSTALLED. FAN IS OPERATING WITHIN DESIGN AIRFLOW.

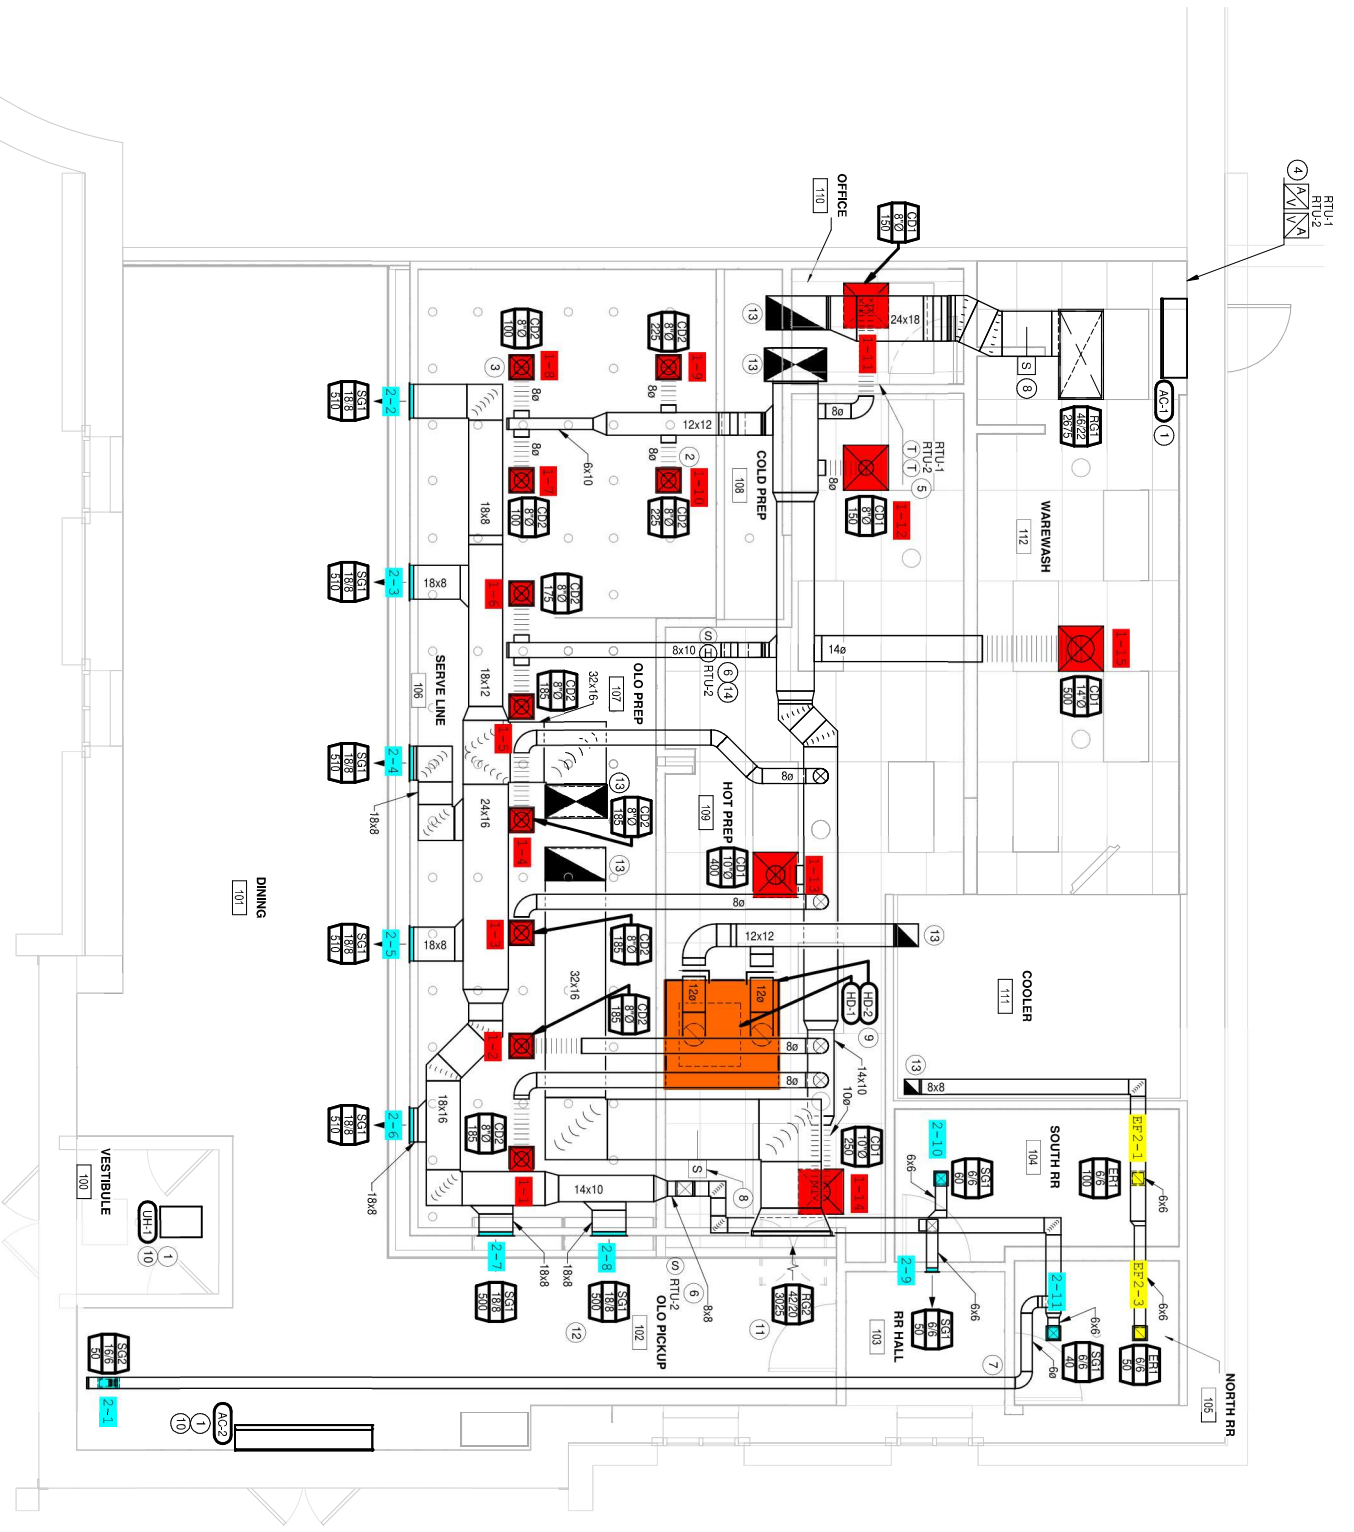
1 HVAC PLAN
1/4" = 1'-0"
NORTH

Description : Diffusers 1-3, 1-4, and 1-14 are not installed. Recommend diffusers are installed per plans. Scheduled airflow for these diffusers was proportionally distributed across installed diffusers.
