**Report: Pre-TAB Report**  
**Function: Test, Adjust, & Balance**  
**Date: 03/03/2026**  
**Completed By: National TAB**

## 03-23-26 WAWA #8245 YEAGERTOWN, PA

Project: 03-23-26 WAWA #8245 YEAGERTOWN, PA

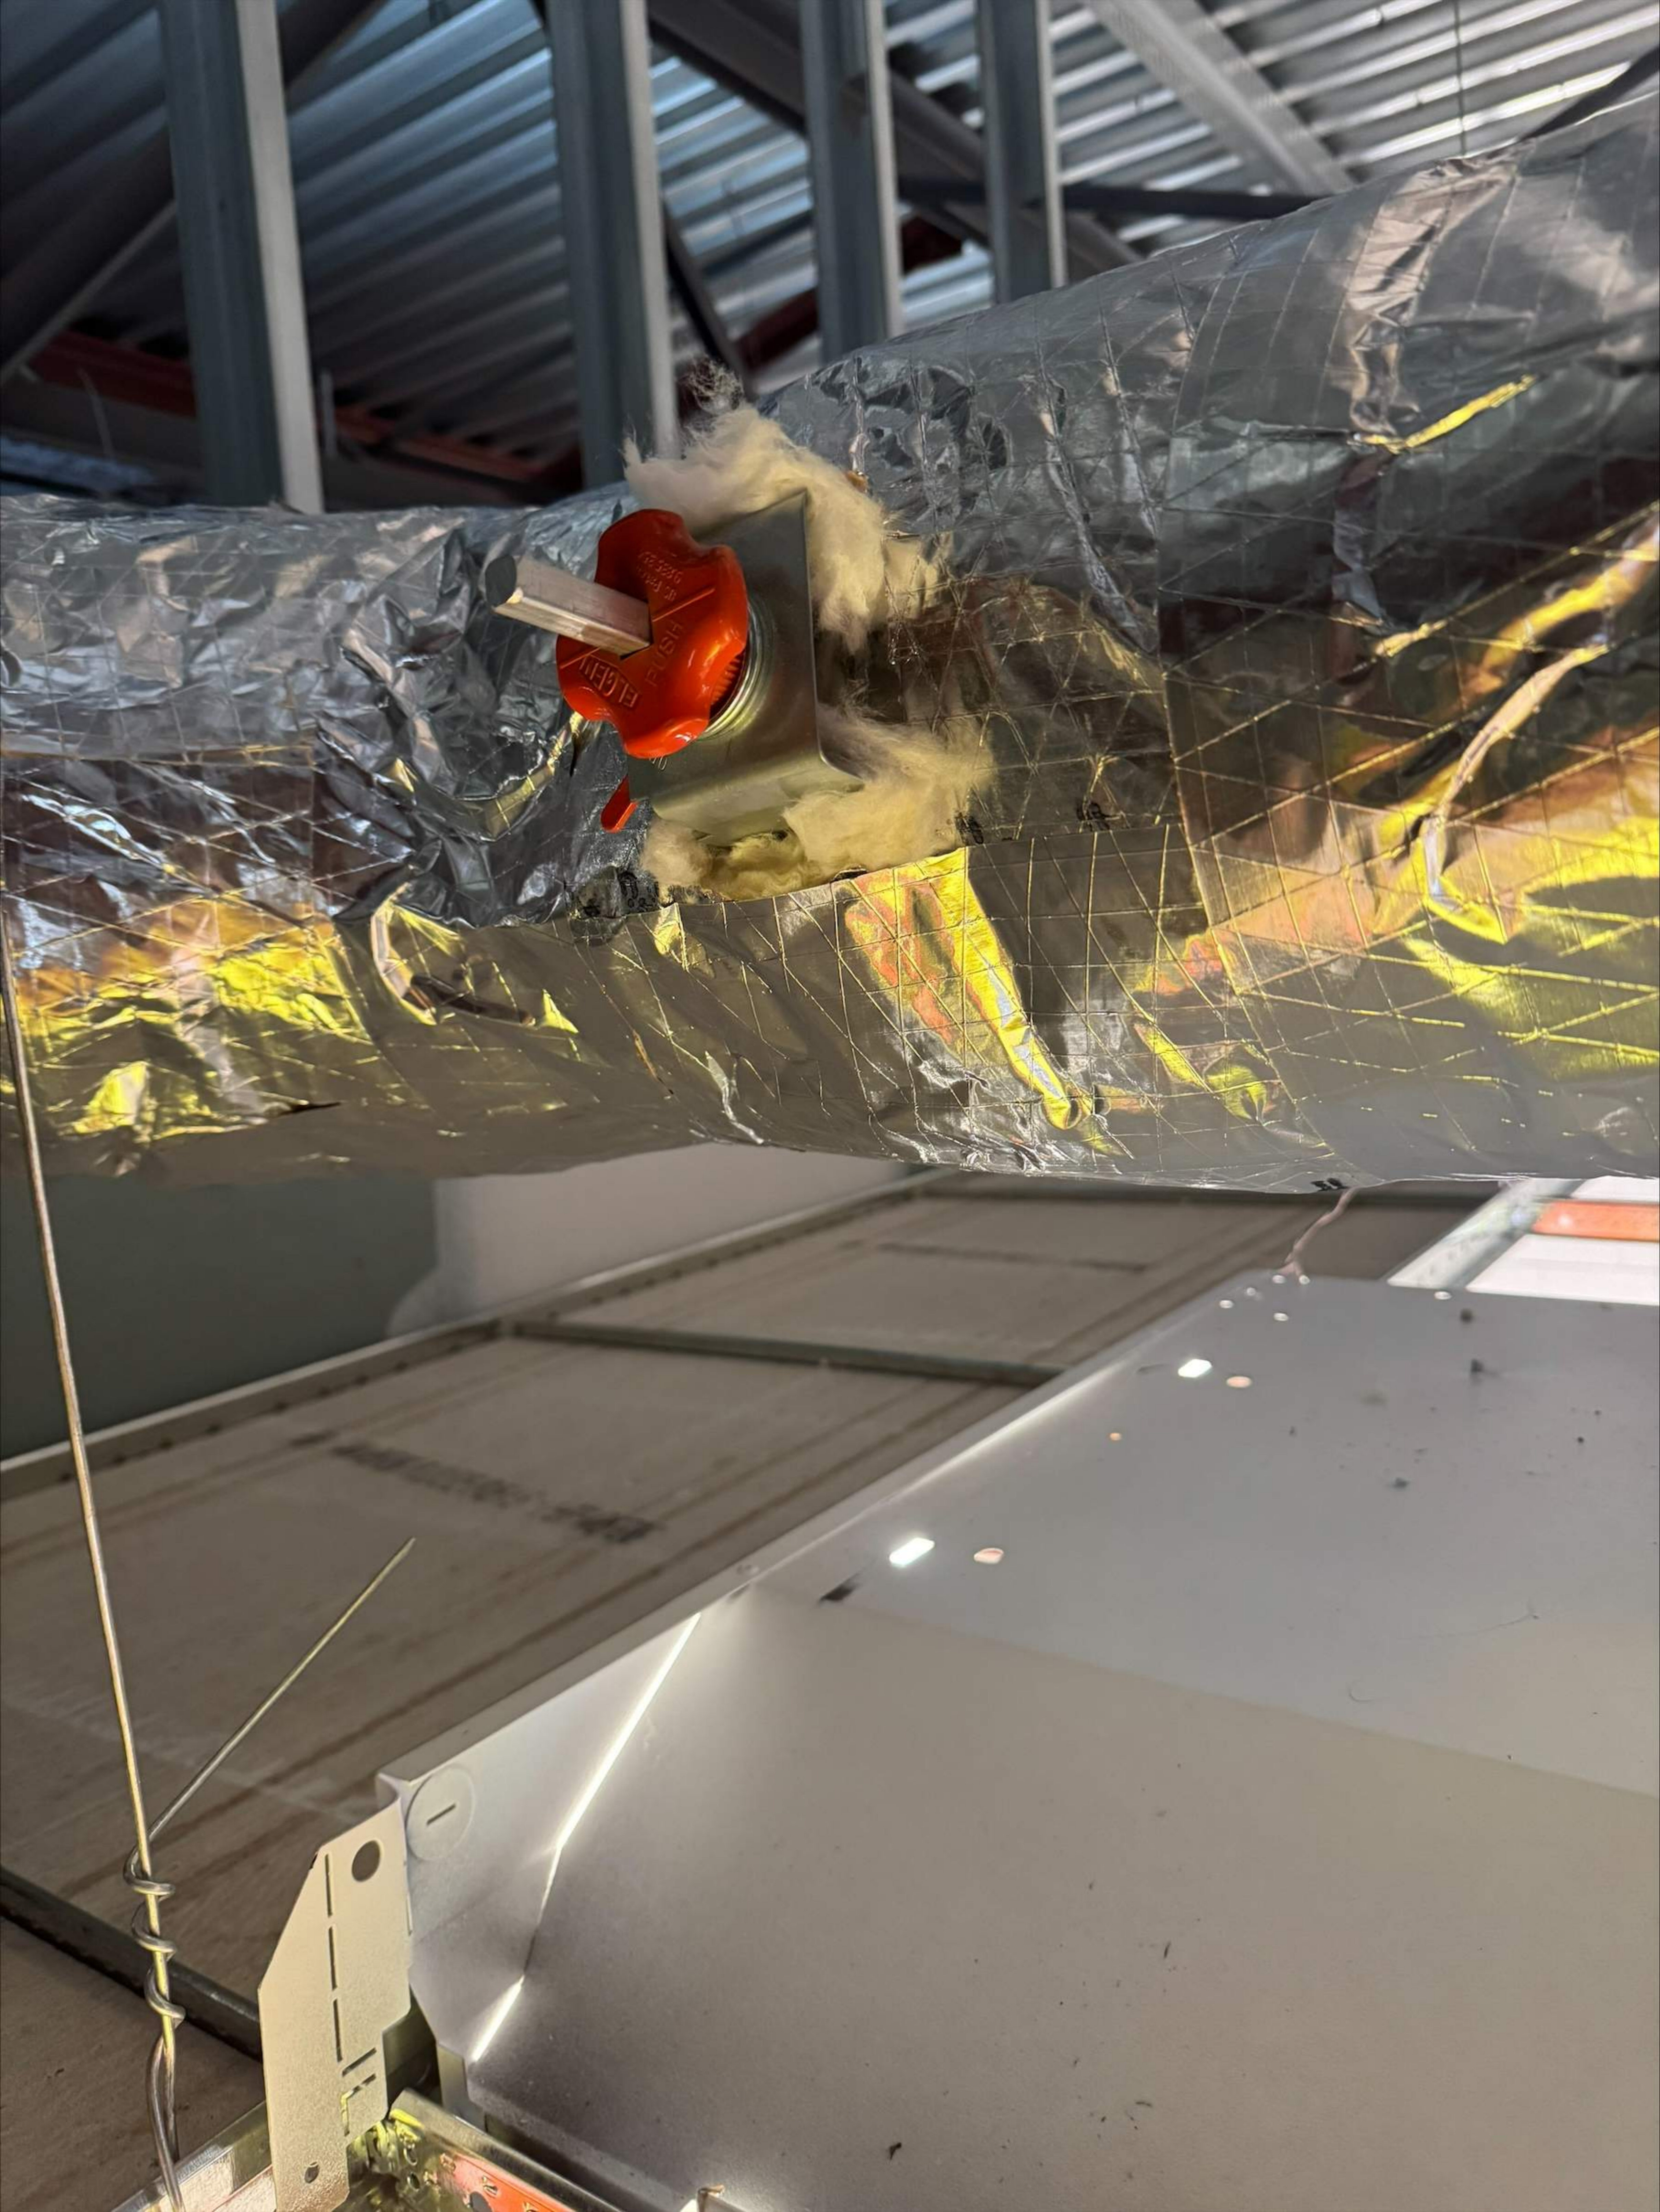
**Issue Name :** 1. Missing damper -office  
**Description :** Office diffuser does not have a damper installed. Add prior to TAB  
**Created By :** National TAB                      **Assigned To :** National TAB - Tyler Youells  
**Status :** Open  
**Priority :** High                                      **Asset Tag :**  
**Originated Date :** 03/03/2026 - Tyler Youells - National TAB

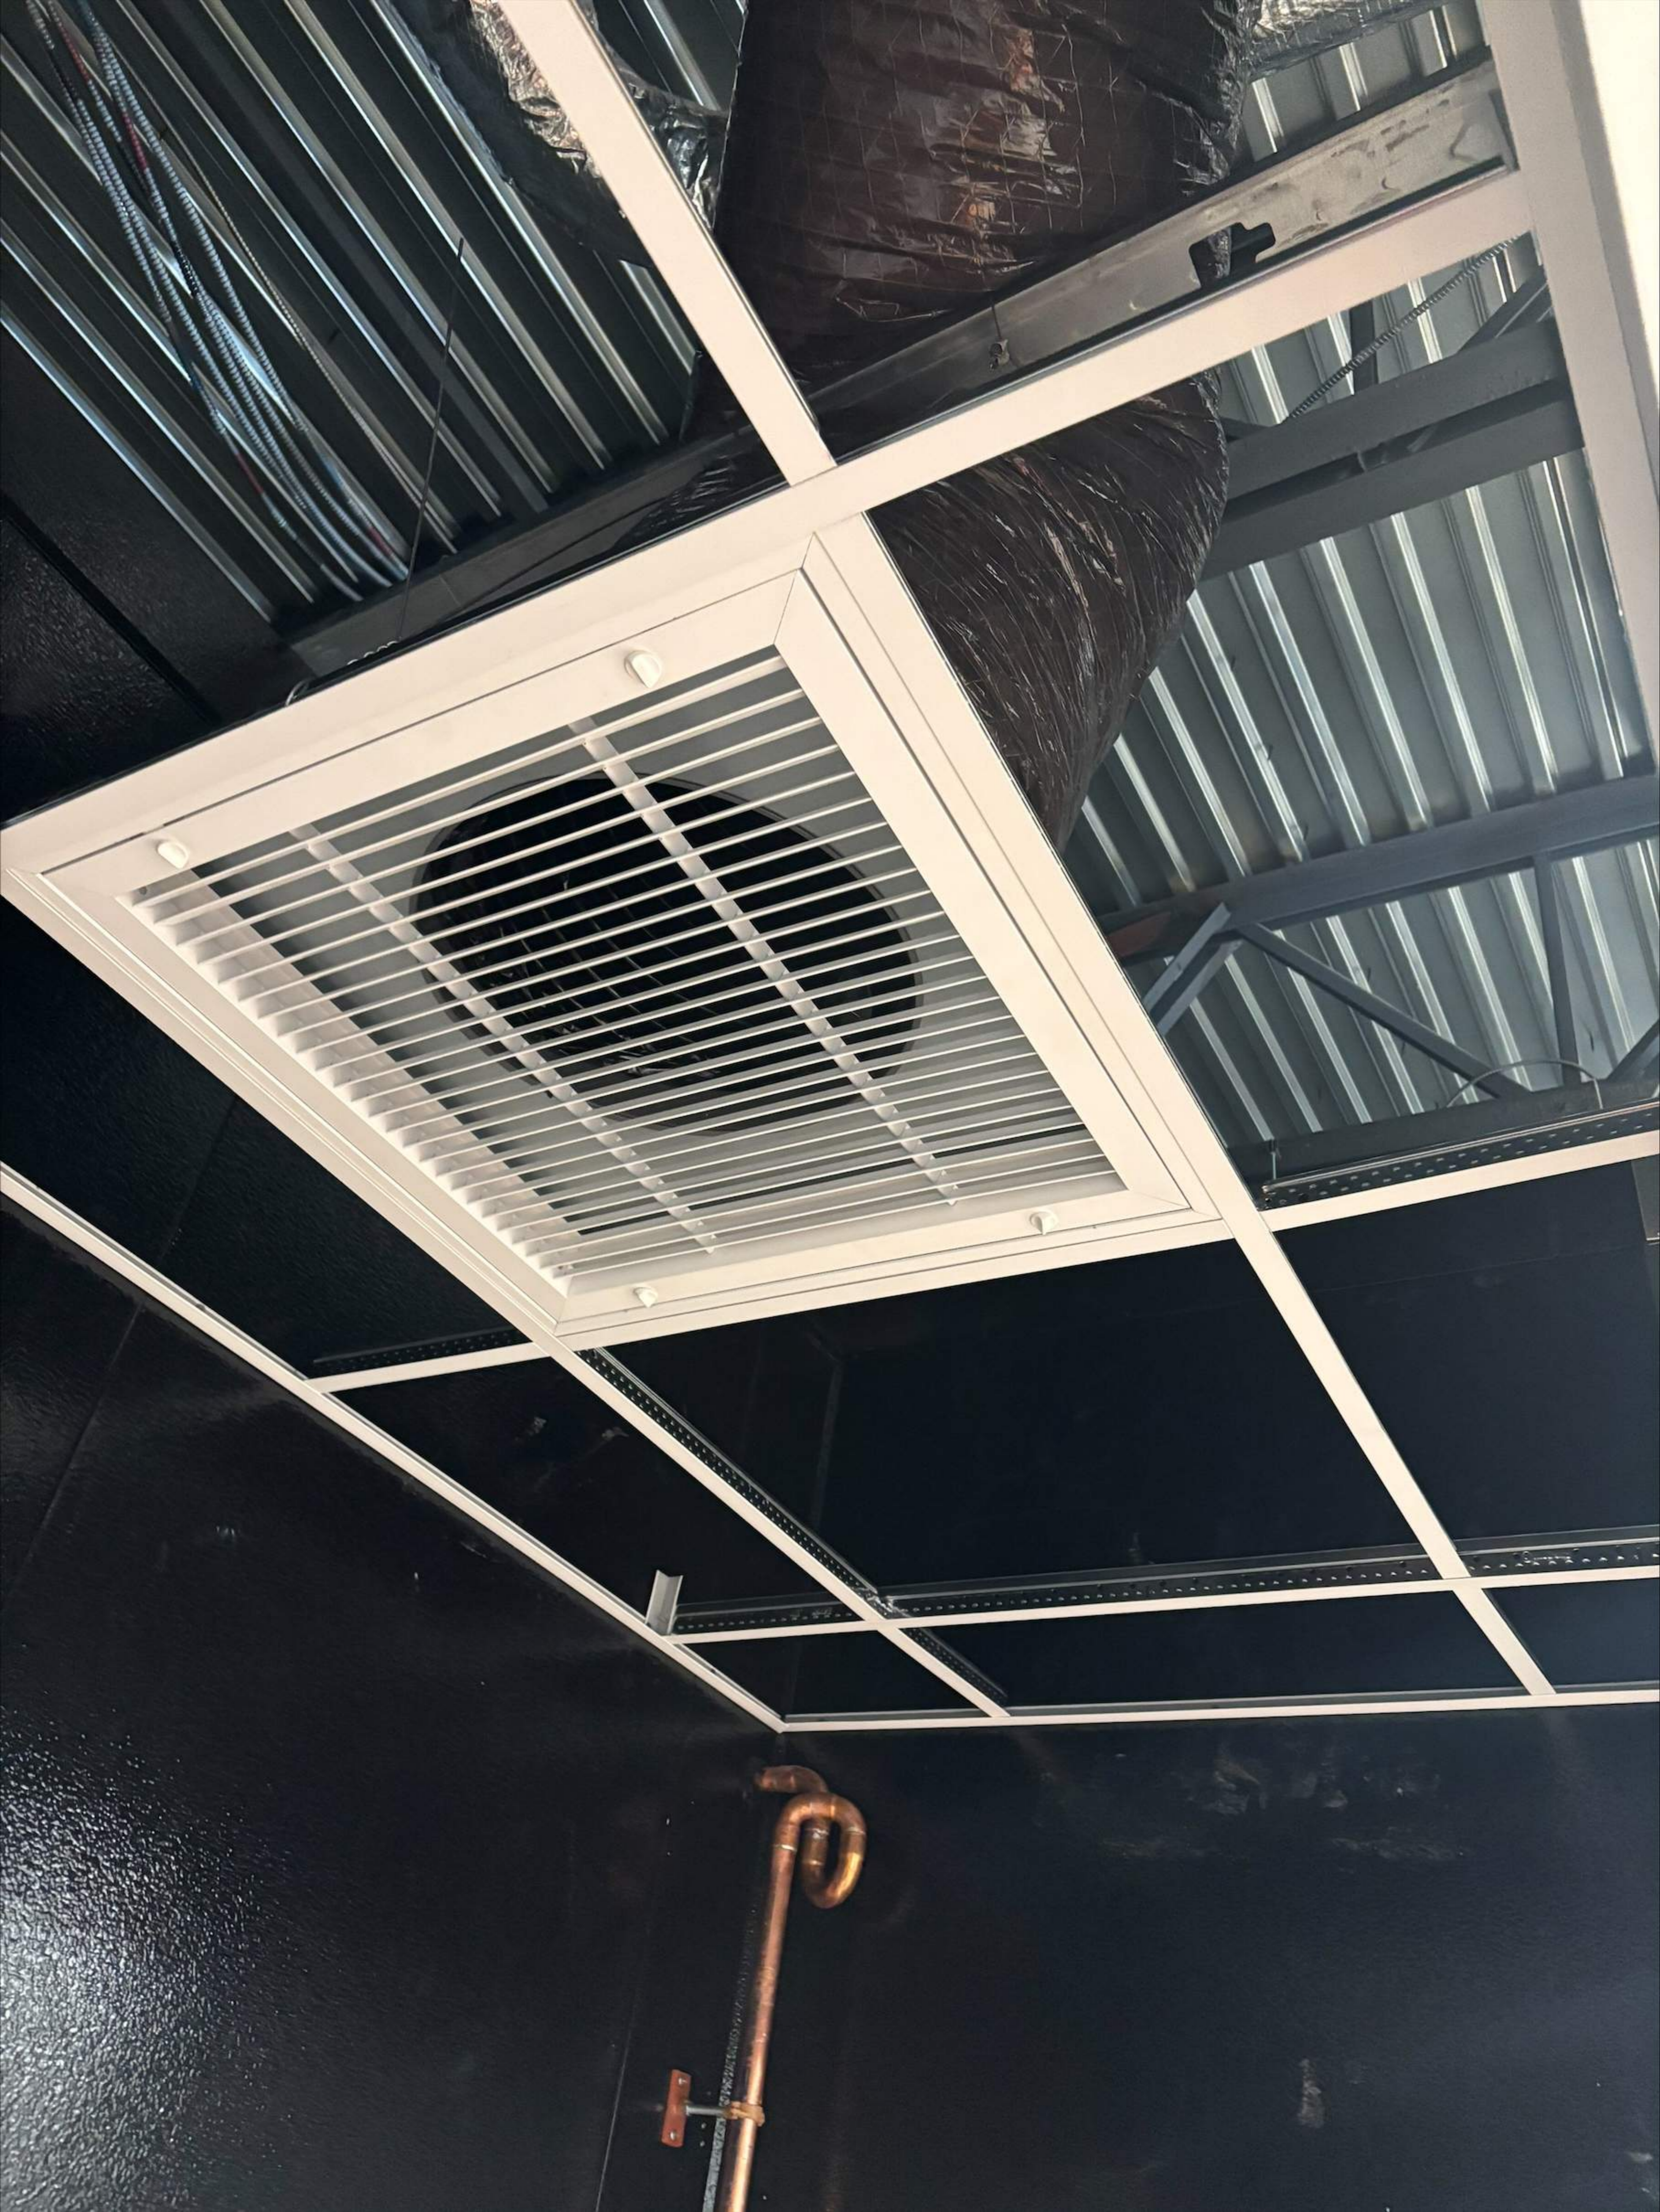
**Issue Name :** 4. Stuck Damper on RTU-3 Return  
**Description :** correct damper so that it can open and close freely. Damper is jammed up halfway closed. Repair prior to TAB.  
**Created By :** National TAB                      **Assigned To :** National TAB - Tyler Youells  
**Status :** Open  
**Priority :** Medium                                      **Asset Tag :**  
**Originated Date :** 03/03/2026 - Tyler Youells - National TAB

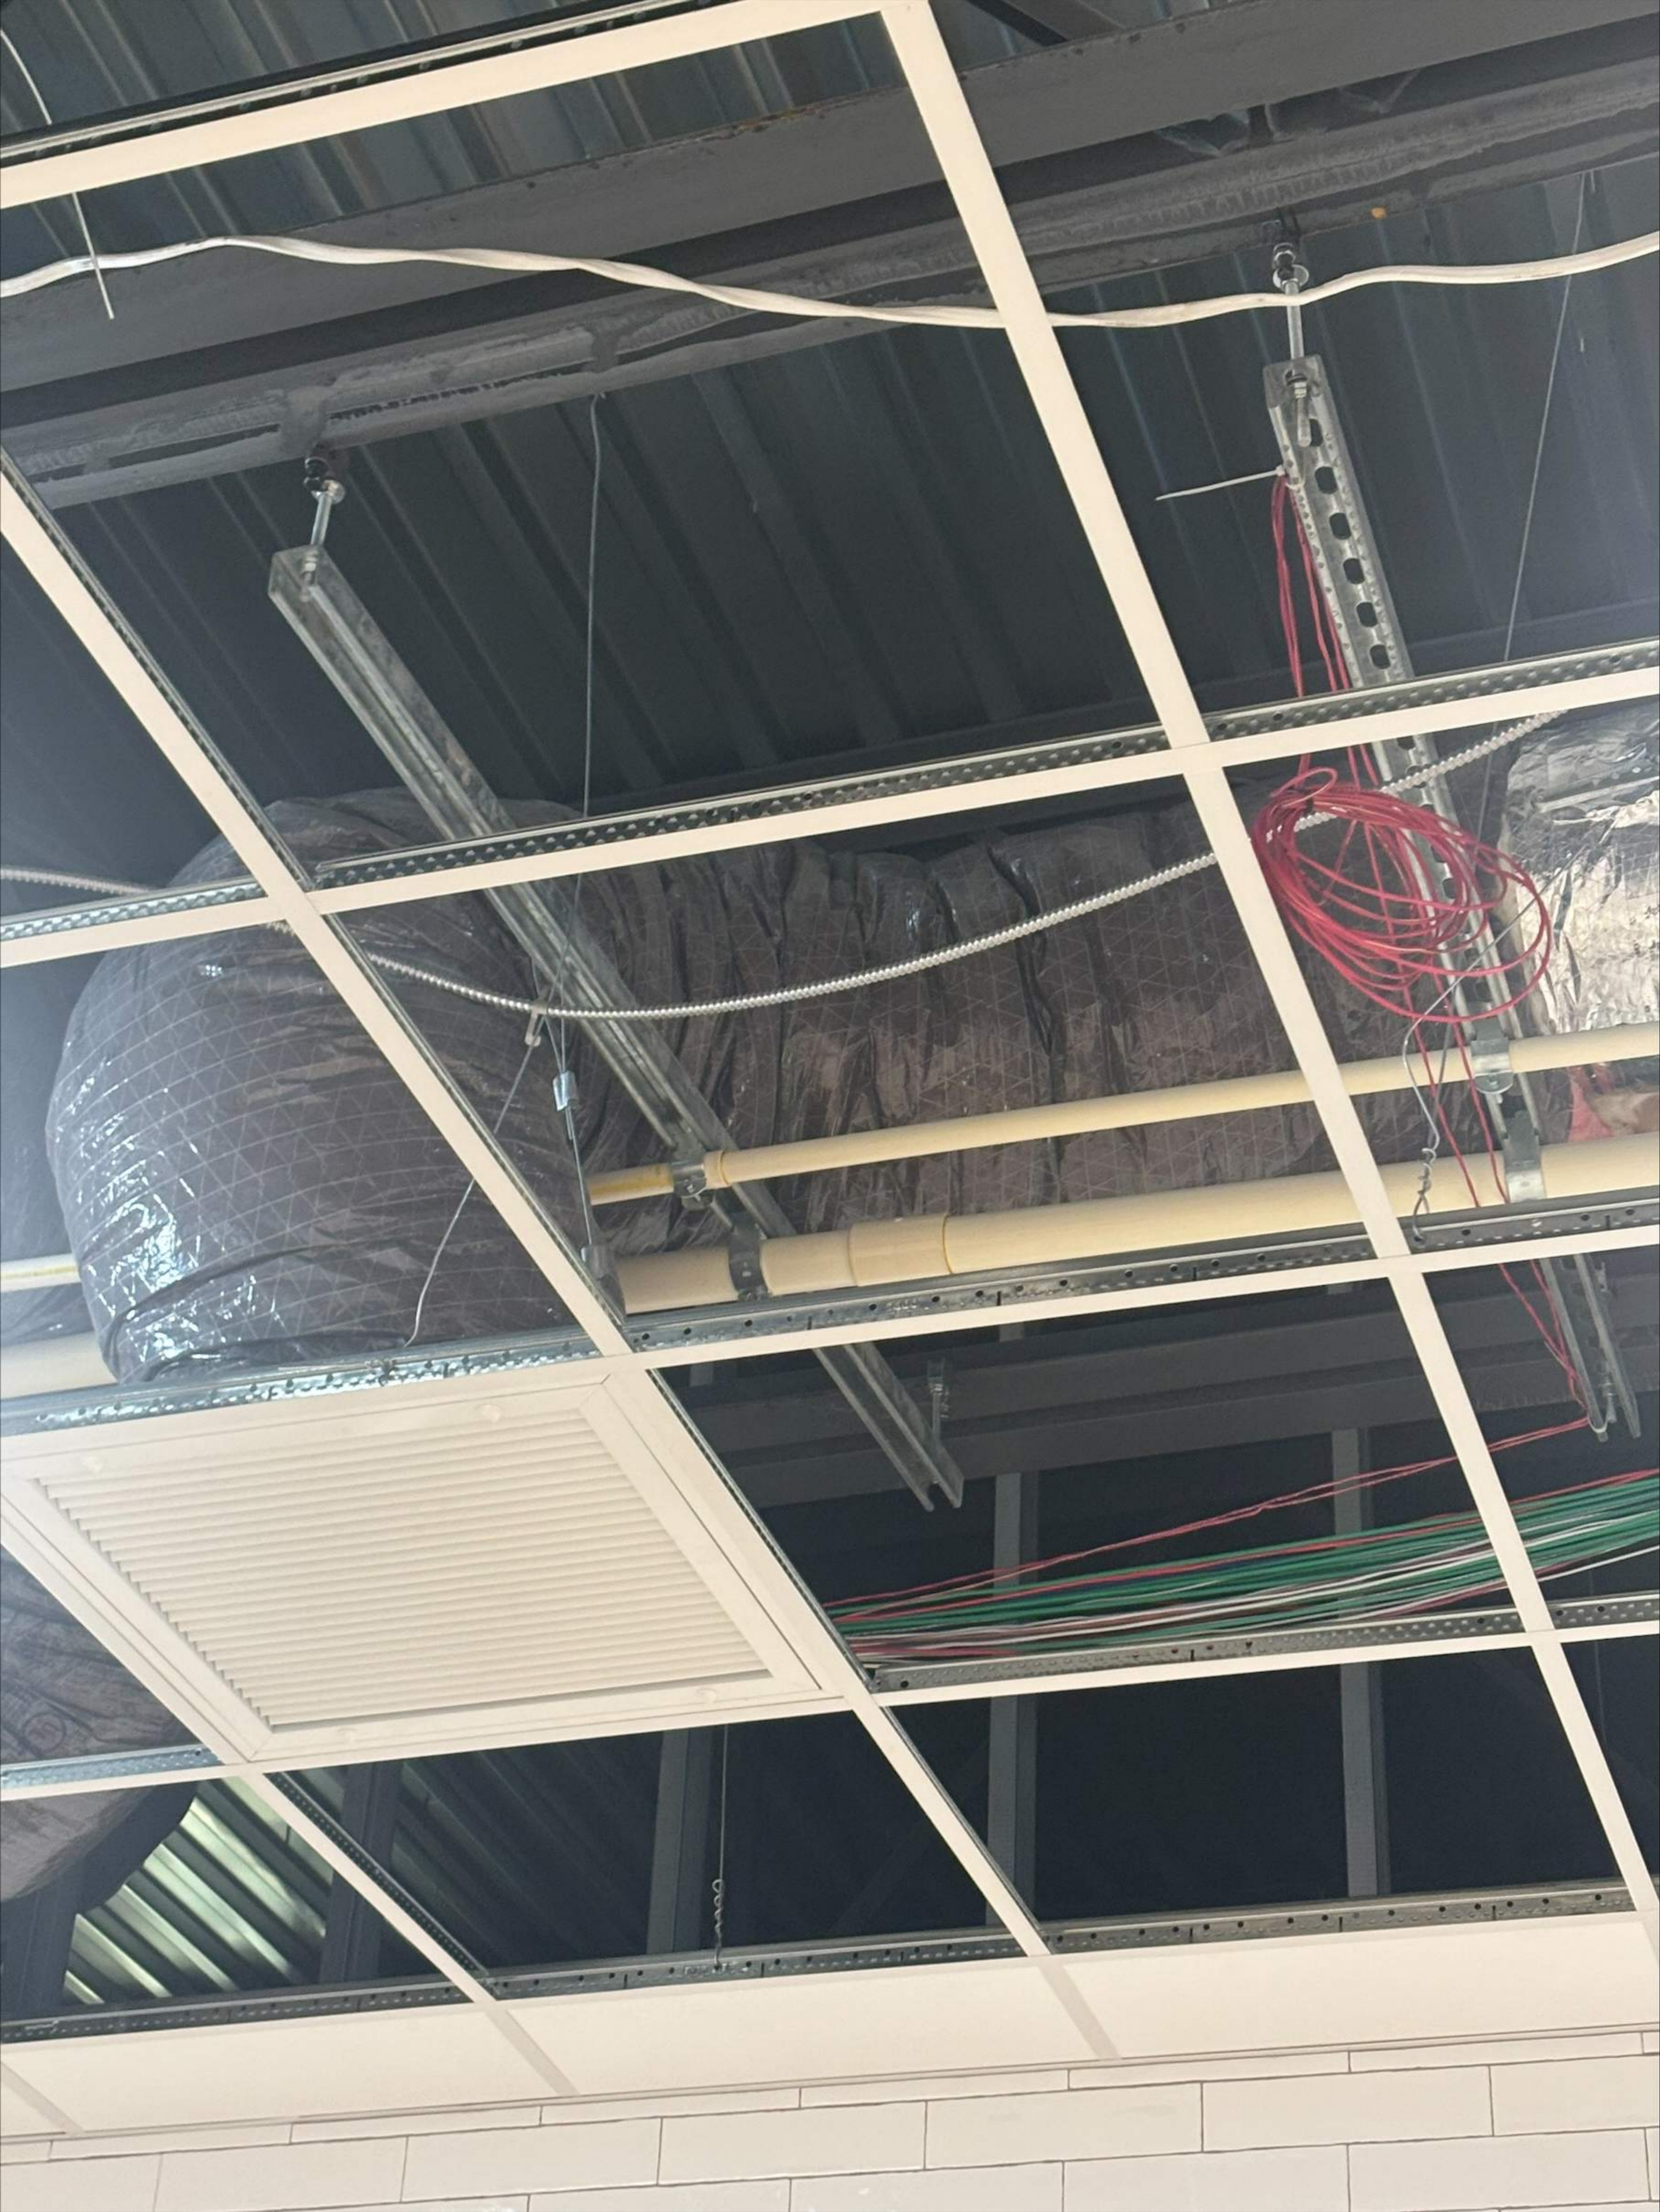
**Issue Name :** 5. Adjust Flexible duct- RTU-3 Return  
**Description :** Adjust the Flexible duct for RTU-3 return, Also recommend adjusting the plumbing support bracket to allow a better flex connection that is less impeded.  
**Created By :** National TAB                      **Assigned To :** National TAB - Tyler Youells  
**Status :** Open  
**Priority :** Medium                                      **Asset Tag :**  
**Originated Date :** 03/03/2026 - Tyler Youells - National TAB

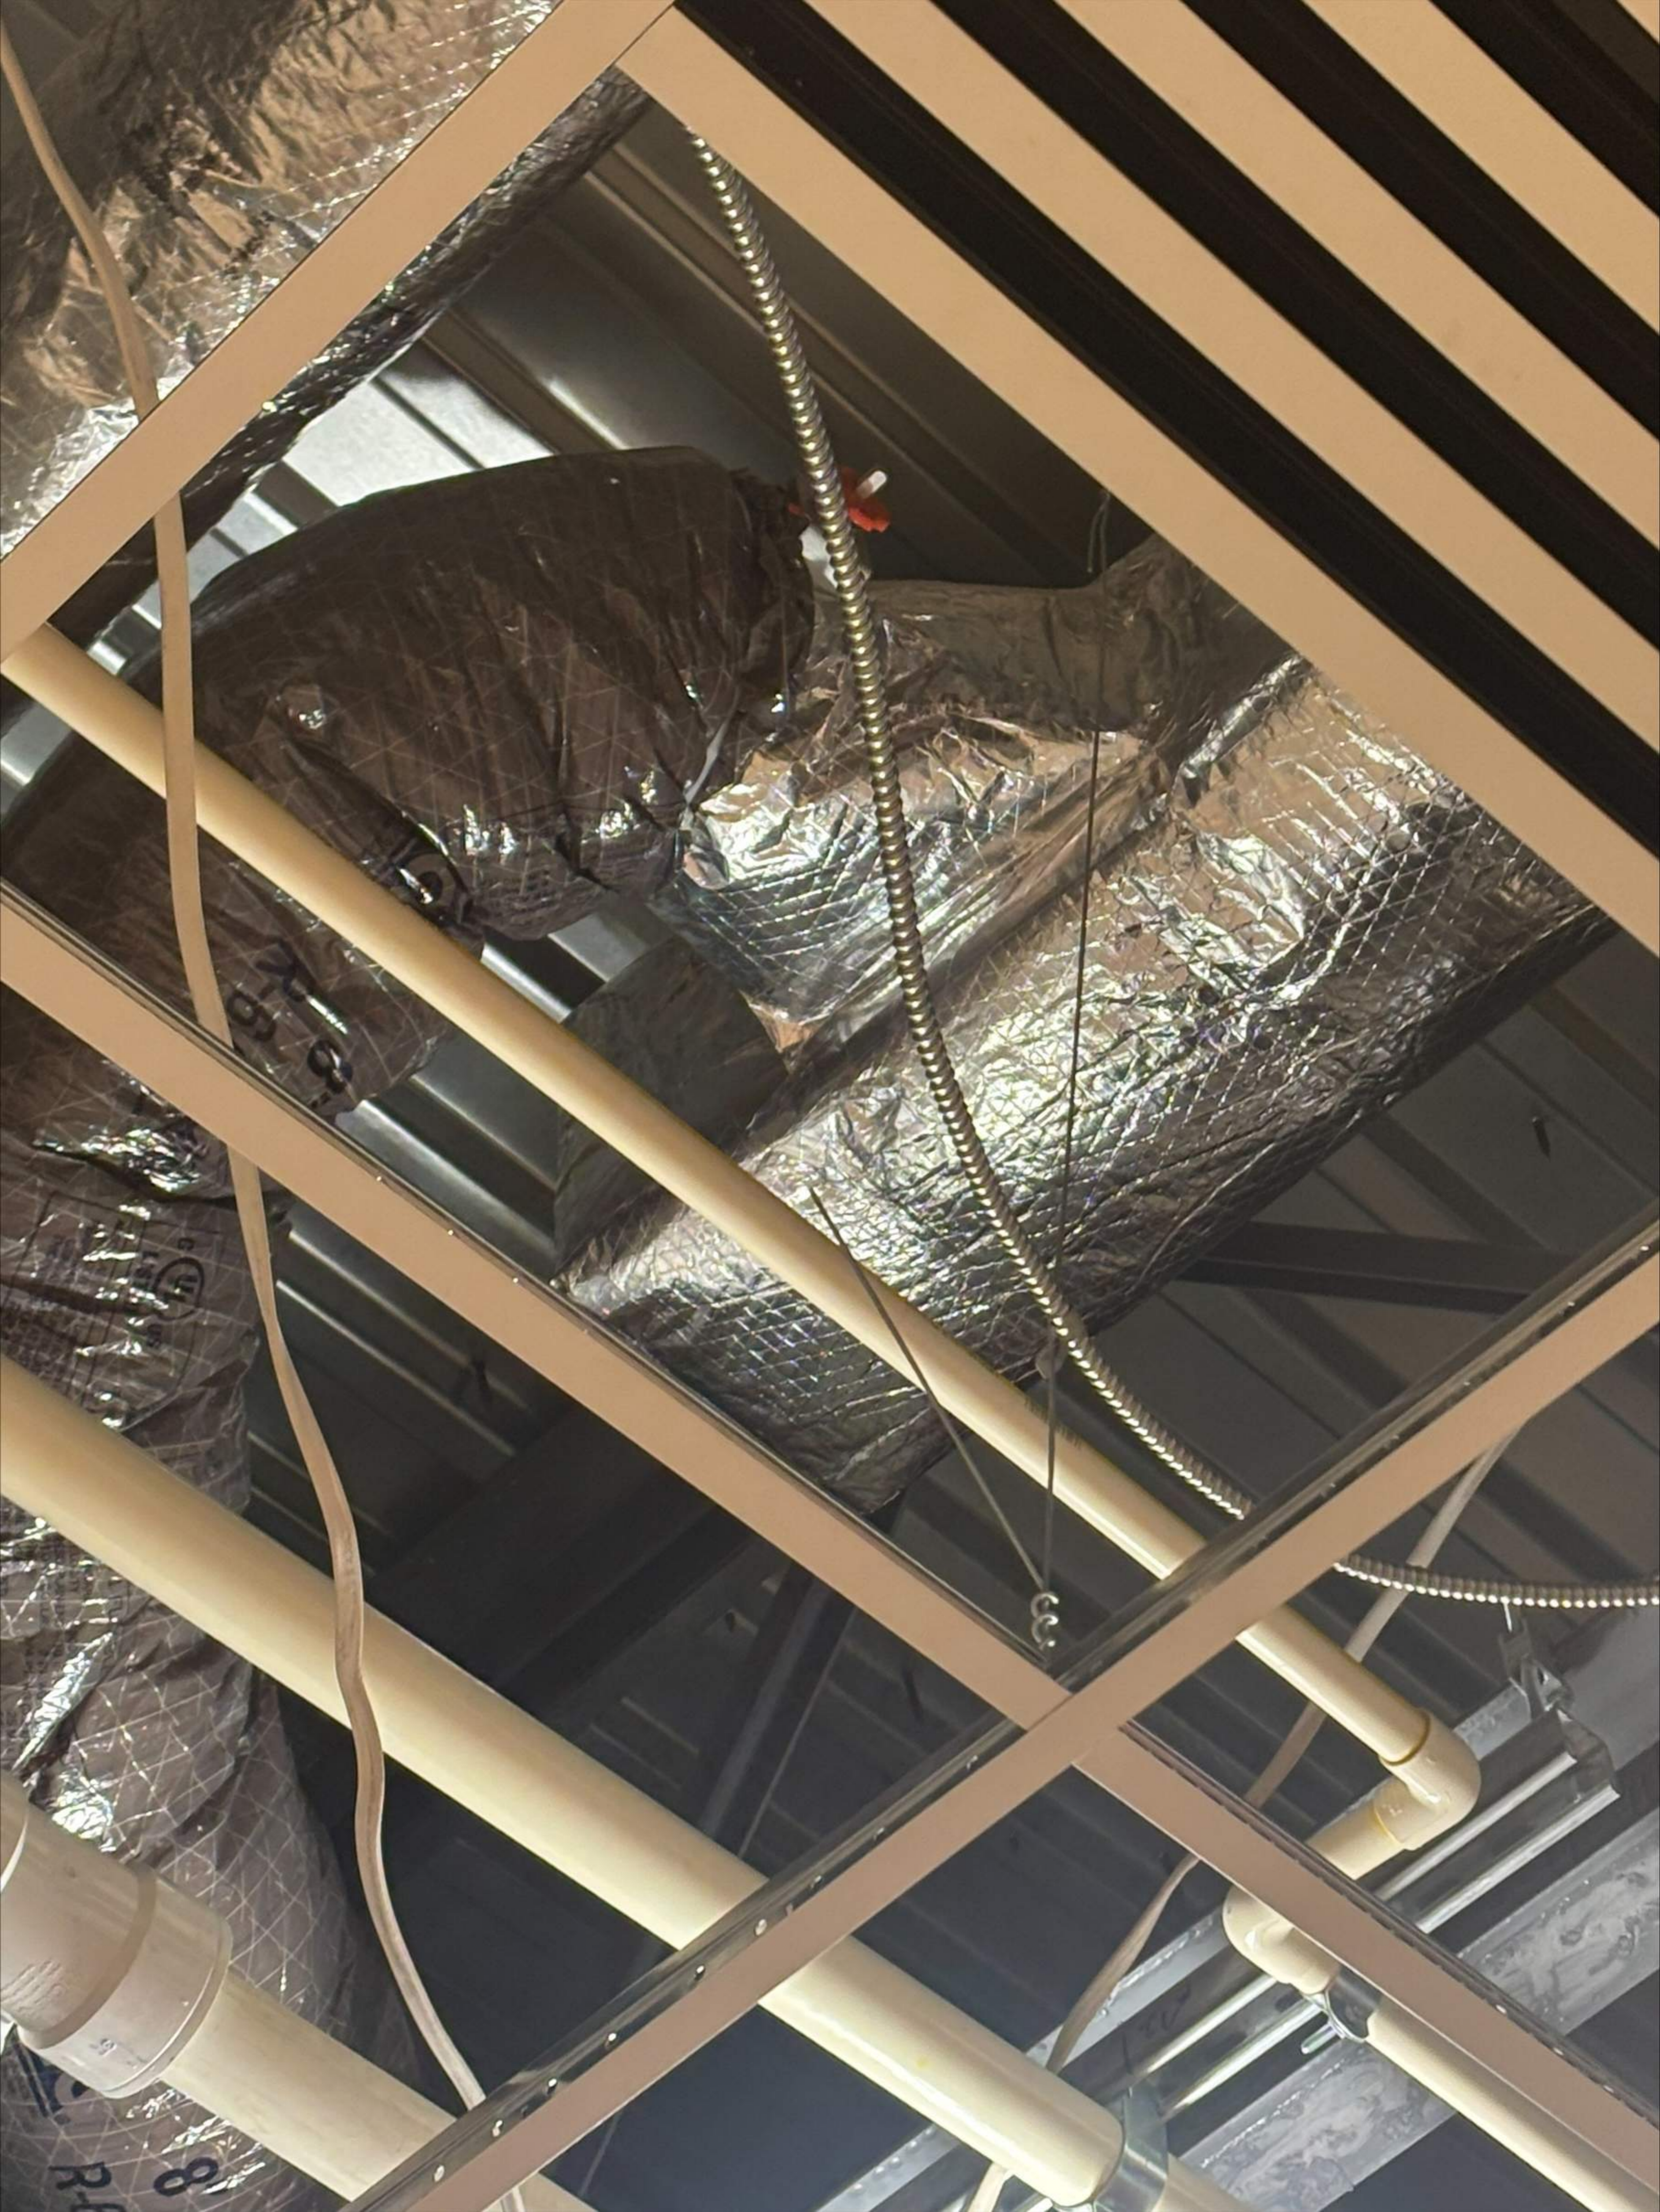
**Issue Name :** 6. Relocate supply takeoff- Delivery RM  
**Description :** Relocate the supply takeoff for the delivery room, current location will cause a tight duct connection. relocate to other side of the supply trunk and routing through Truss gap.  
**Created By :** National TAB                      **Assigned To :** National TAB - Tyler Youells  
**Status :** Open  
**Priority :** High                                      **Asset Tag :**  
**Originated Date :** 03/03/2026 - Tyler Youells - National TAB

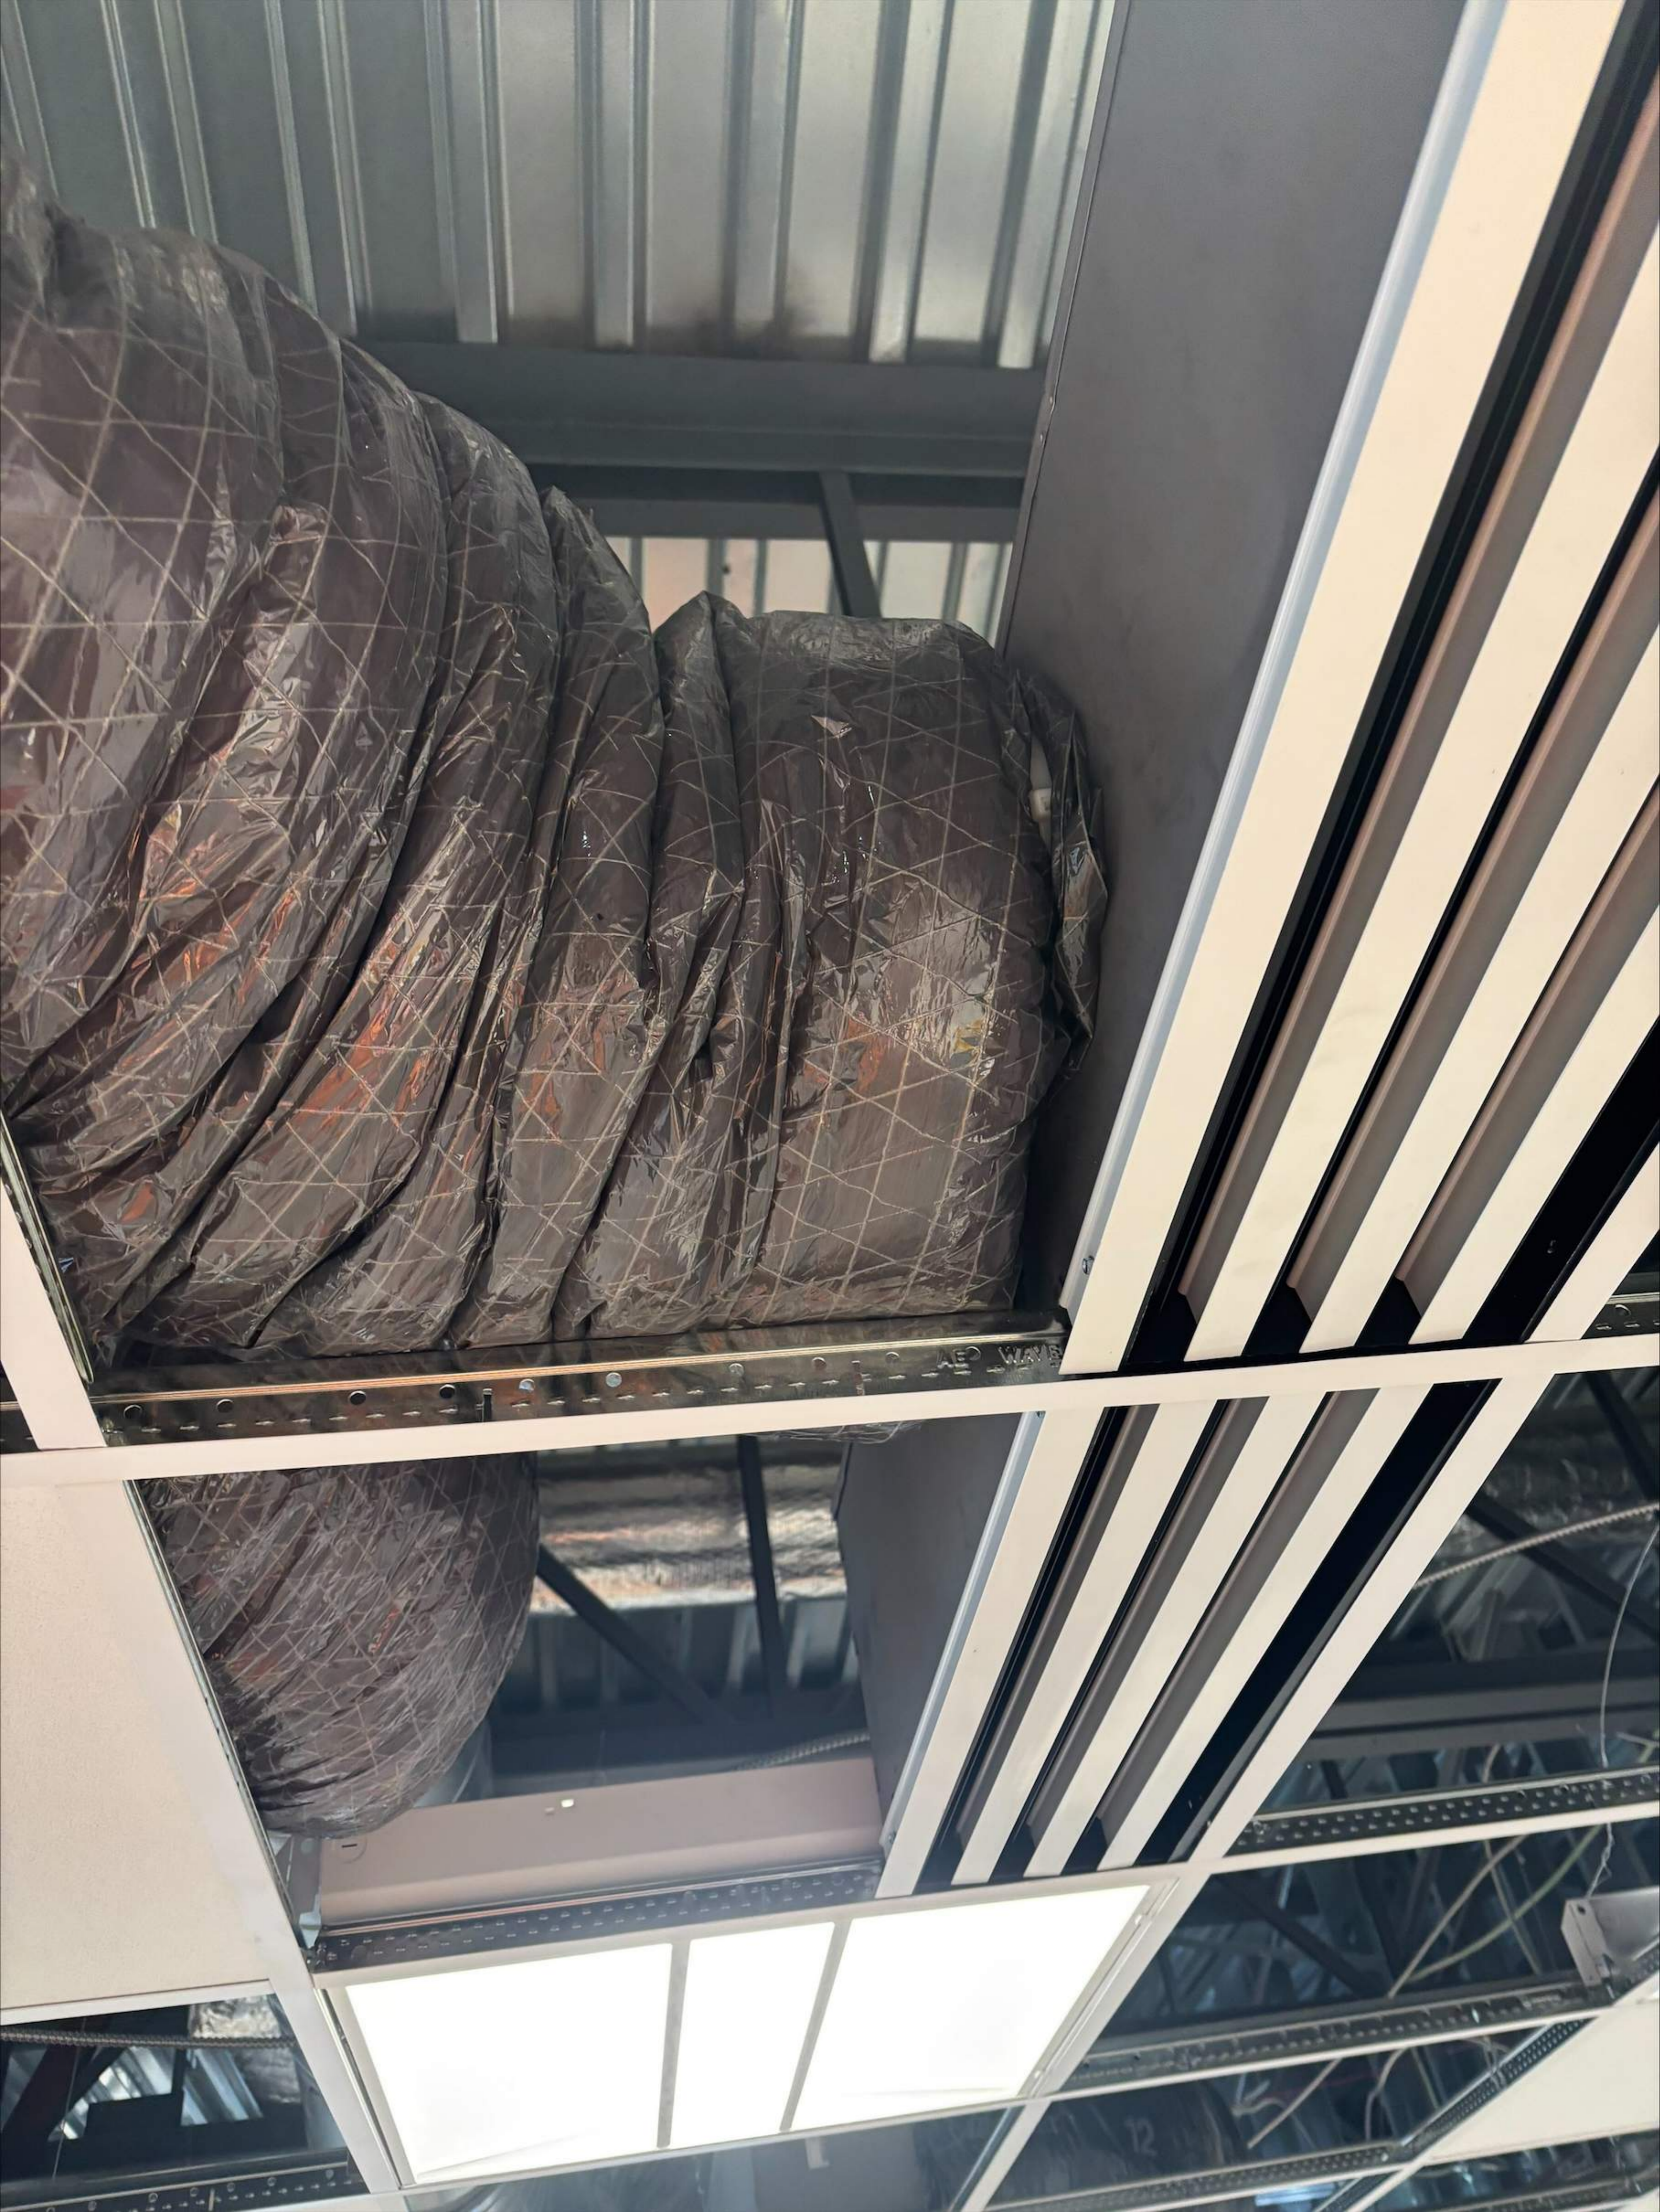
9. Flip orientation of the linear diffuser for proper duct connection
10. Duct drop is not a plenum drop and has a radiused elbow, seek engineer approval and or recommendation to repair

**Issue Name :** 9. Flip Linear diffuser orientation  
**Description :** Recommend flipping Linear diffuser orientation to allow for a more appropriate and laminar flex connection. ensure proper clearances.  
**Created By :** National TAB                      **Assigned To :** National TAB - Tyler Youells  
**Status :** Open  
**Priority :** Medium                                      **Asset Tag :**  
**Originated Date :** 03/03/2026 - Tyler Youells - National TAB

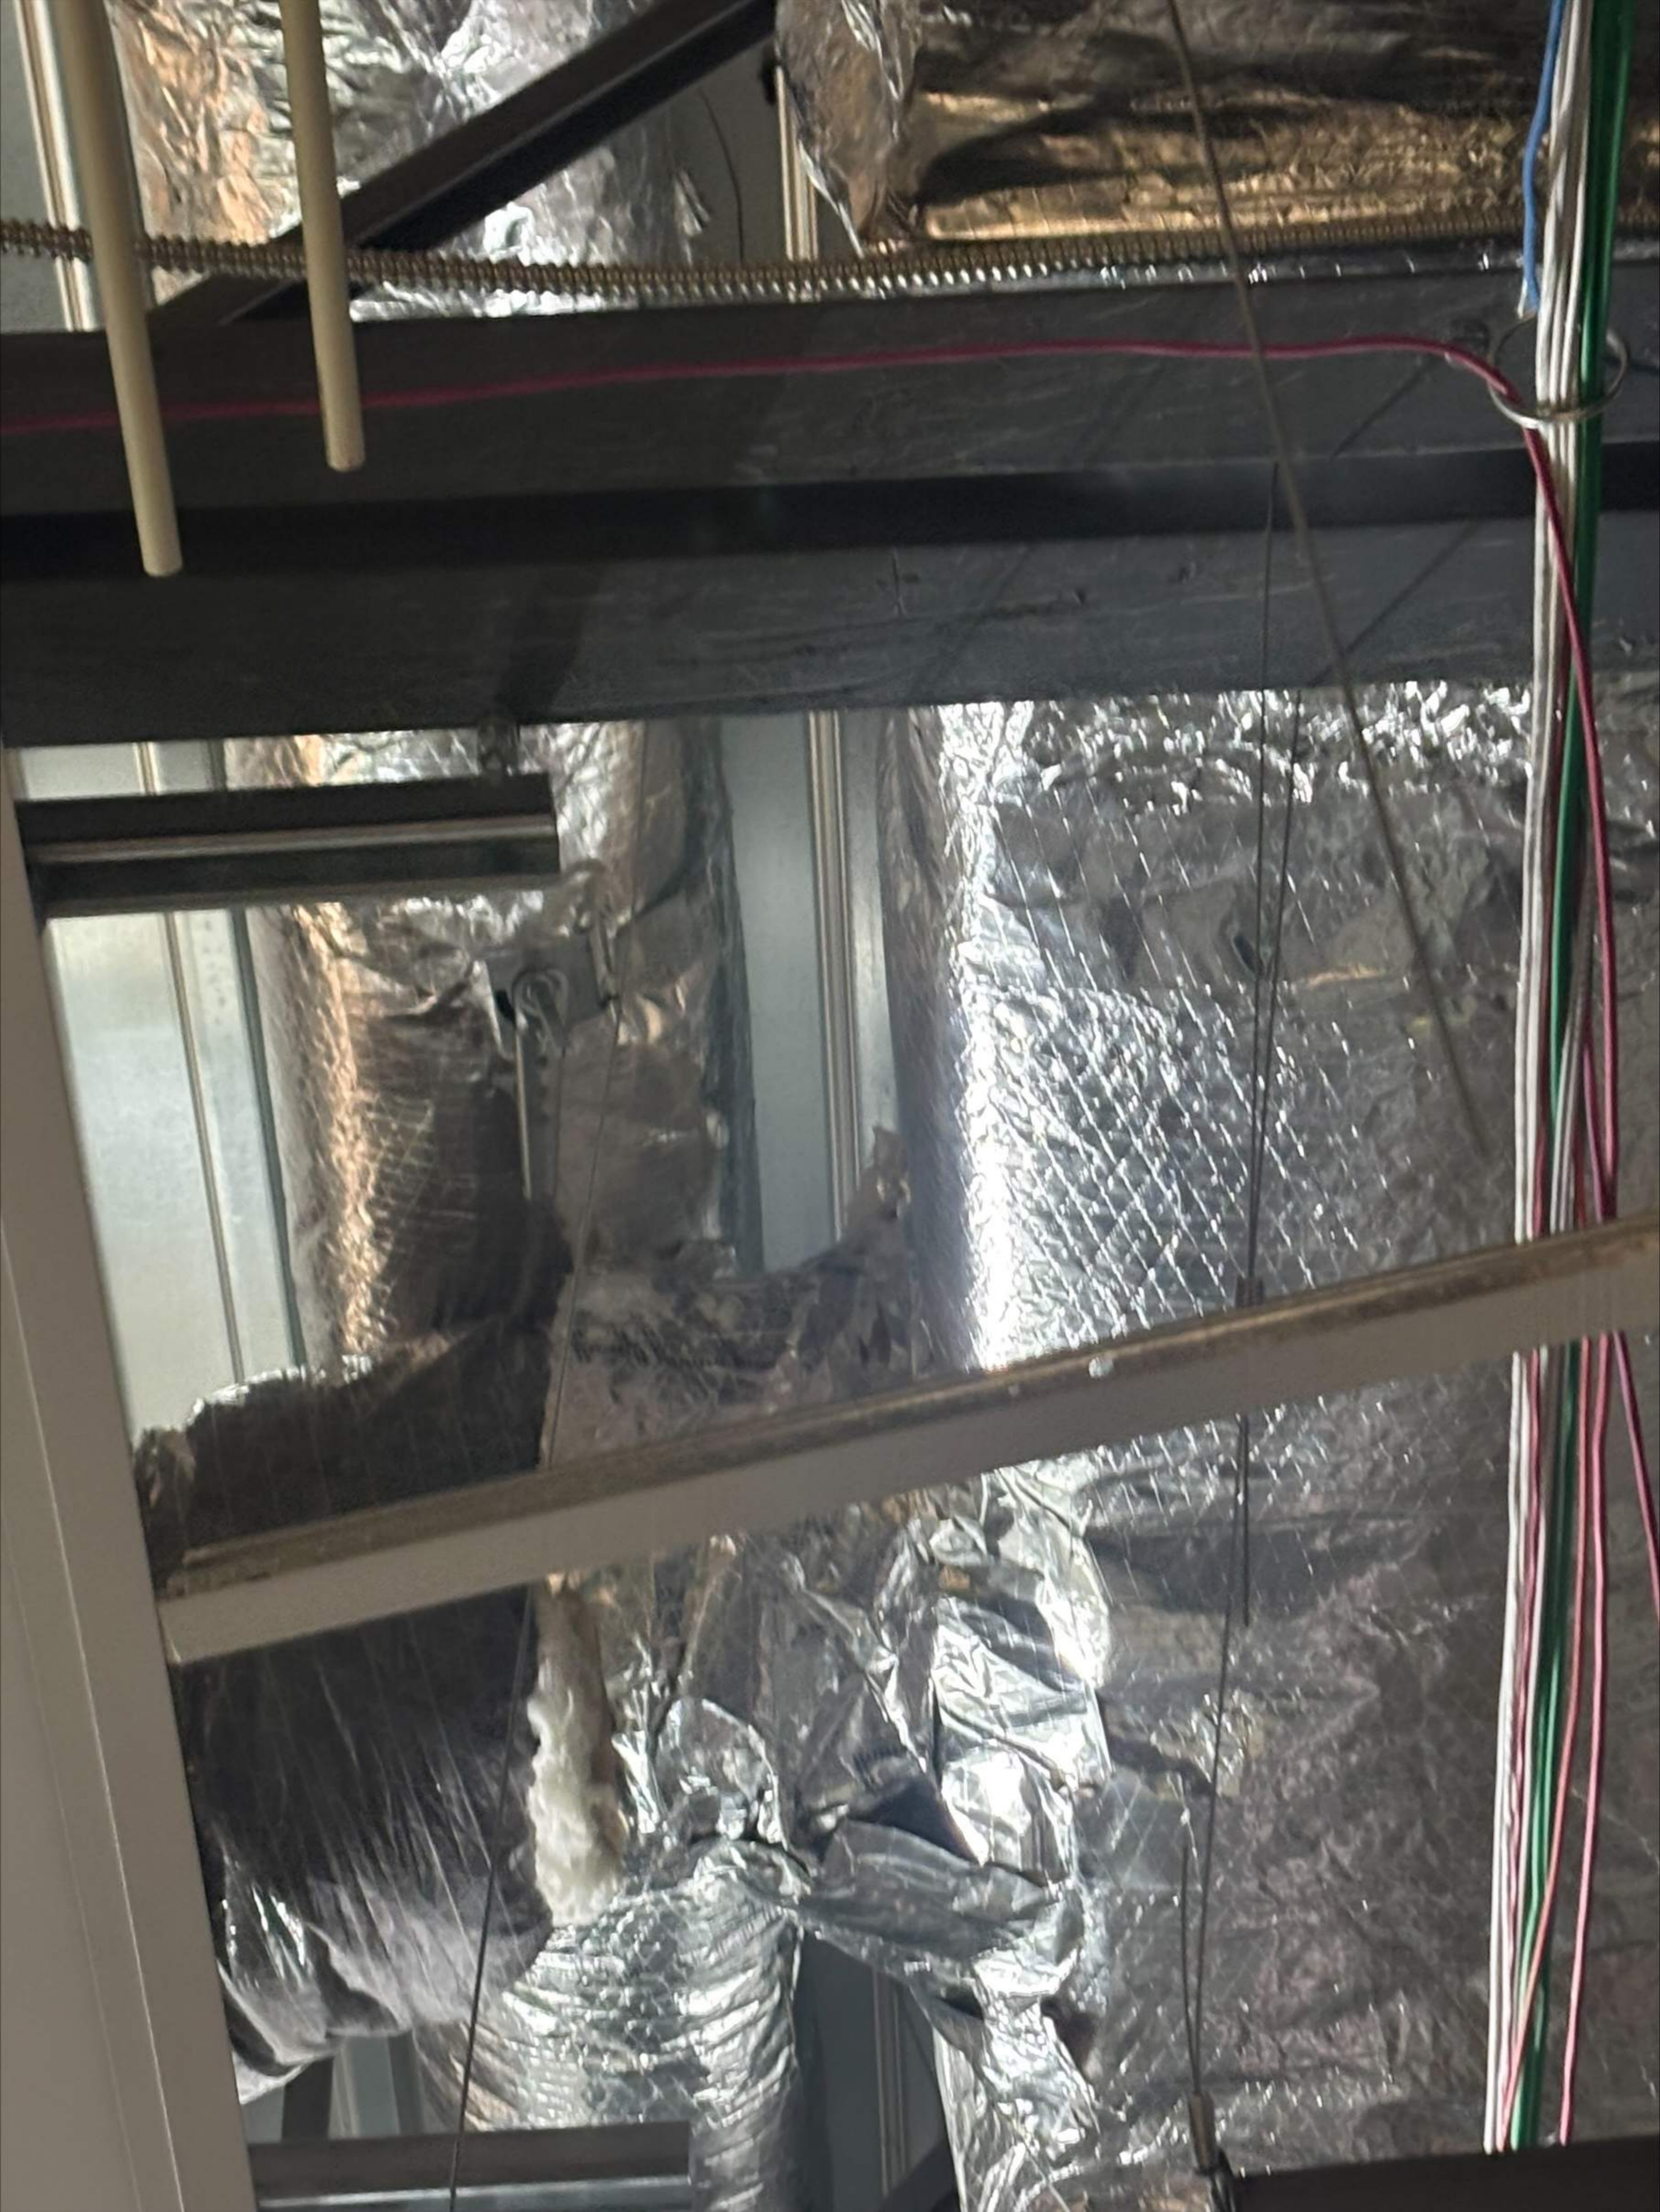
**Issue Name :** 10. AC-3 Supply drop  
**Description :** AC-3 supply drop was installed as a Radiused drop and not as a supply plenum drop per Keynote 18. Recommend EOR review and approve if acceptable  
**Created By :** National TAB                      **Assigned To :** National TAB - Tyler Youells  
**Status :** Open  
**Priority :** High                                      **Asset Tag :**  
**Originated Date :** 03/03/2026 - Tyler Youells - National TAB
