**Report: Pre-TAB Report**  
**Function: Test, Adjust, & Balance**  
**Date: 03/03/2026**  
**Completed By: National TAB**

## 03-23-26 WAWA #8245 YEAGERTOWN, PA

Project: 03-23-26 WAWA #8245 YEAGERTOWN, PA

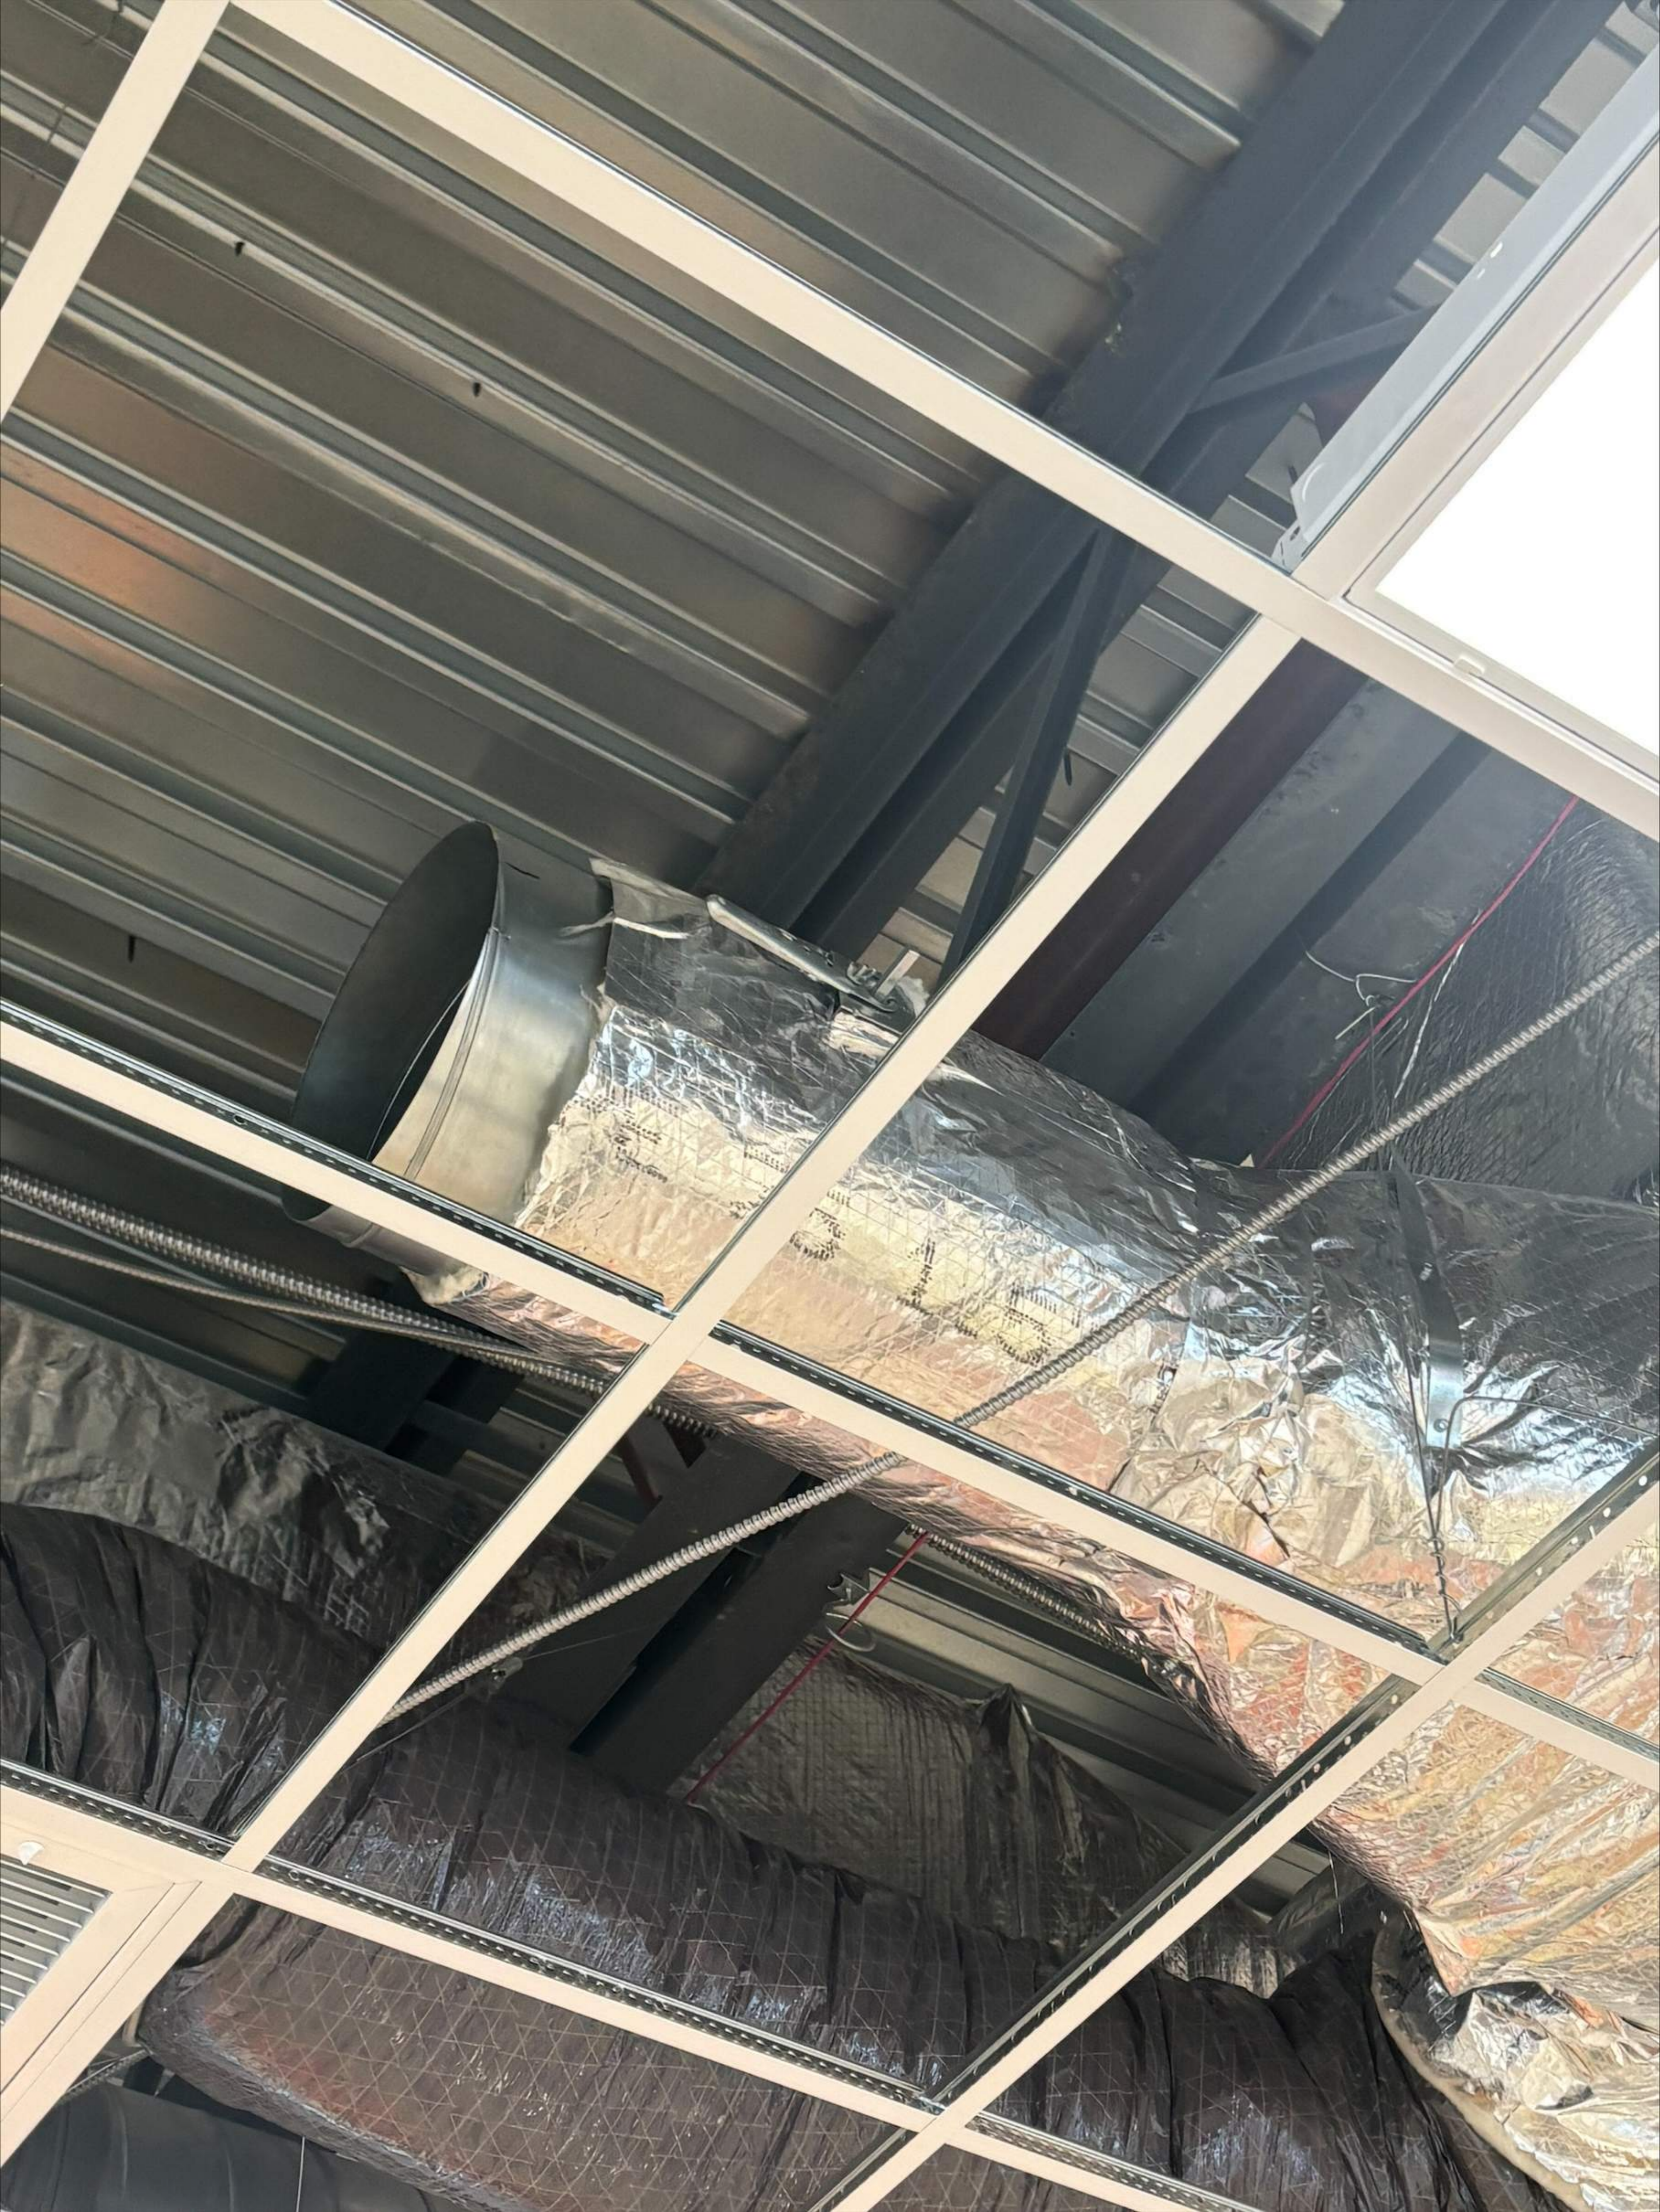
12. Missing damper for return grille
13. Return grille flex duct is excessive and needs to utilize more hard duct and flex needs to be better supported
14. Start collar orientation is opposite of directional airflow (transition is not properly oriented) correct orientation and adjust damper position so it is still accessible.

**Issue Name :** 12. Missing Damper- Return Grille  
**Description :** Rtu-1 Return grille does not have a damper installed. Install damper prior to TAB.  
**Created By :** National TAB                      **Assigned To :** National TAB - Tyler Youells  
**Status :** Open  
**Priority :** High                                      **Asset Tag :**  
**Originated Date :** 03/03/2026 - Tyler Youells - National TAB
