Report: TAB Report
Function: Test, Adjust, & Balance
Date: 09/05/2025
Completed By: National TAB

PROJECT
08-25-25 WAWA #6613 CHANTILLY, VA

Project: 08-25-25 WAWA #6613 CHANTILLY, VA

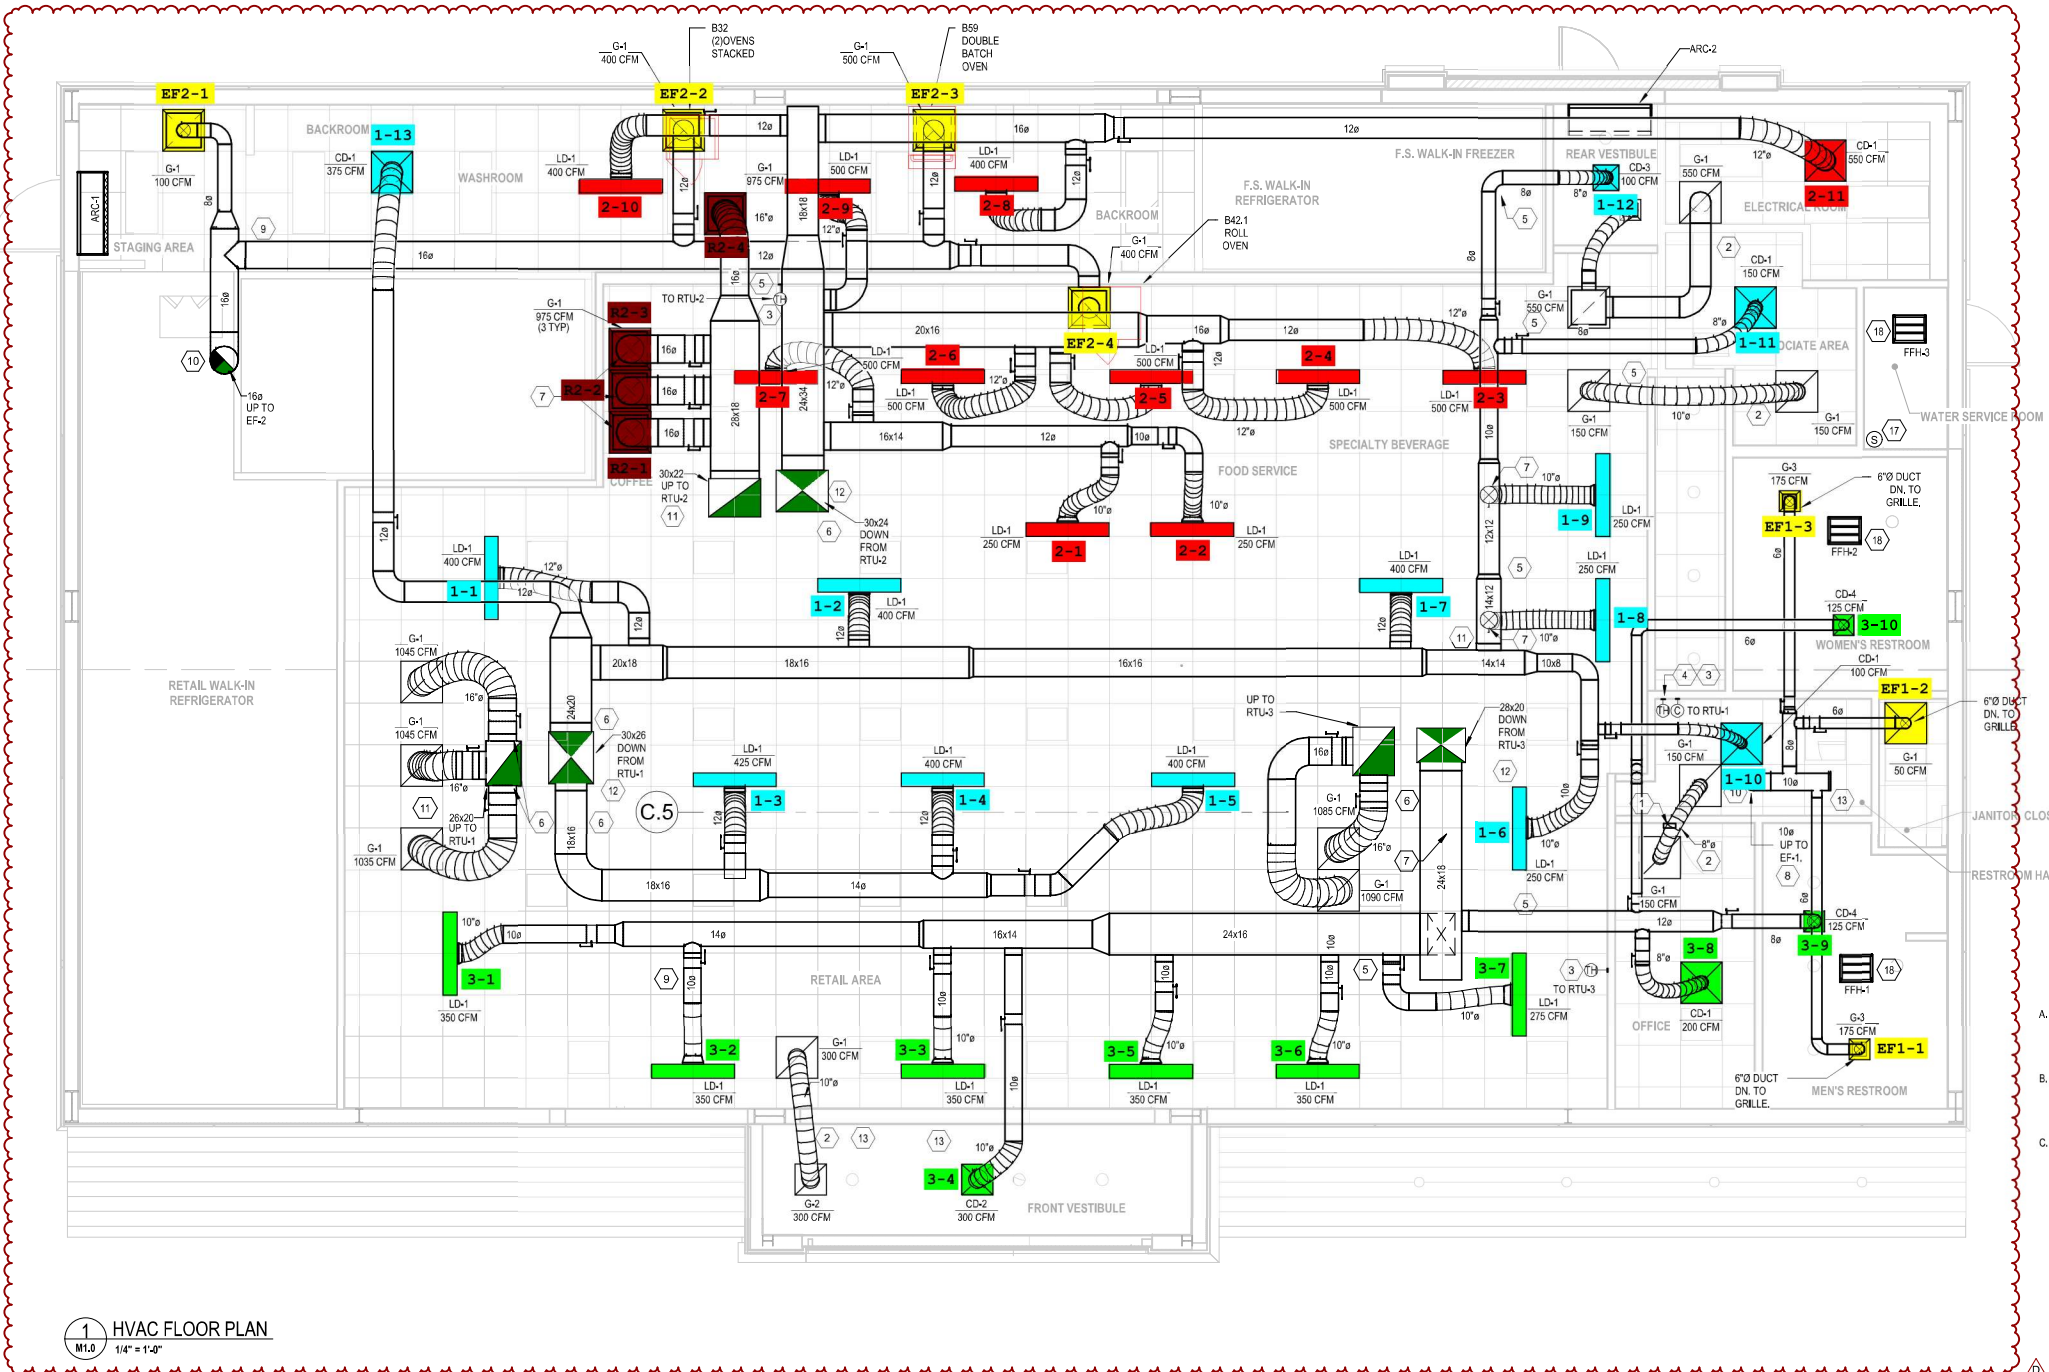
1 HVAC FLOOR PLAN
 M.T.O. 1/4" = 1'-0"

EF1-2 Janitorial closet diffuser not installed, lying above ceiling. Not suspecting this to be major cause for cfm loss.
 EF1 speed controller max speed.

EF2/BOH

Asset									
Asset Name	Location	Type	Size	DESIGN CFM	AK	CFM(1)	CFM(2)	FINAL CFM	% to design
EGRD1	STAGING AREA	G-1	8"	100		169	205	205	205.0
EGRD2	WASHROOM	G-1	12"	400		158	203	203	50.8
EGRD3	BACKROOM	G-1	12"	500		209	259	259	51.8
EGRD4	FOOD SERVICE	G-1	12"	400		190	202	202	50.5
Total				1400		726	869	869	62.07%
